# **STS-71 SPACE SHUTTLE MISSION REPORT**

August 1995

**National Aeronautics and  
Space Administration**

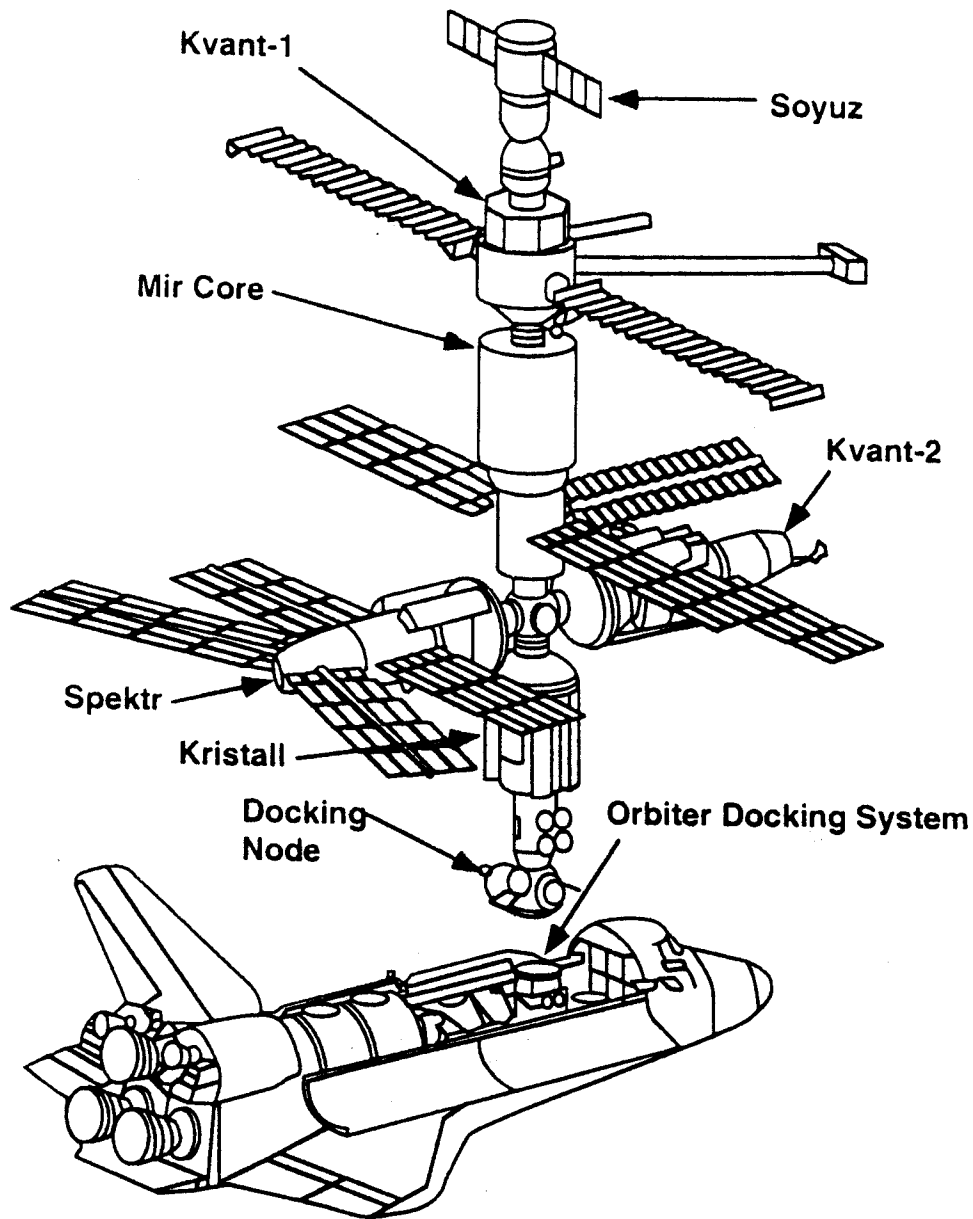
**Orbiter Docking System Mating  
 to Mir Space Station**

Both Atlantis and the Mir were equipped with an APDS that had a three-petal androgynous capture ring mounted on six interconnected ball screw shock absorbers, which arrest the relative motion between the two vehicles and prevent a collision. The Orbiter crew's primary visual aid for aligning the docking mechanism during rendezvous was a television camera that was mounted inside the airlock of the ODS. The camera

viewed a target at the center of the Mir mechanism through a window in the upper hatch.

- a. It is more compact with an overall external diameter of 60 inches compared to 80 inches for the ASTP, although the inner egress tunnel diameter remains approximately the same;
- b. The APDS docking mechanism has 12 structural latches, compared to eight on the ASTP unit;
- c. The APDS guide ring and extend/retract mechanism are packaged inside the egress tunnel rather than being outside of the mechanism as they were on ASTP; and
- d. The three guide petals on the APDS point inboard rather than outboard.
