NAVY DEPARTMENT
OFFICE OF NAVAL RECORDS AND LIBRARY
HISTORICAL SECTION

Publication Number 4

“THE NORTHERN BARRAGE”
(TAKING UP THE MINES)

Taking Up the Mines.

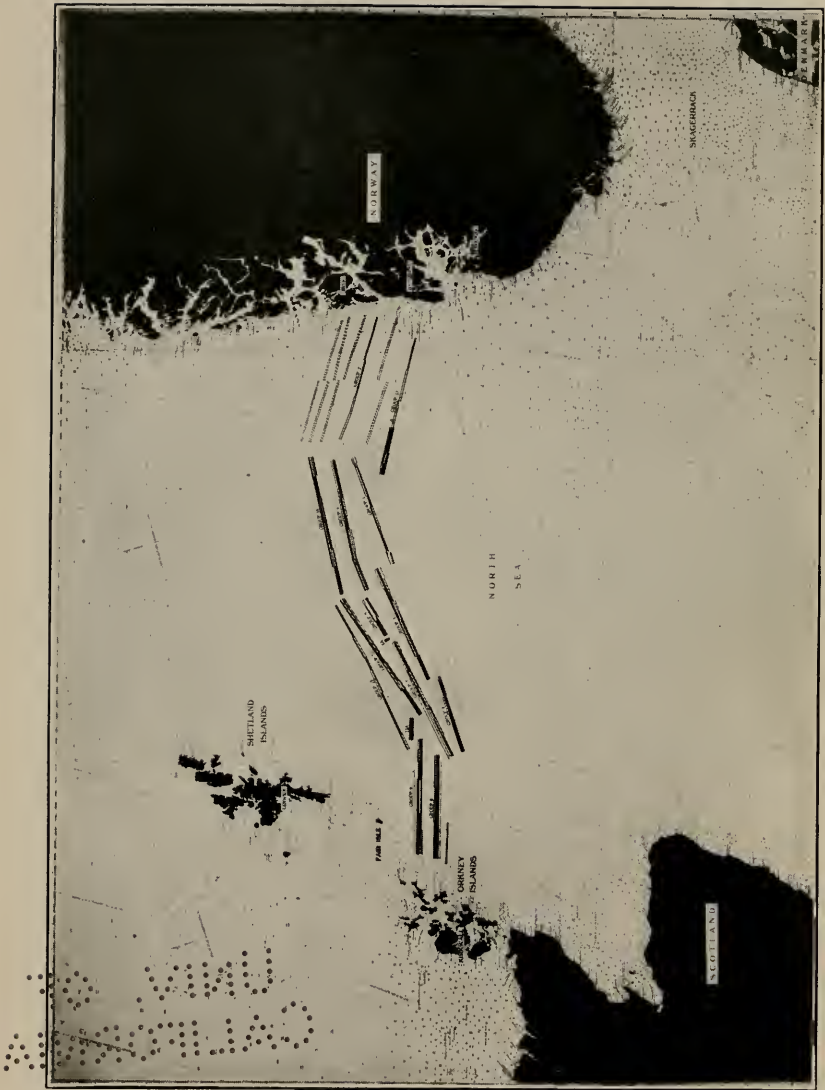
Frontispiece.

The North Sea mine barrage consisting of 56,611 American and 13,652 British mines. The dotted lines indicate British mine fields.

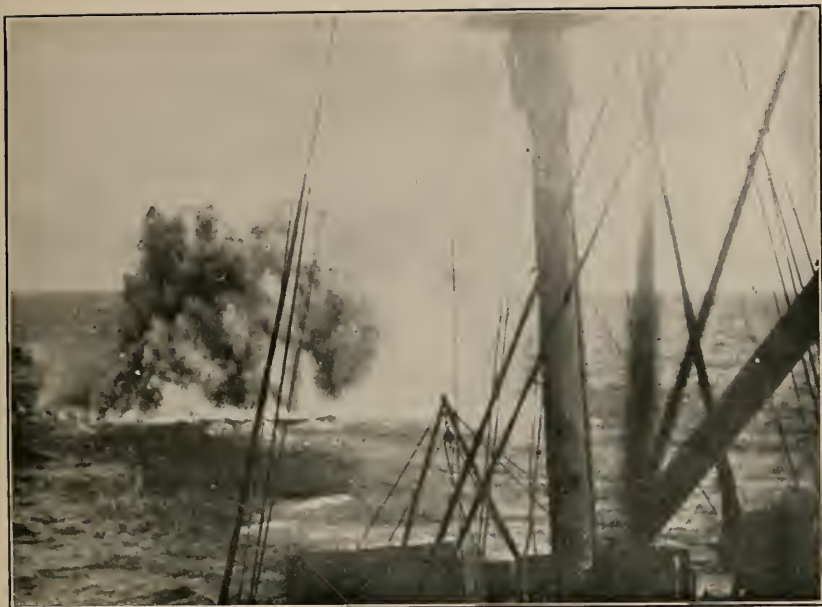
Explosion of mine on contact with sweeping cable electrically charged. (Pages 10-16.)

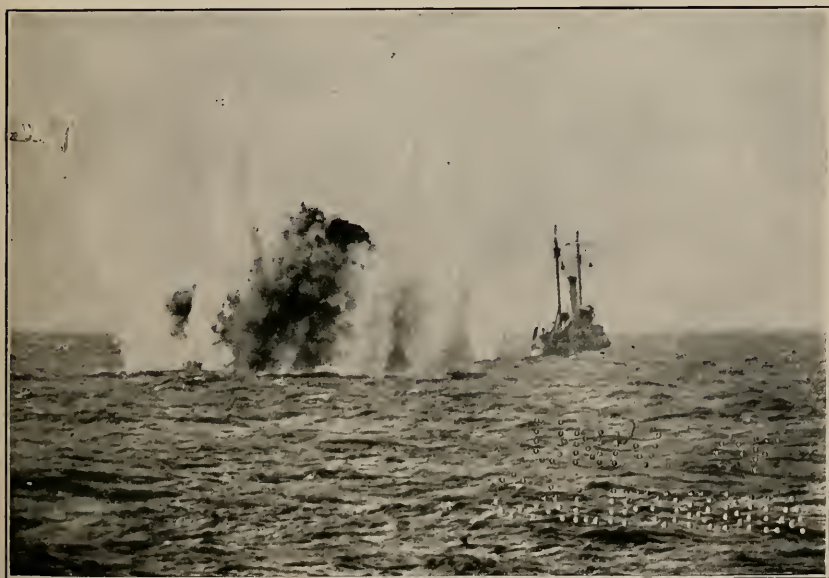
A mine explosion close astern the U. S. S. Patapsco. The black gases of combustion can be seen in the center of the explosion. (Page 40.)

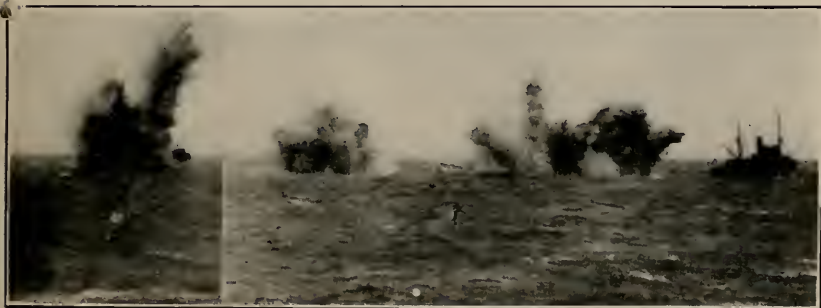
Three explosions between the Lapwing and Penguin. (Page 40.)

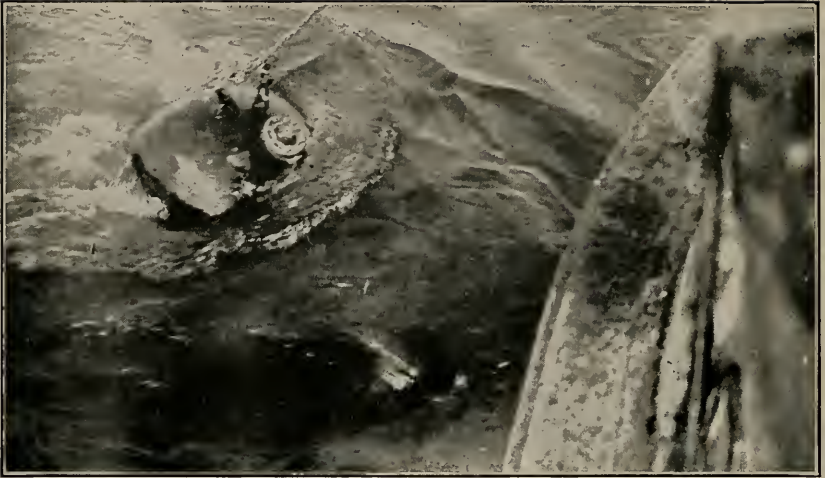
A mine foul of the U. S. S. Patuxent's kite. The mine exploded in less than a minute after this picture was taken. (Page 27.)

The *Patuxent* was the first victim. On May 12 the sweep had been severed by an explosion and had to be hauled on board to be repaired. When the kite was within sight a mine could be seen hanging by its mooring cable. The commanding officer immediately sent all hands forward to a place of safety, going aft himself to clear it with the assistance of his chief boatswain's mate. The mine was on the surface about 10 feet from the side of the ship when suddenly, without apparent cause, it exploded. Several men were blown overboard by the mass of flying water, but all were rescued. The commanding officer, who at the time of the explosion was only a few feet from the mine, escaped with the loss of his thumb, which was amputated by a flying fragment. Since the force of the explosion had been largely spent in the air, the damage to the ship was not serious, and a few days in dry dock were sufficient to repair her.

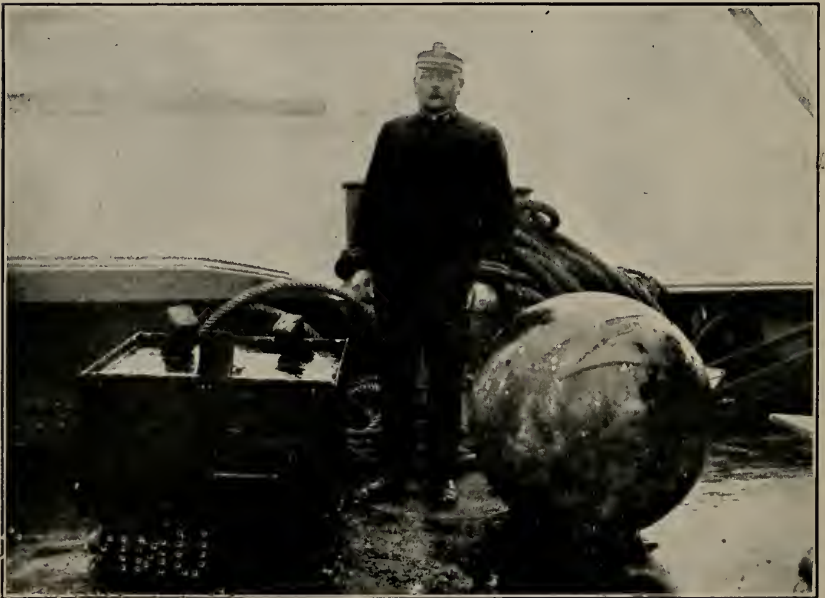
A complete mine recovered during sweeping operations. T. N. T. lying on the deck. (Page 27.)

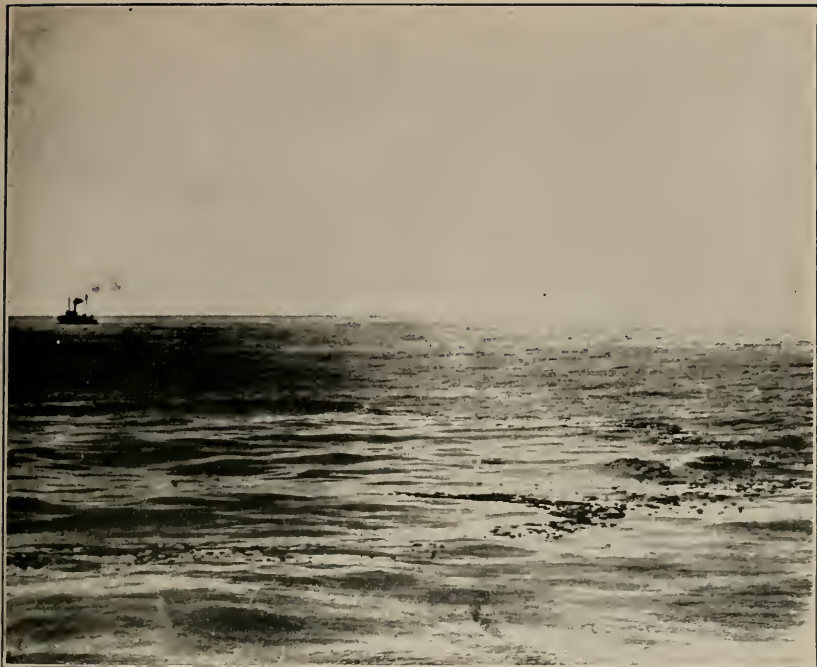
Explosion of deepest level mine. A circle of brown discolored water spreading slowly around the vessel. (Page 18.)

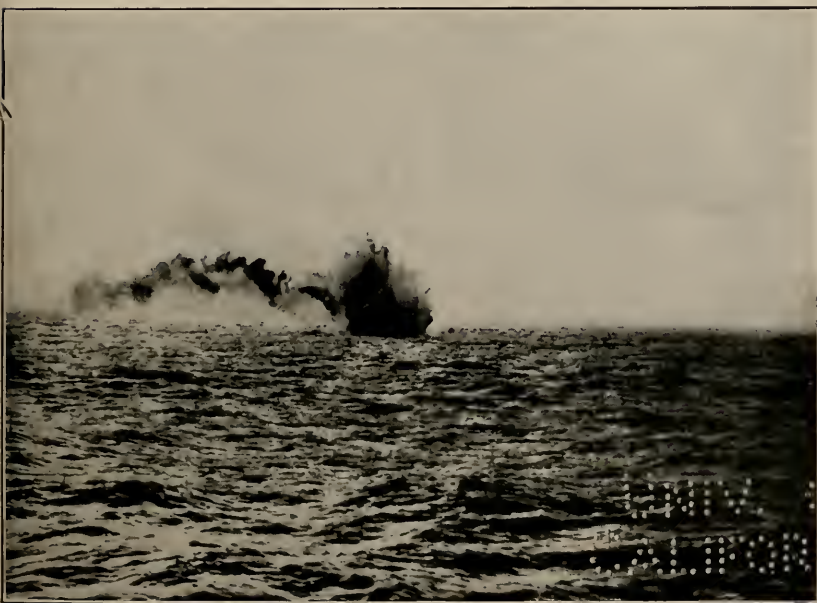
U. S. S. Bobolink in the midst of a mine explosion. Completely destroyed May 20, 1919. The vessel's smoke can be seen emerging from the left of the explosion. (Page 28.)

The ship was seriously damaged. The after hull plating had been driven in in places as much as 2 and 3 feet; the rudder and rudder post were gone; the propeller distorted and shaft bent; the engine had been thrown out of line; the towing engine, capstan, searchlights, and many other fixtures had been broken or disabled. The boilers, fortunately, were not damaged, which enabled the wrecking pumps to handle the water which poured into the after part of the ship.

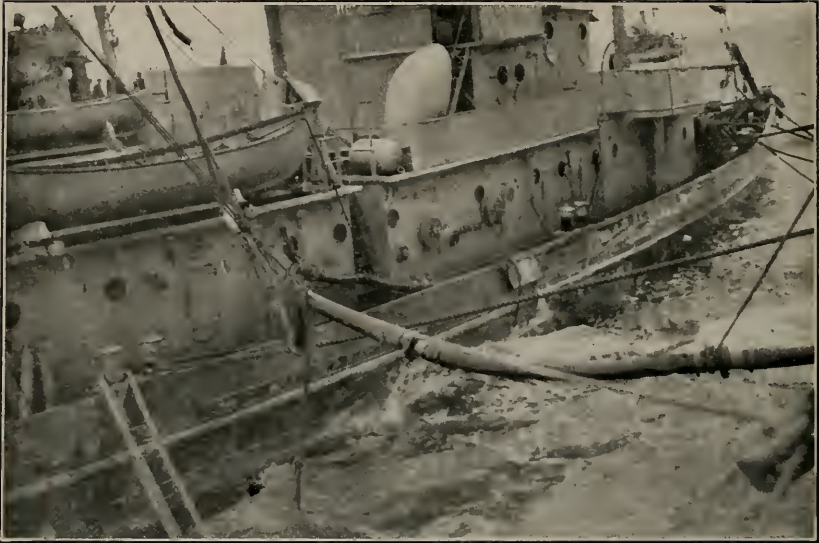
U. S. S. Pelican shortly after she was countermined, showing the pump line from U. S. S. Eider keeping the Pelican afloat. (Page 41.)

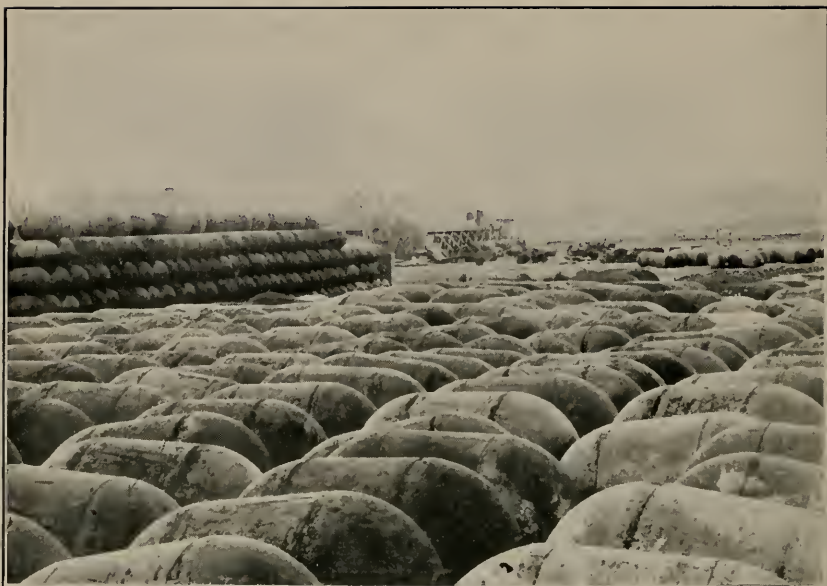
Sphero-cylindrical steel buoys stowed at Carness Point. These buoys were used for marker buoys for the mine fields. (Page 68.)

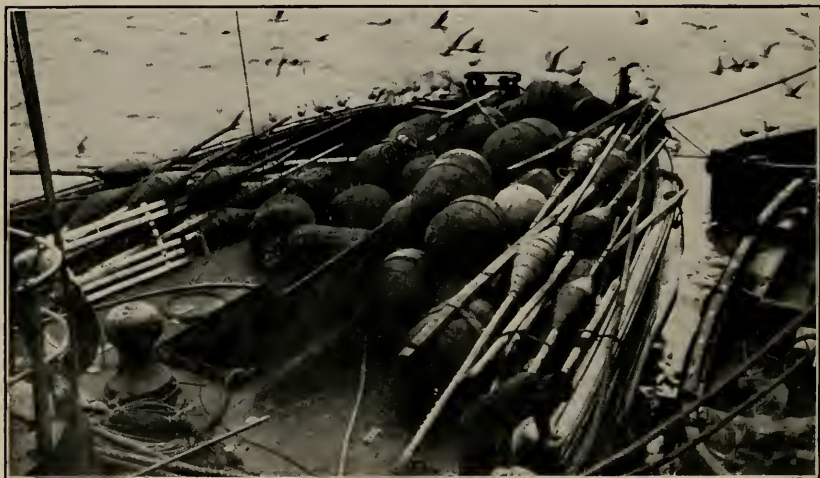
A deckload of marker buoys and dan buoys. The long slender spars with a barrel in the middle are called dan buoys. (Page 68.)
