PROJECT TECHNICAL REPORT
TASK E-72B

LUMINARY 1B DAP PREFLIGHT PERFORMANCE
EVALUATION

NAS 9-8166

13 November 1969

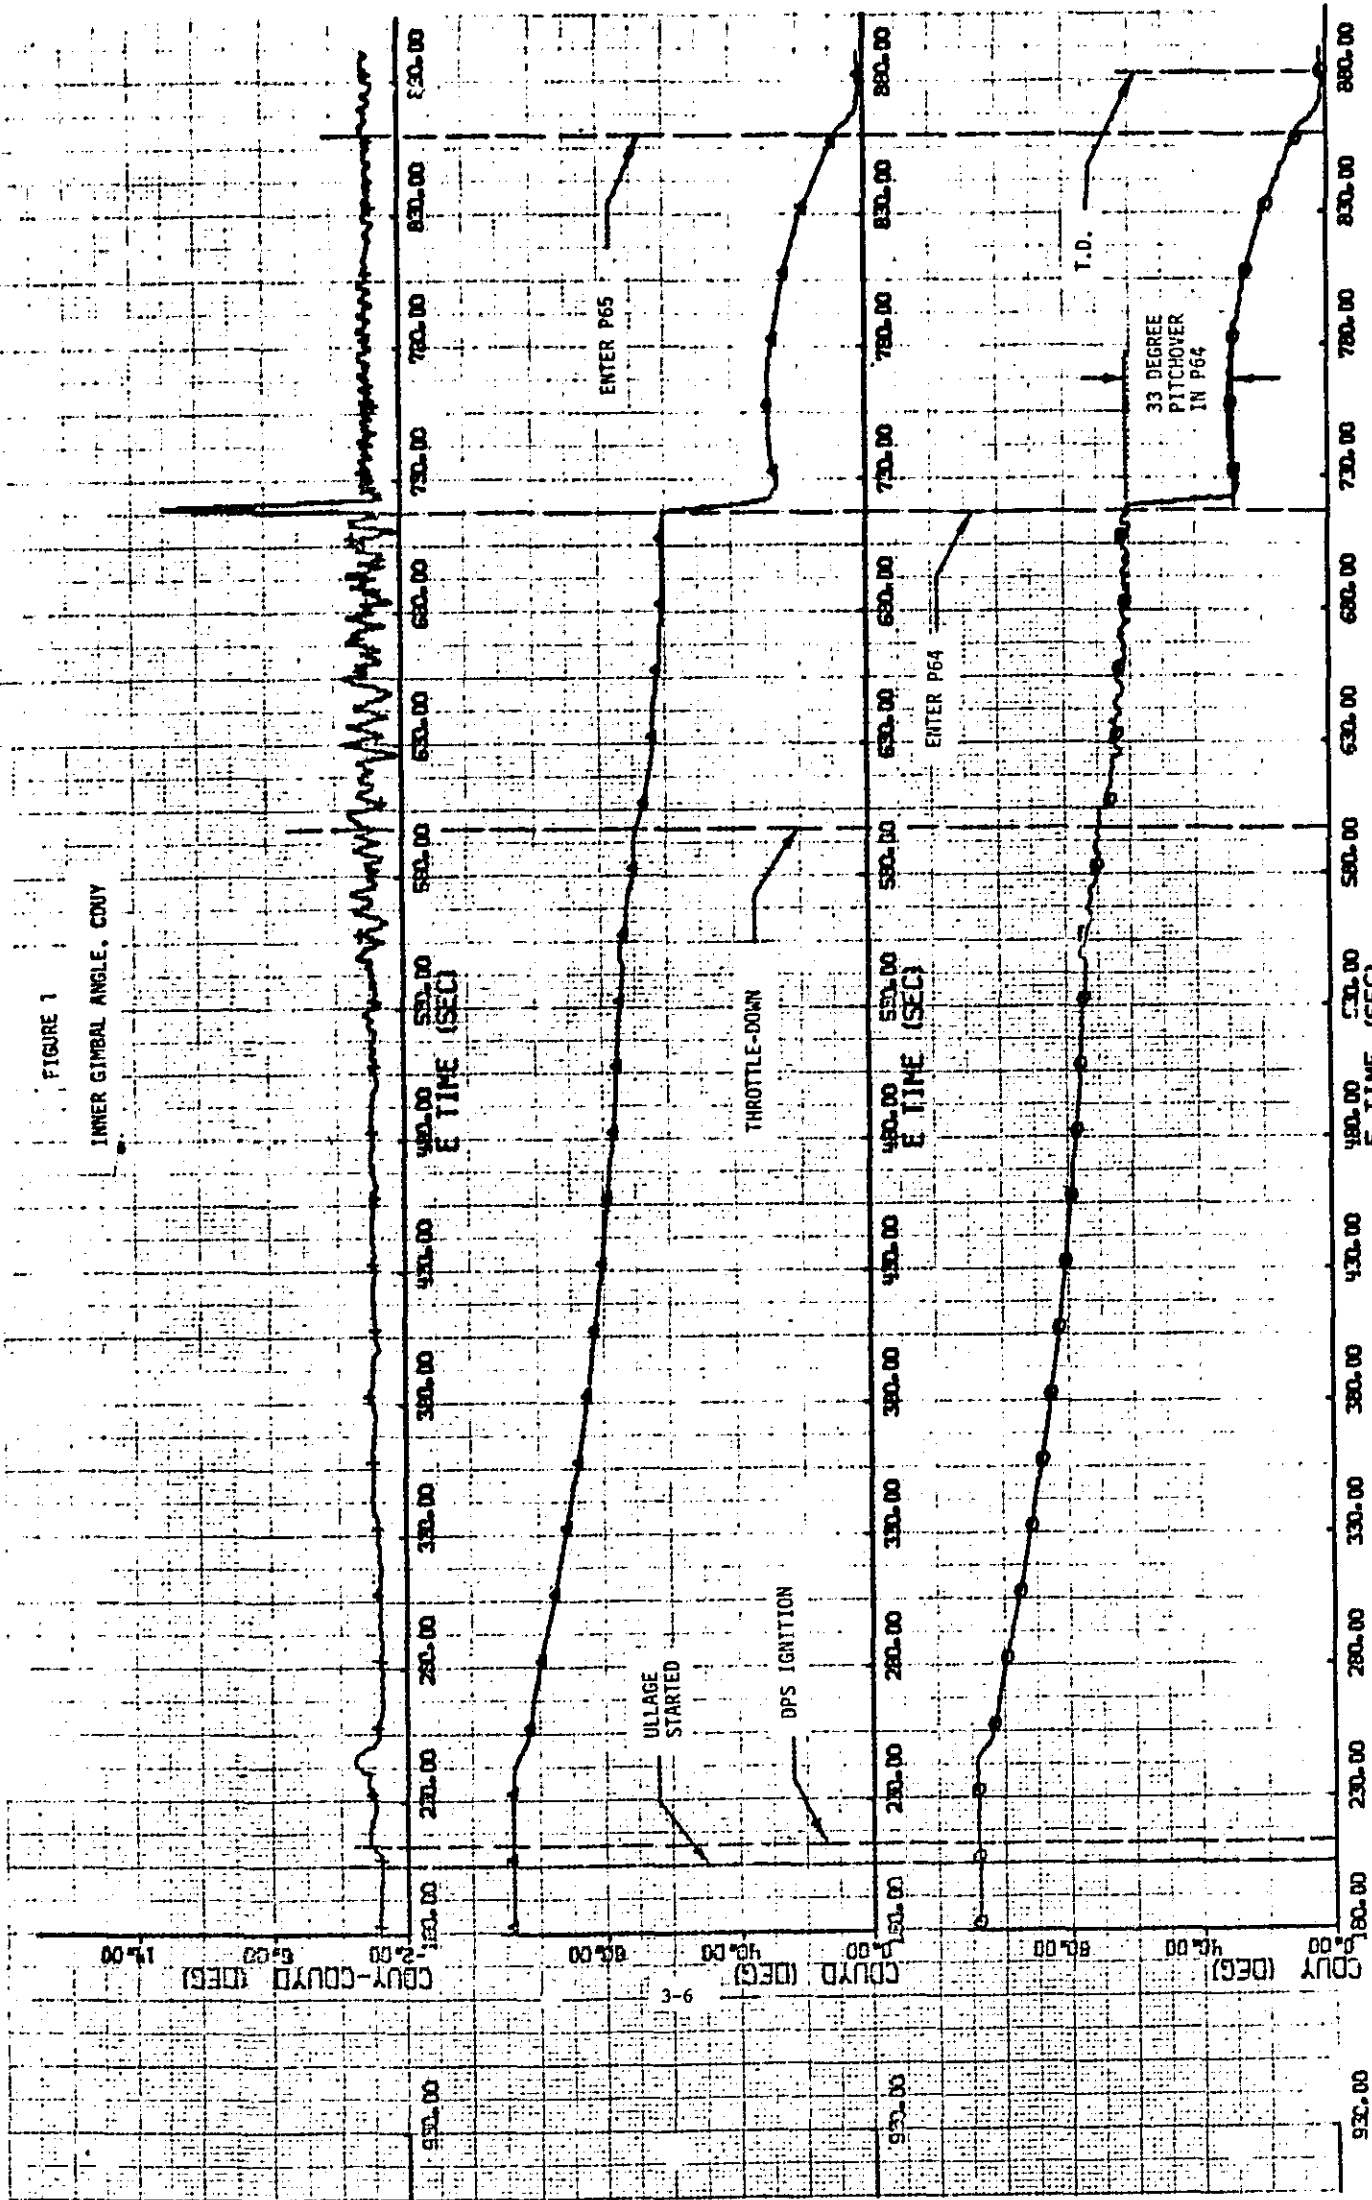
FIGURE 1

INNER GIMBAL ANGLE, CDUV

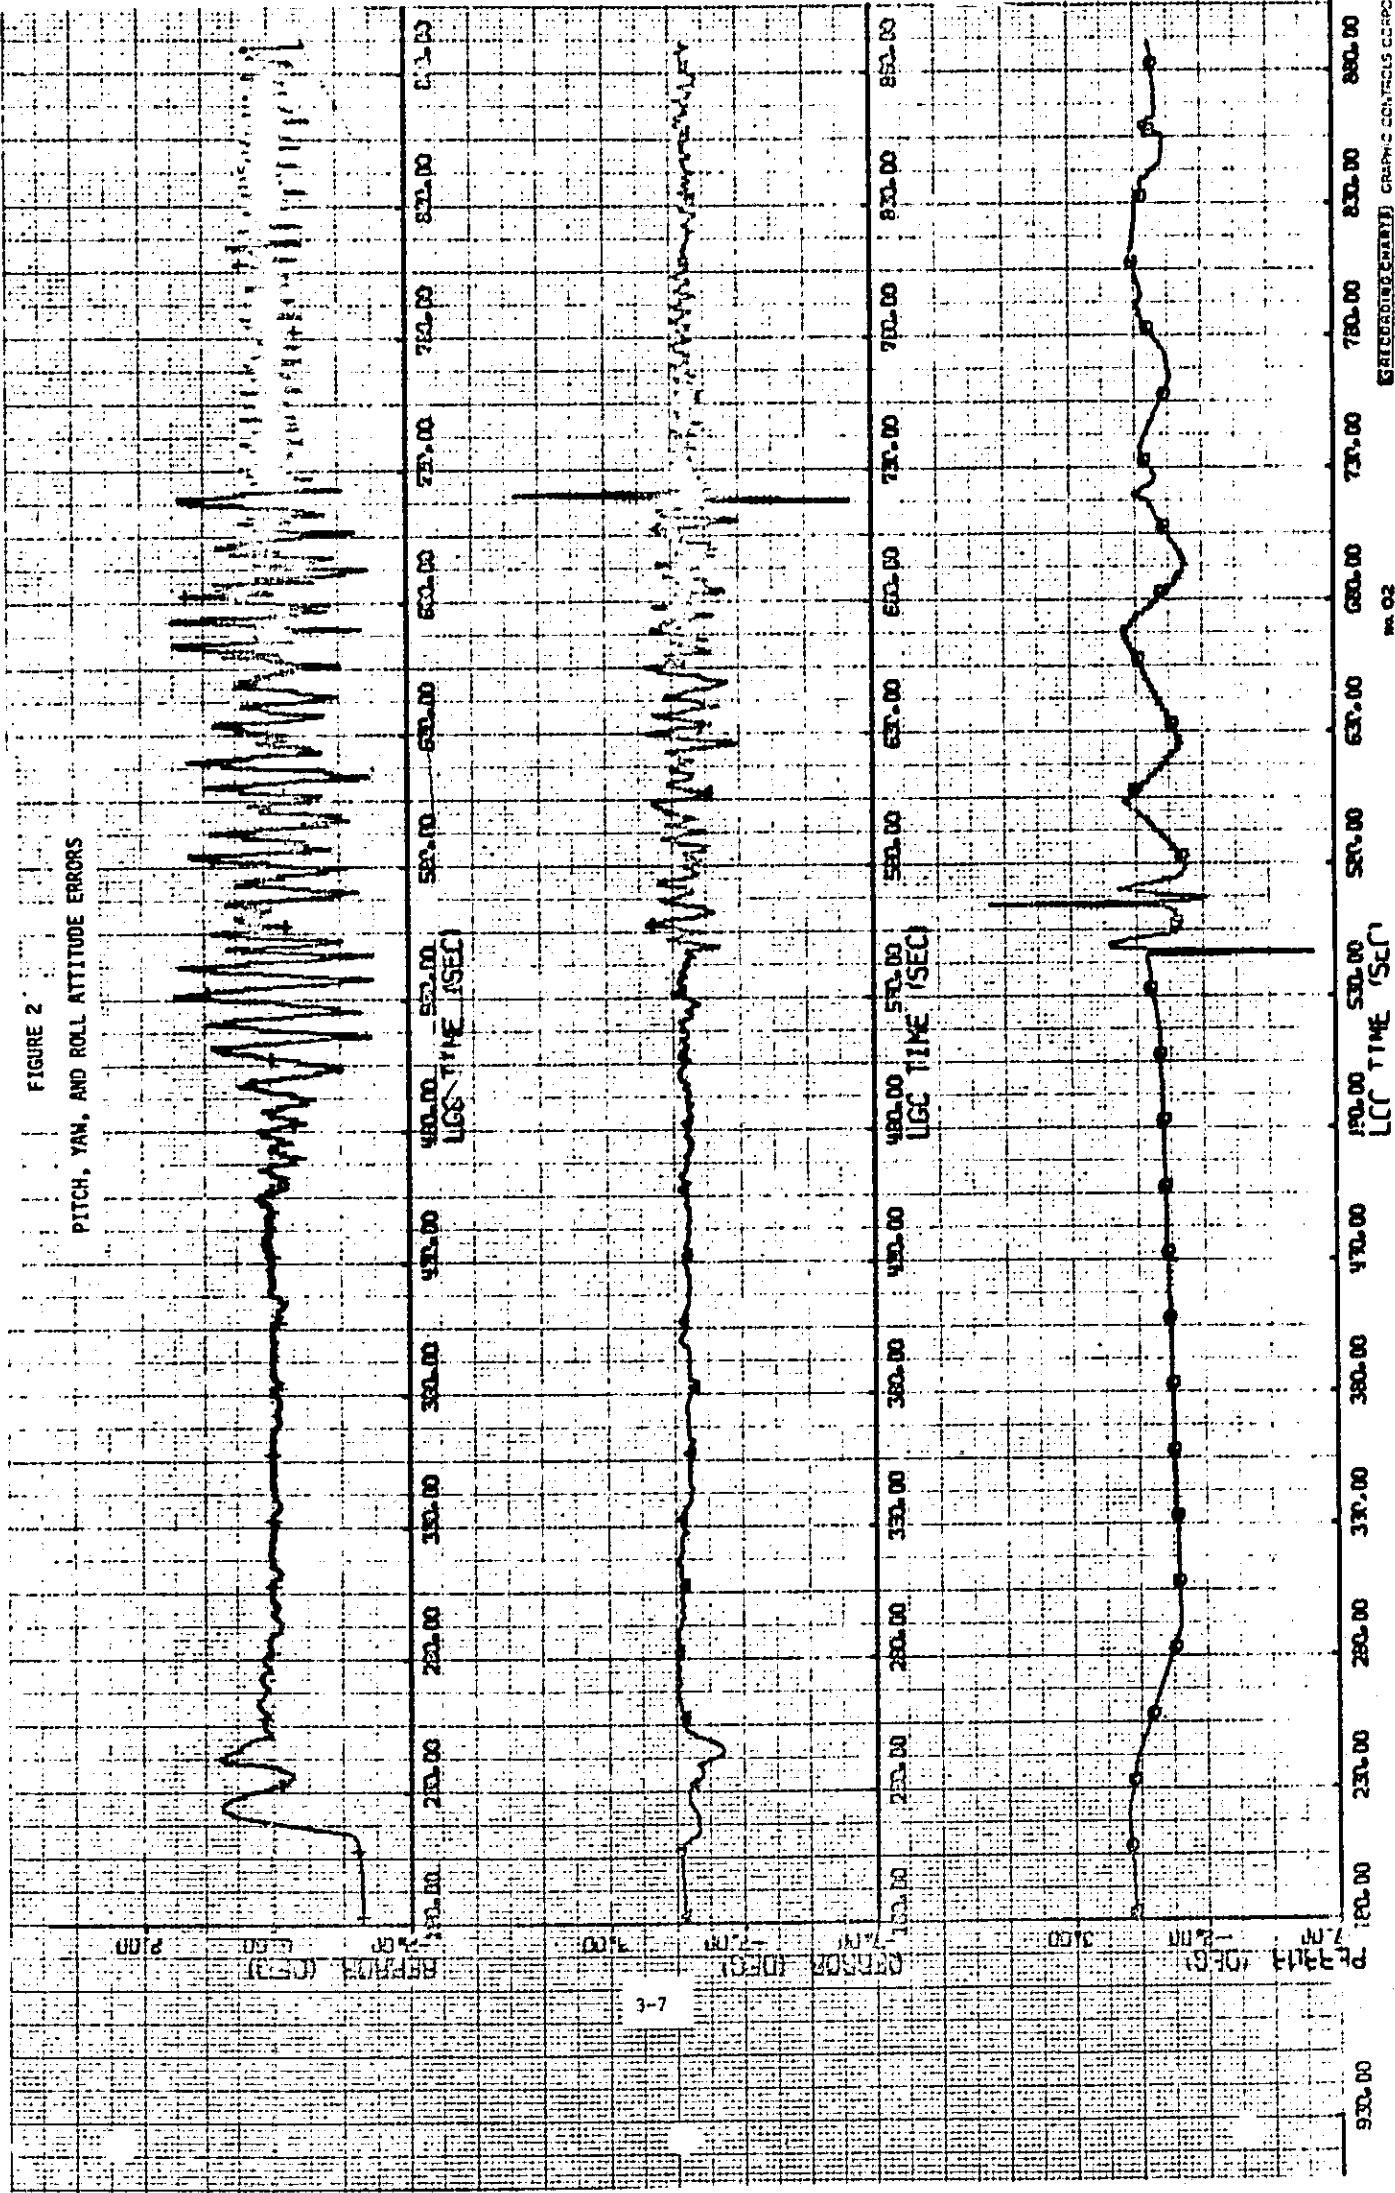
FIGURE 2
 PITCH, YAW, AND ROLL ATTITUDE ERRORS

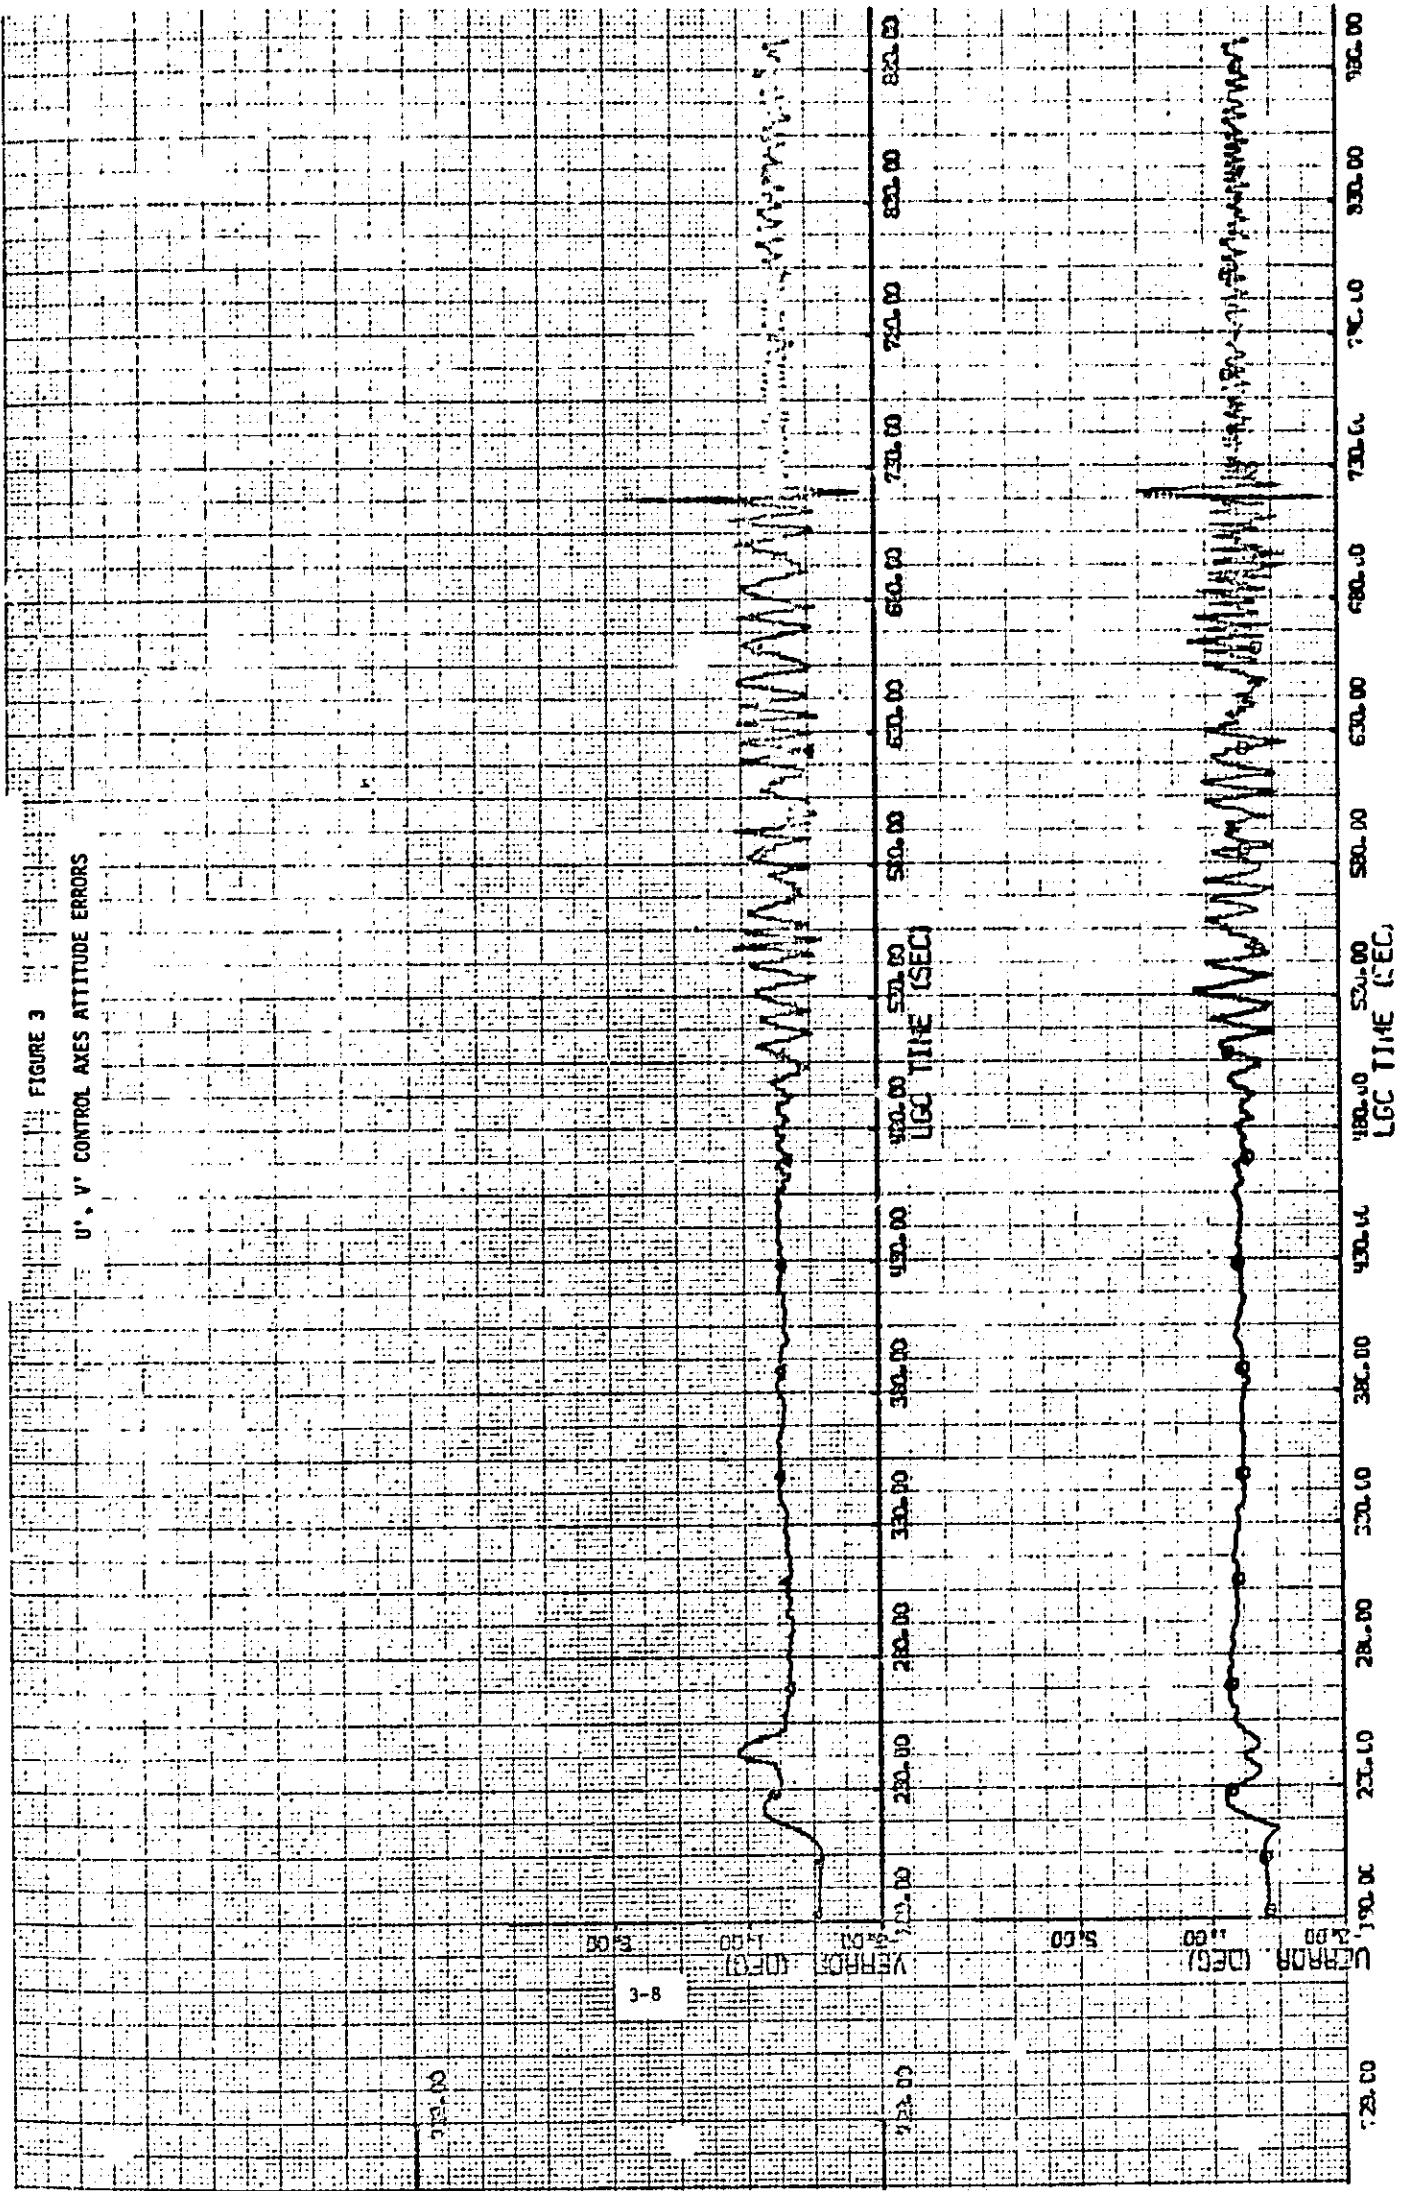
FIGURE 3
U, V CONTROL AXES ATTITUDE ERRORS

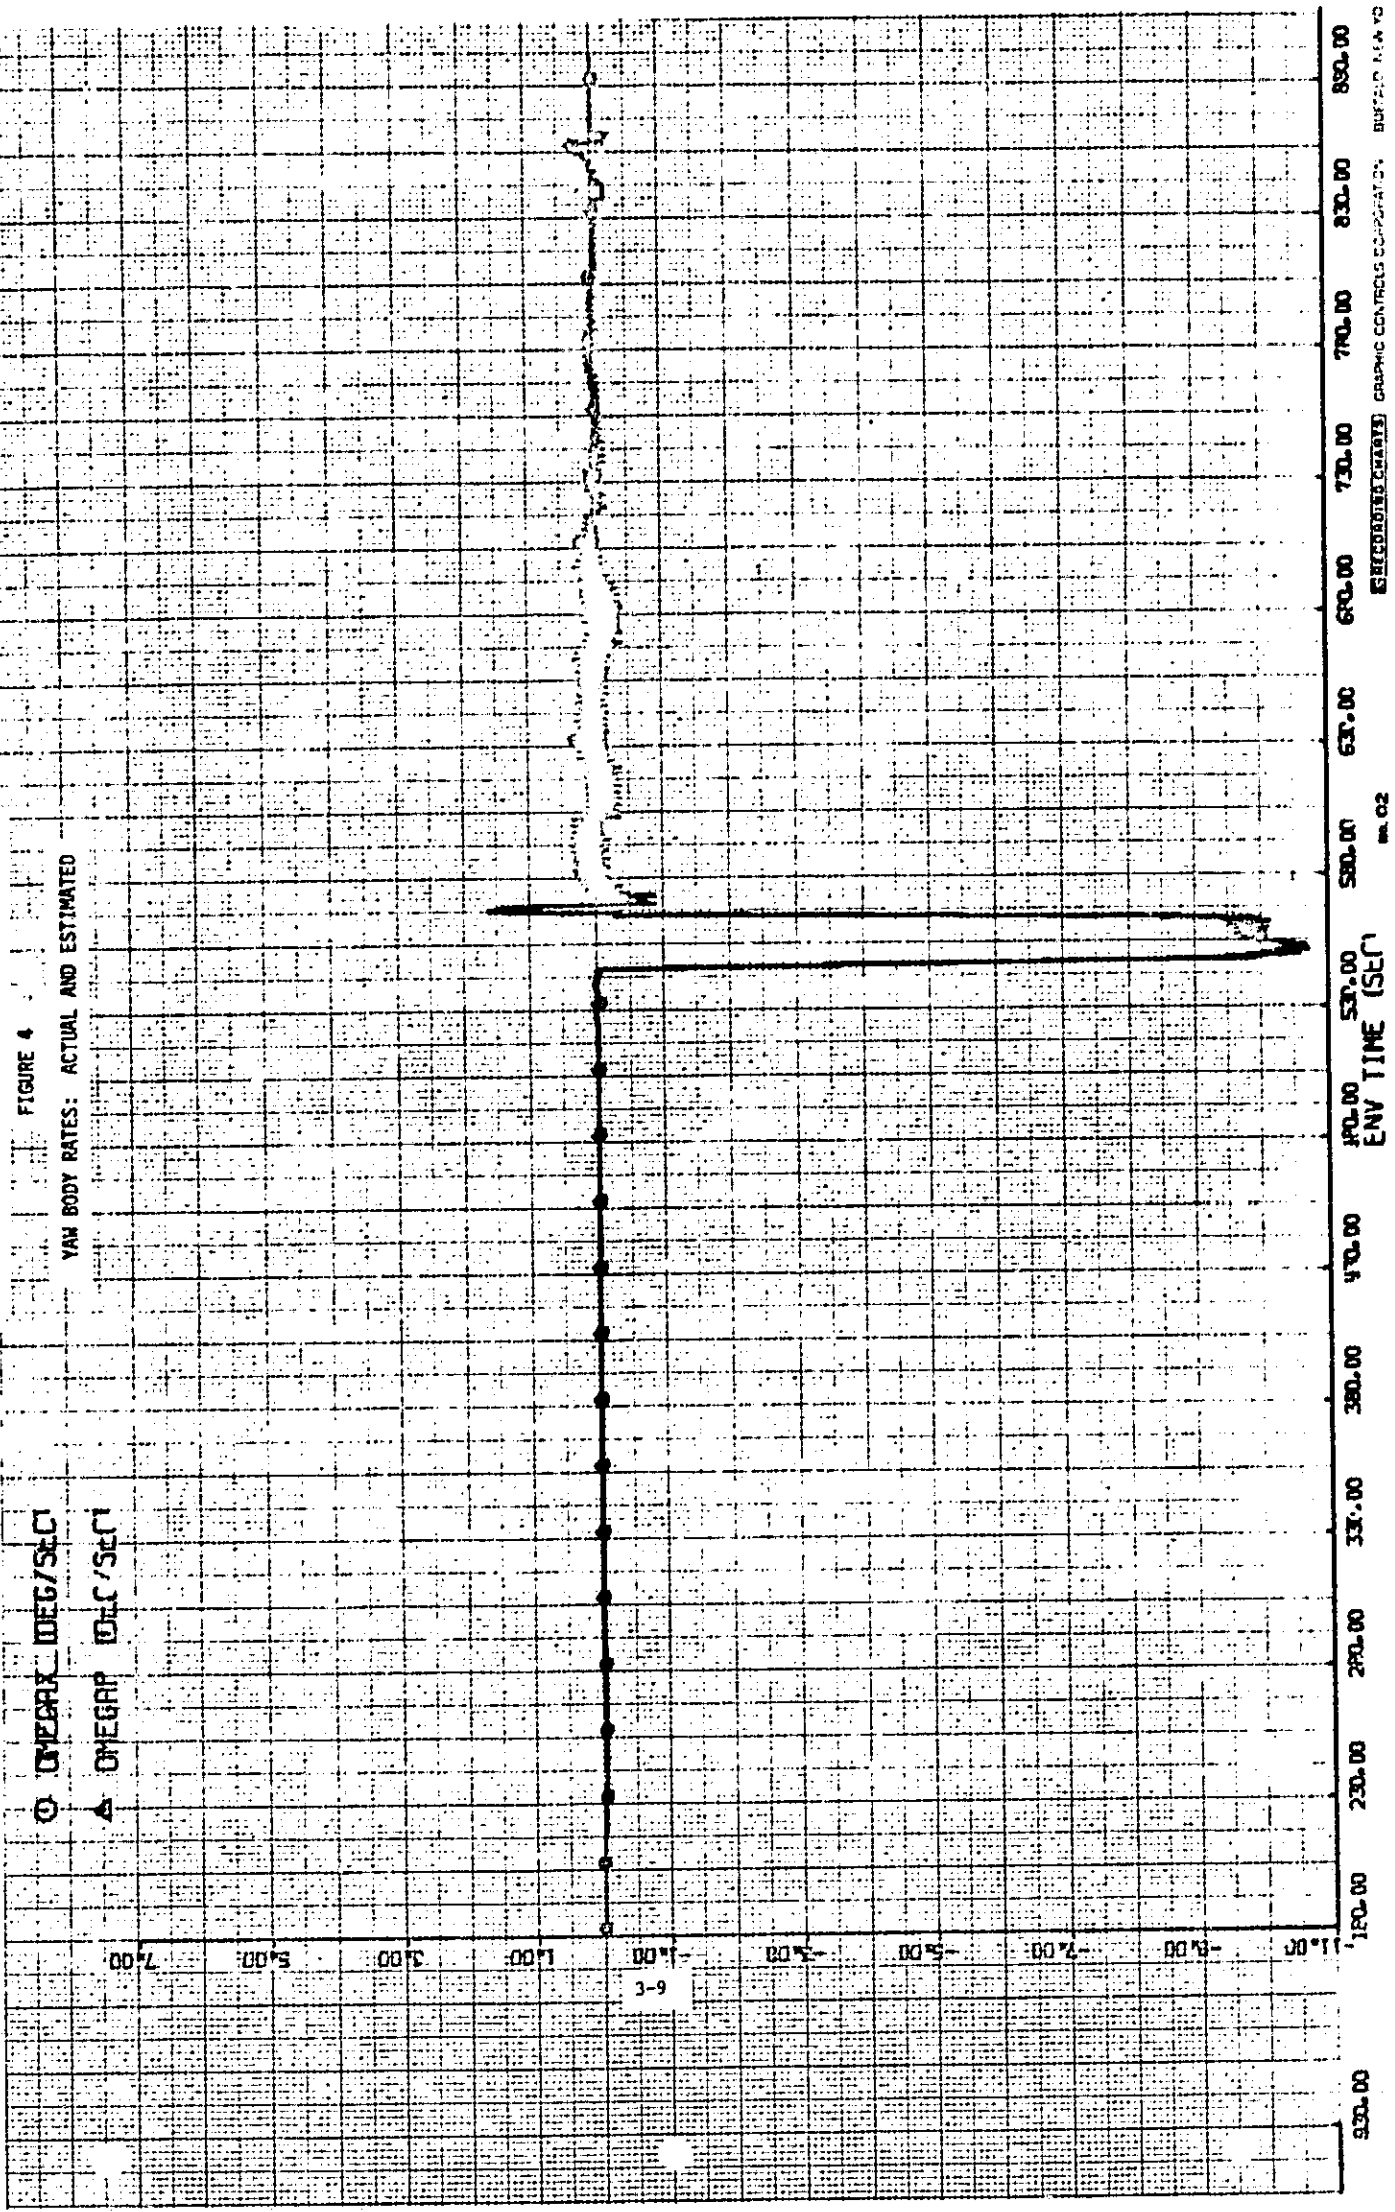
FIGURE 4
YAW BODY RATES: ACTUAL AND ESTIMATED

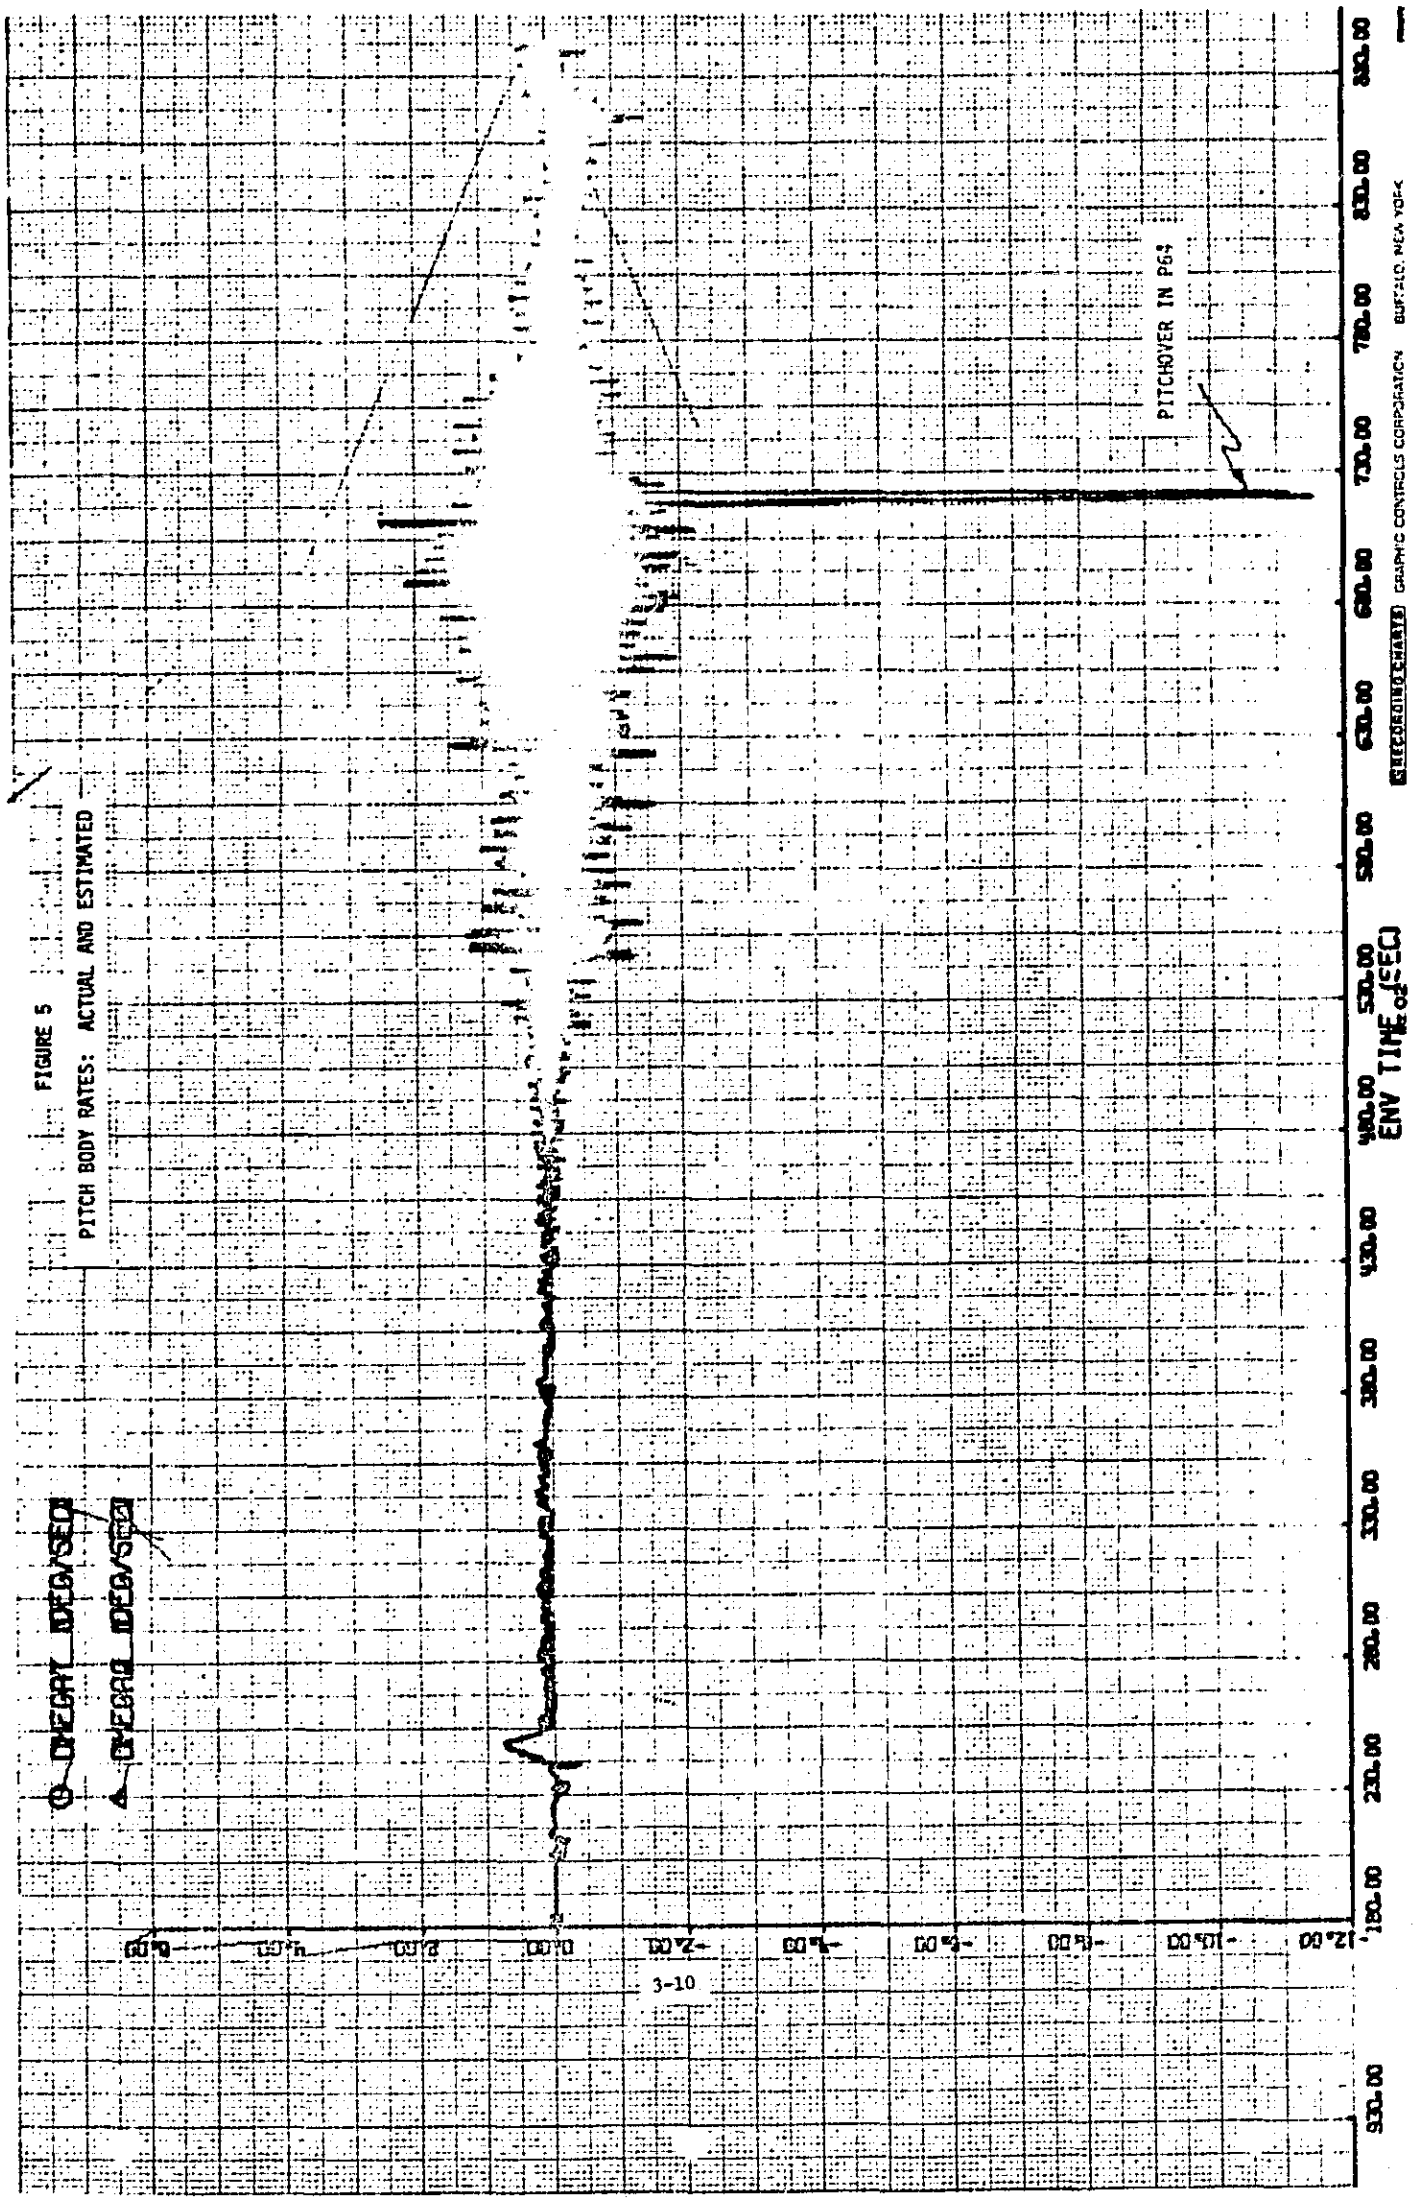
FIGURE 5
 PITCH BODY RATES: ACTUAL AND ESTIMATED

PITCHOVER IN P64

The Visibility Phase program, P64, was entered 504.5 seconds after ignition. The pitchover maneuver started approximately one second after the start of P64. The commanded pitchover angle was 31 degrees and the peak angular rate about the pitch axis during this maneuver was 11.5 deg/sec. Figures 15 and 16 are expanded plots of pitch and roll rates respectively during the pitchover maneuver. It can be seen that there is very little overshoot in the pitch axis during the maneuver. The oscillations seen in these figures are caused by slosh. It is interesting

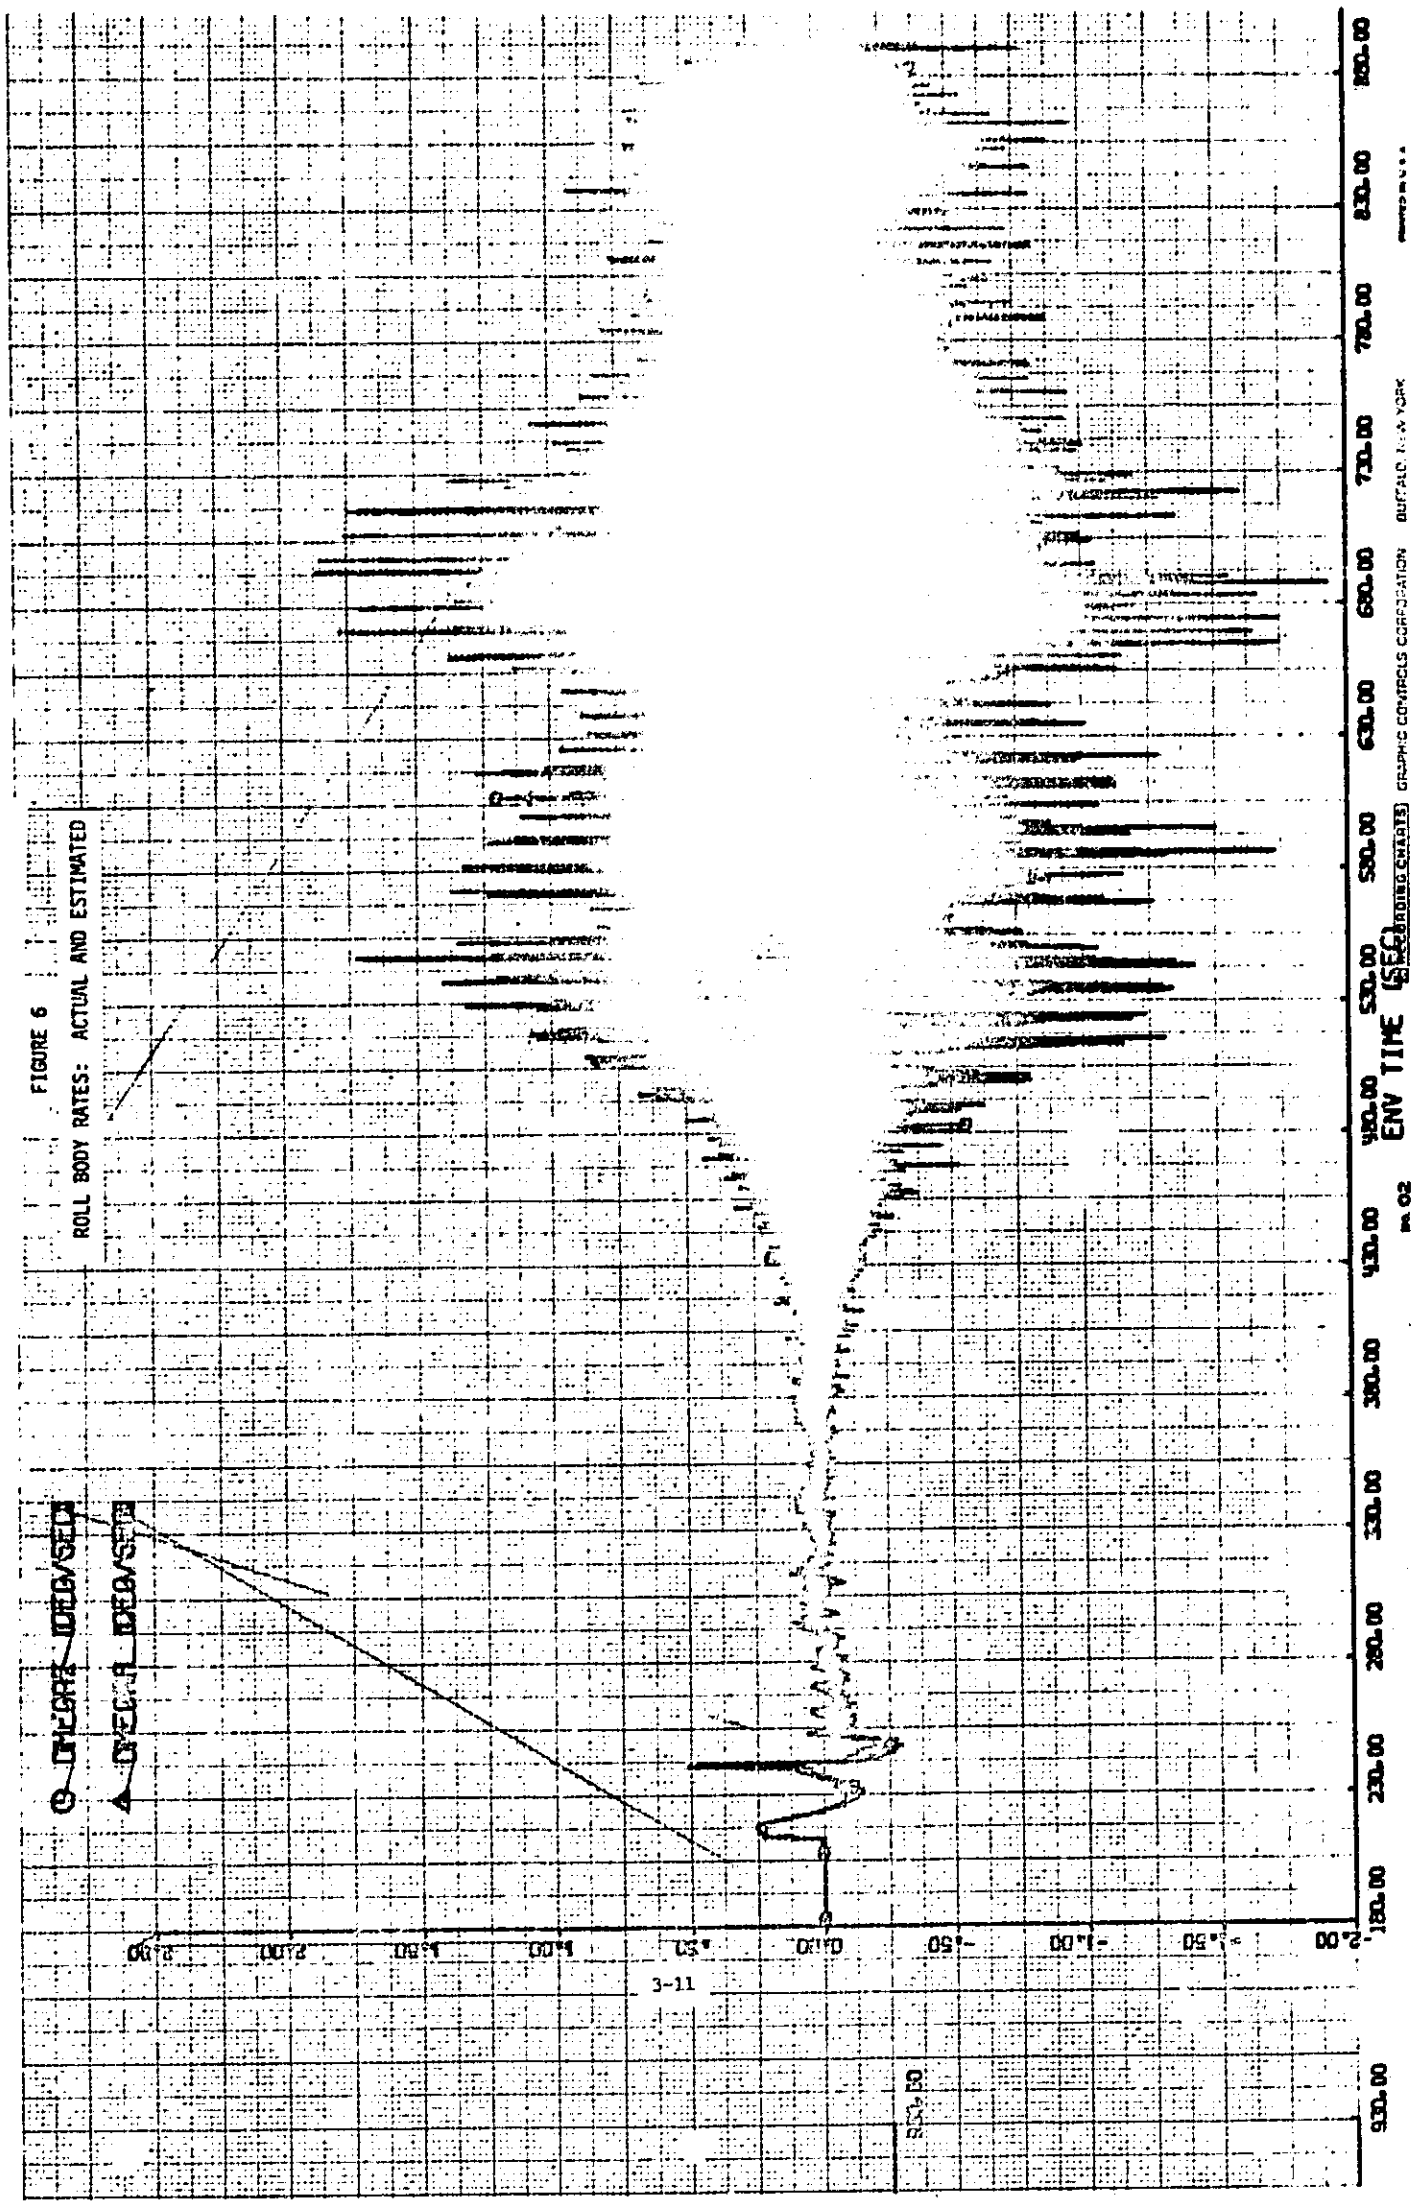
FIGURE 6
ROLL BODY RATES: ACTUAL AND ESTIMATED

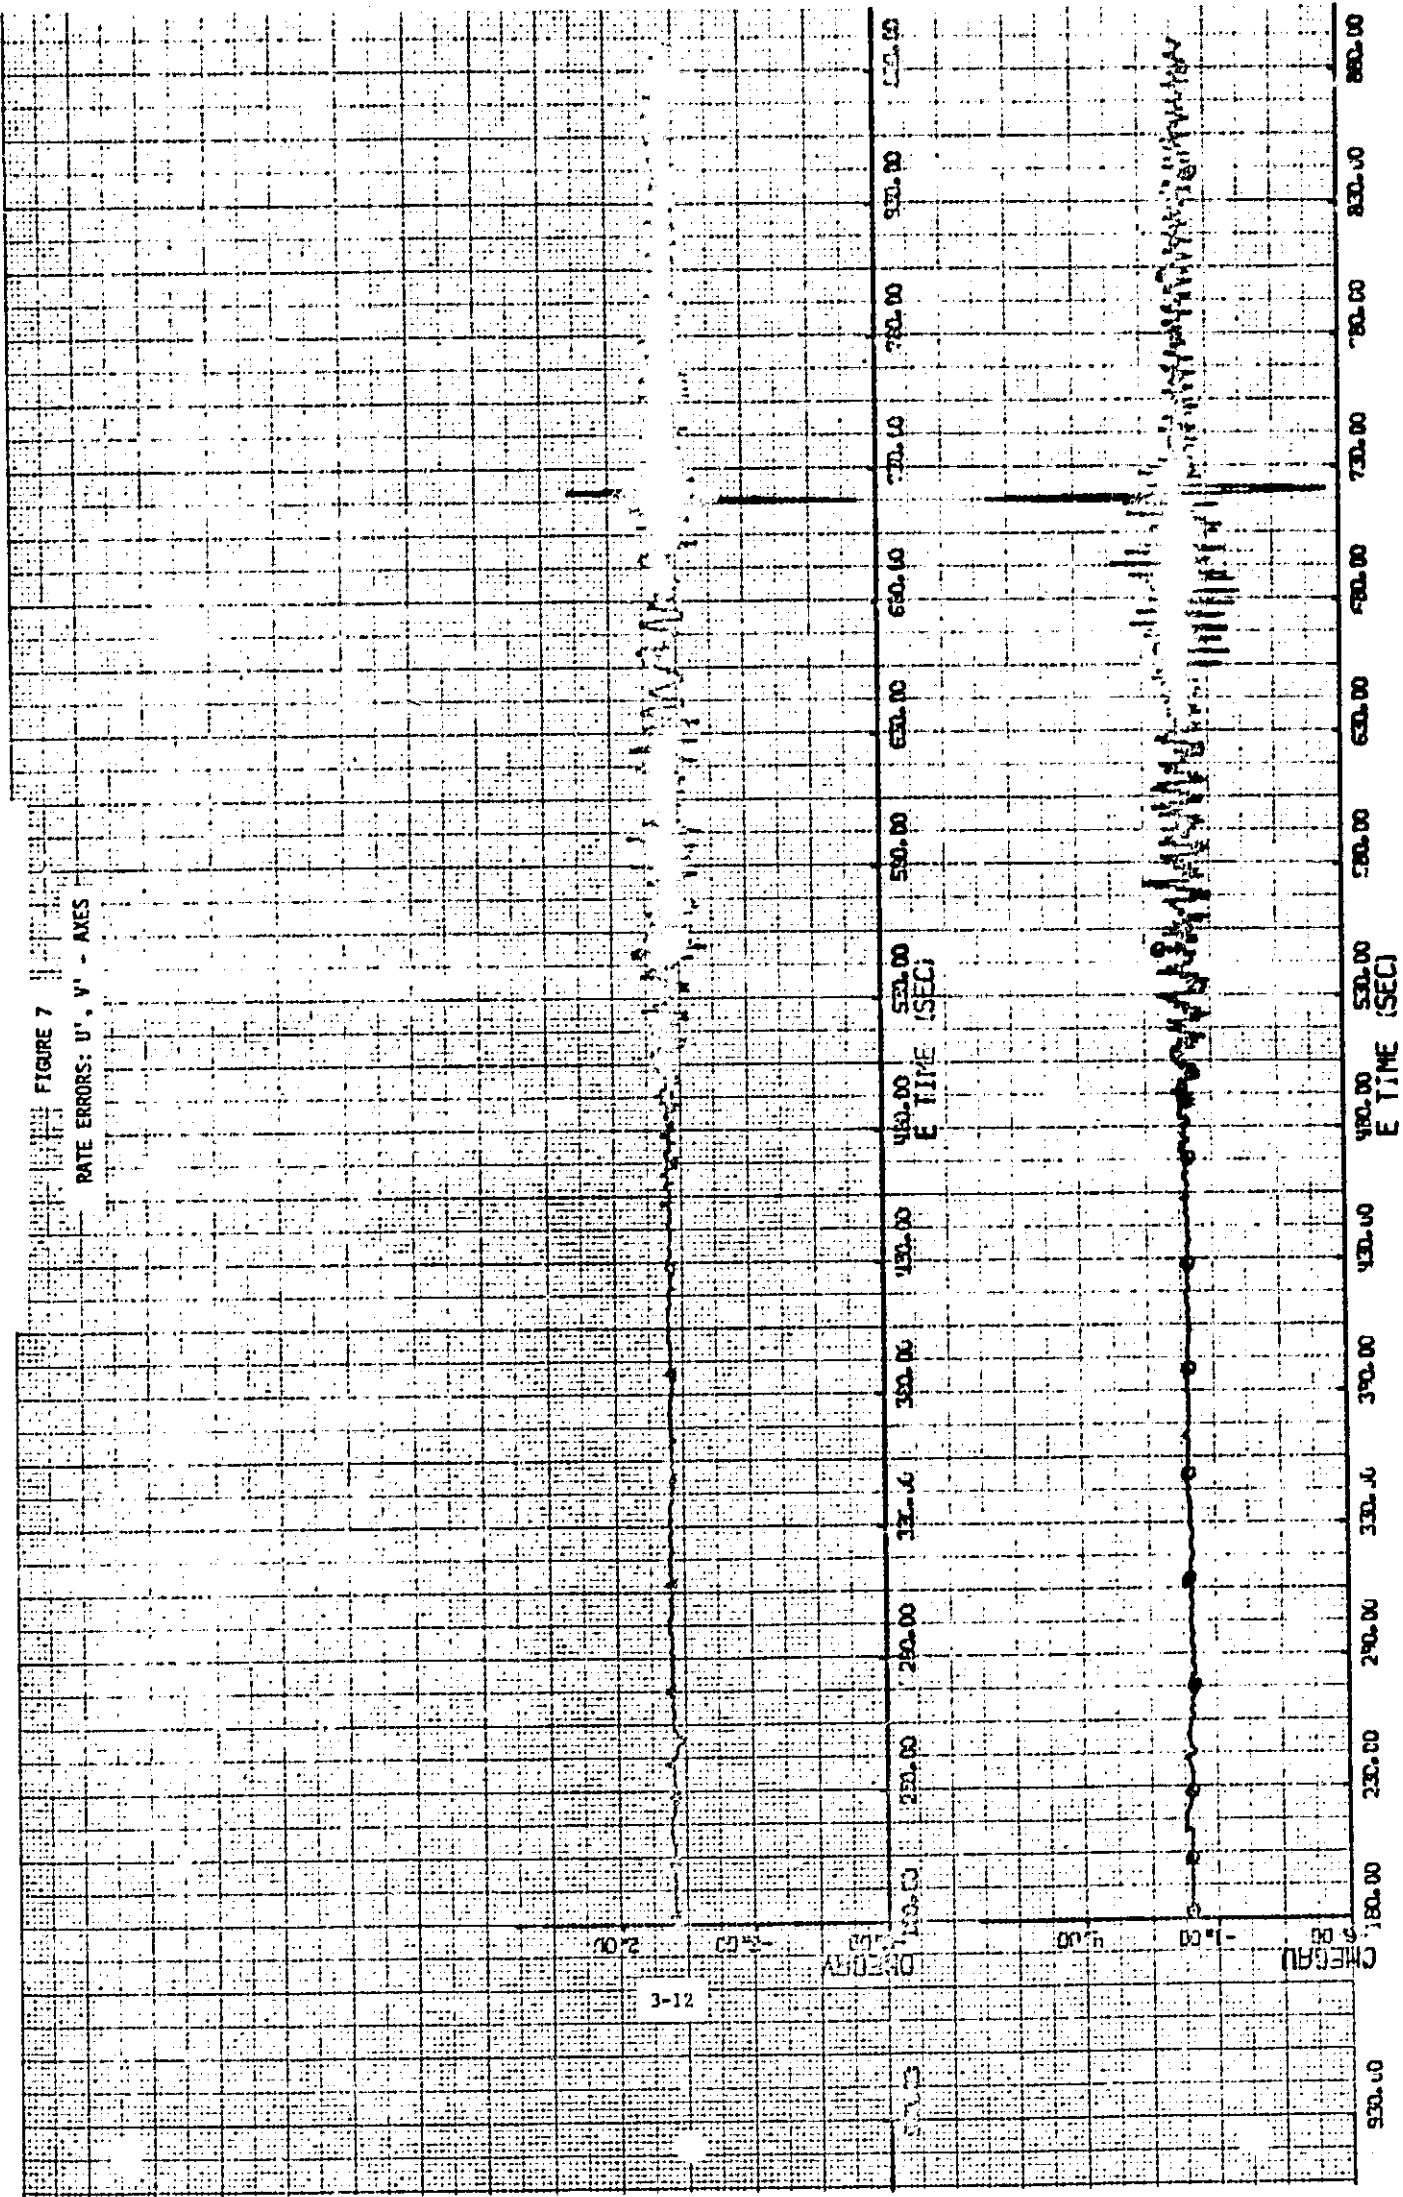
FIGURE 7
RATE ERRORS: U', V' - AXES
