PROJECT TECHNICAL REPORT
TASK E-72B

LUMINARY 1B DAP PREFLIGHT PERFORMANCE
EVALUATION

NAS 9-8166

13 November 1969

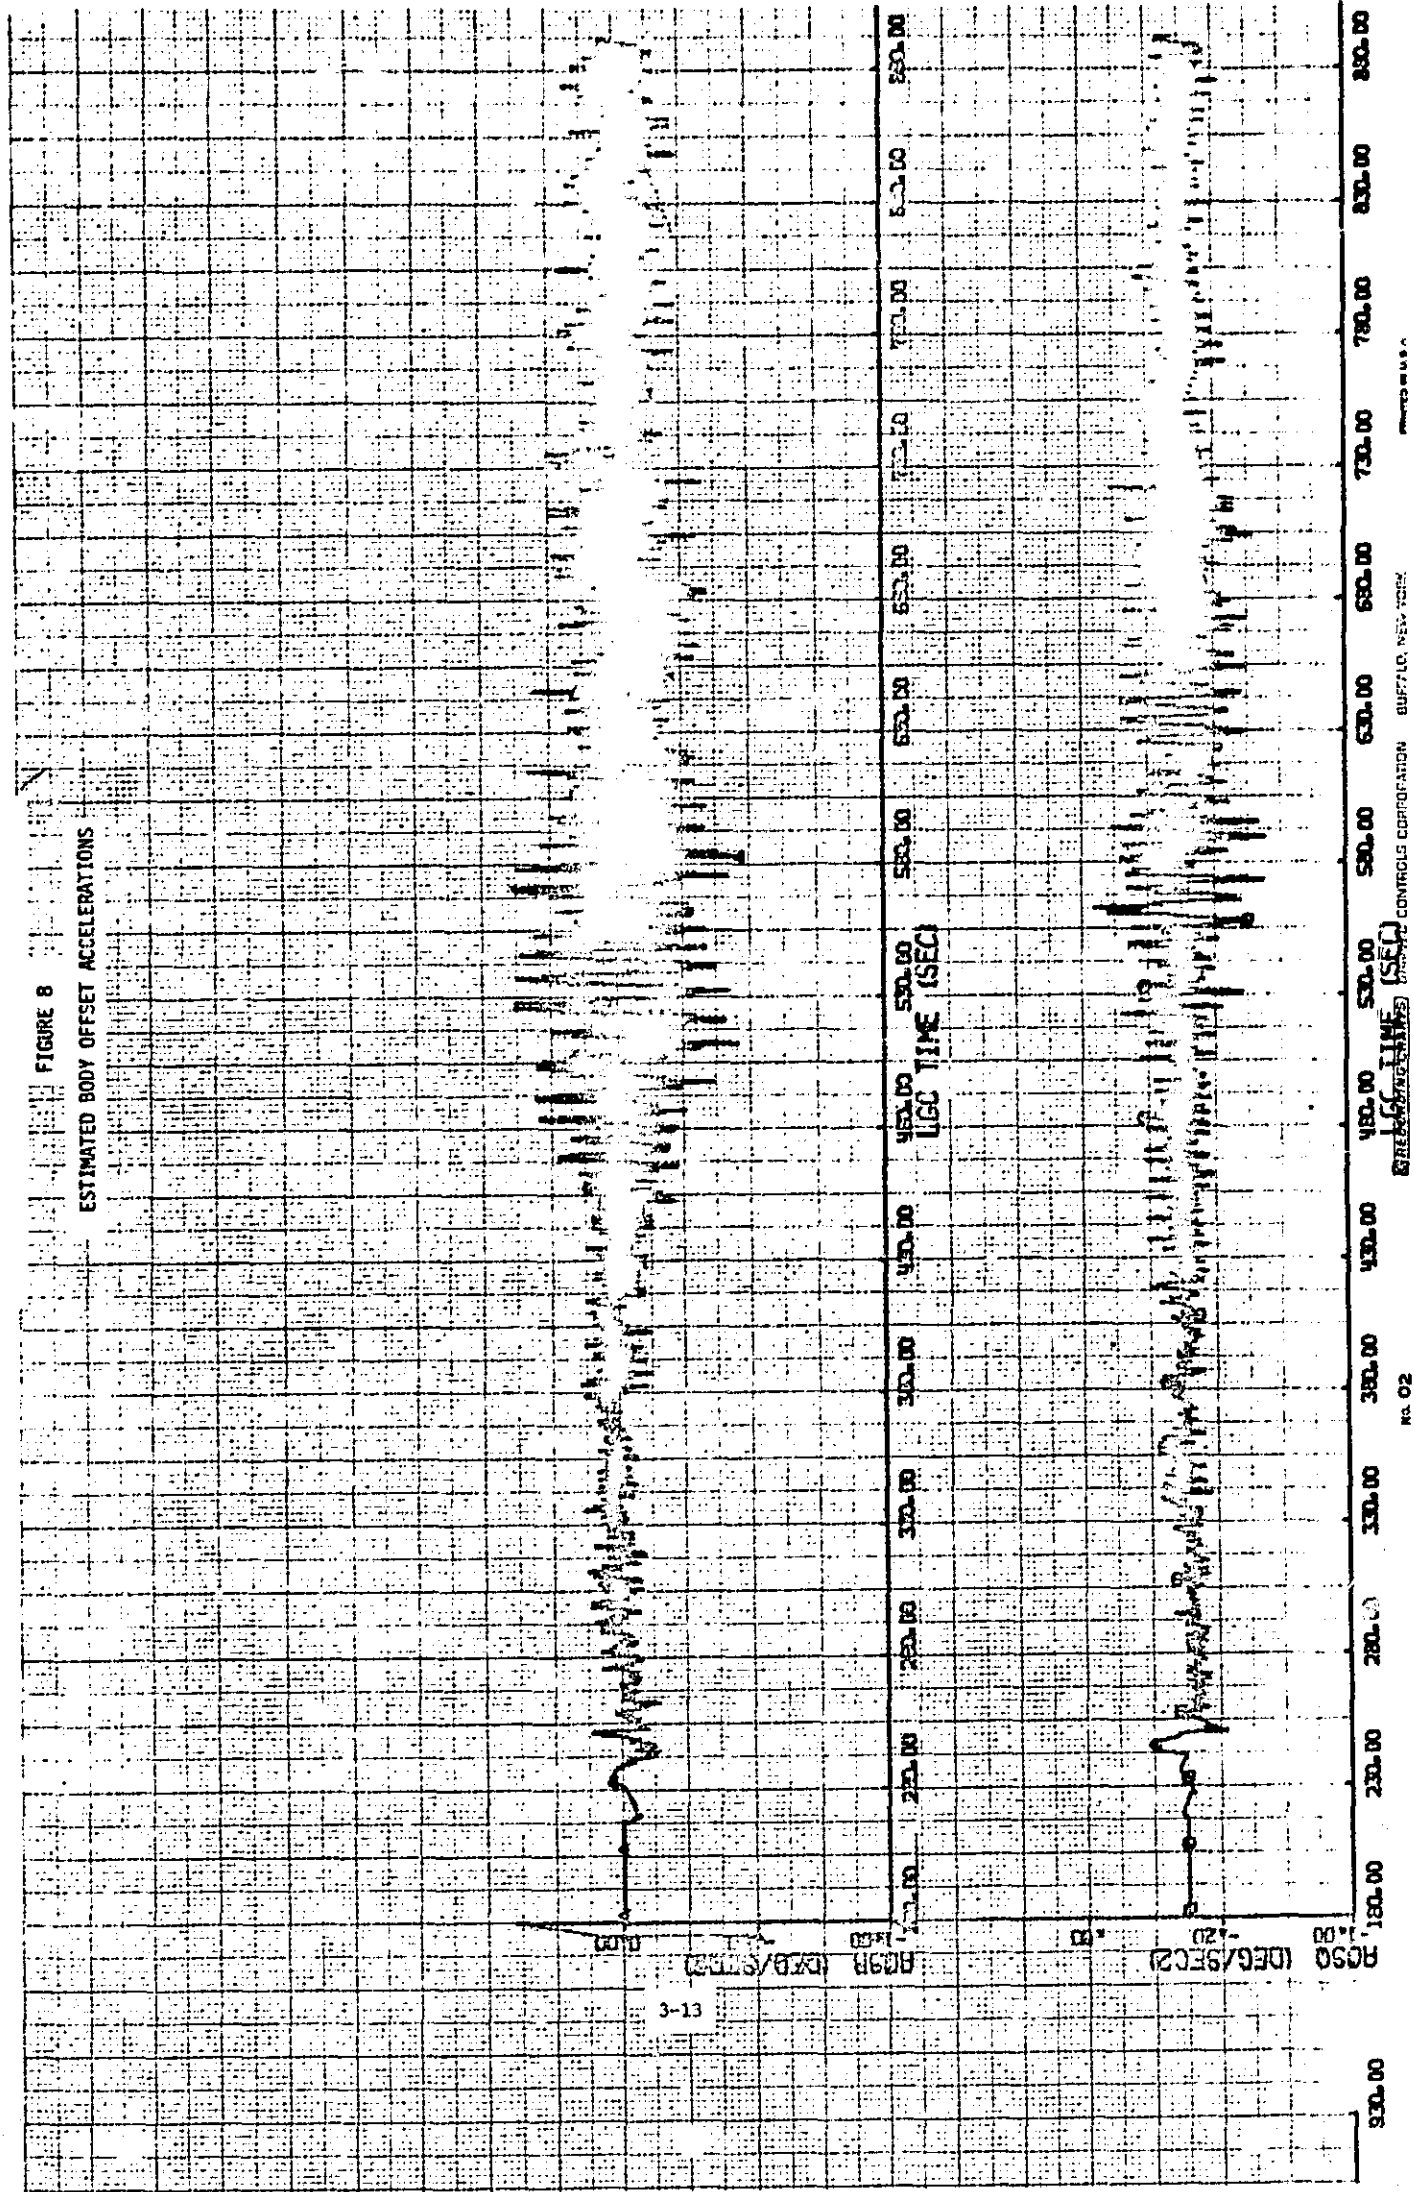
FIGURE 8

ESTIMATED BODY OFFSET ACCELERATIONS

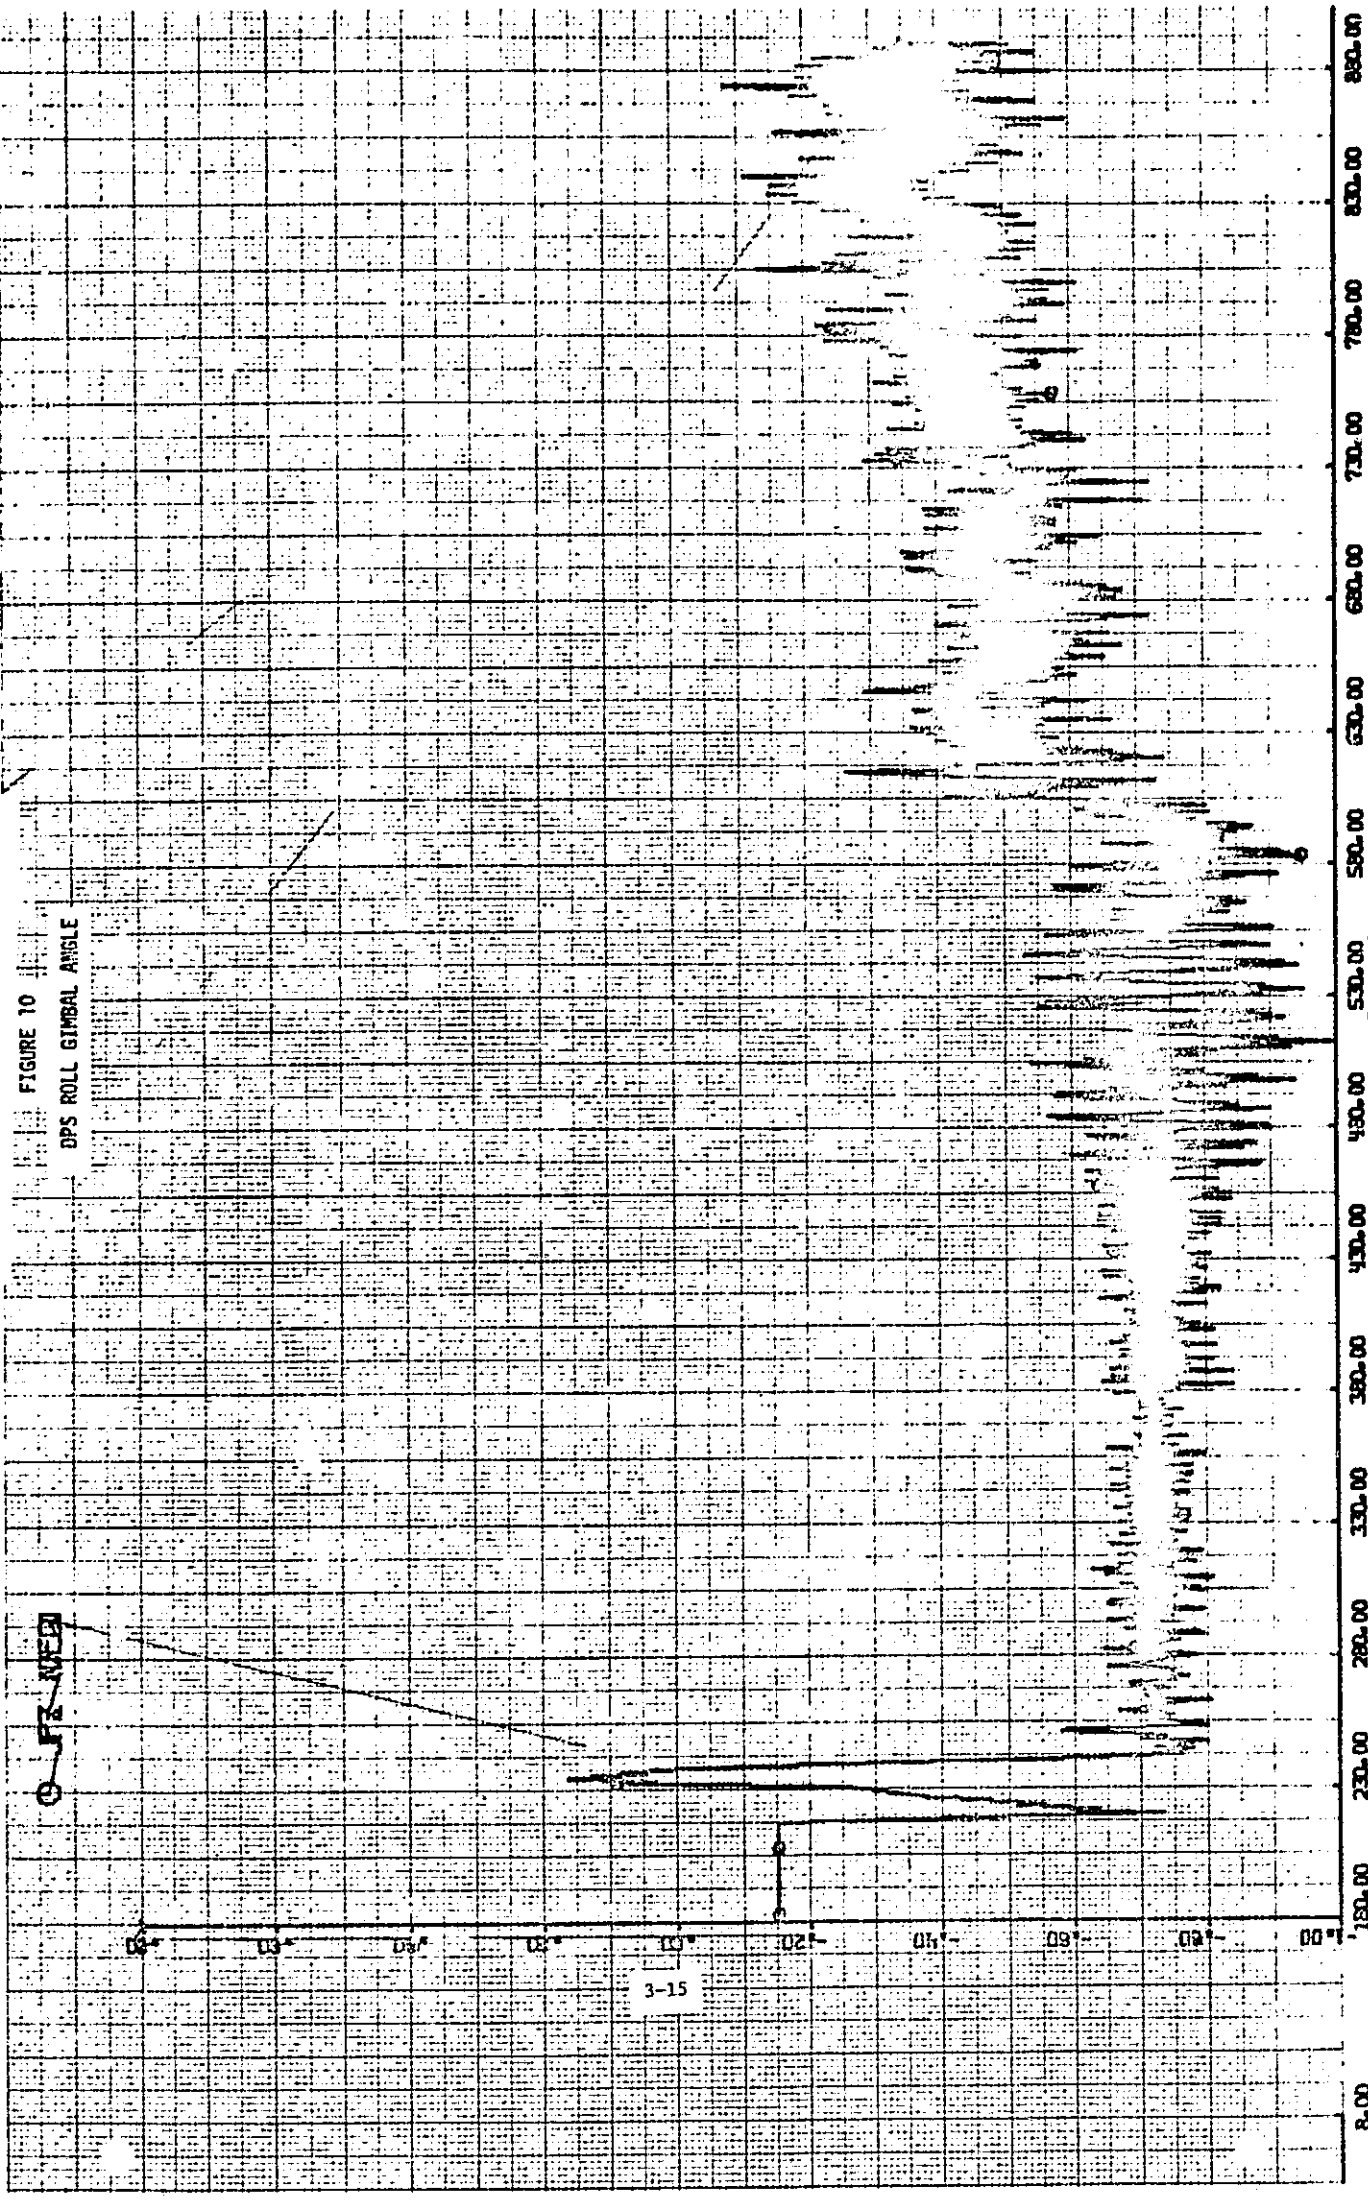
FIGURE 10
DPS ROLL GIMBAL ANGLE

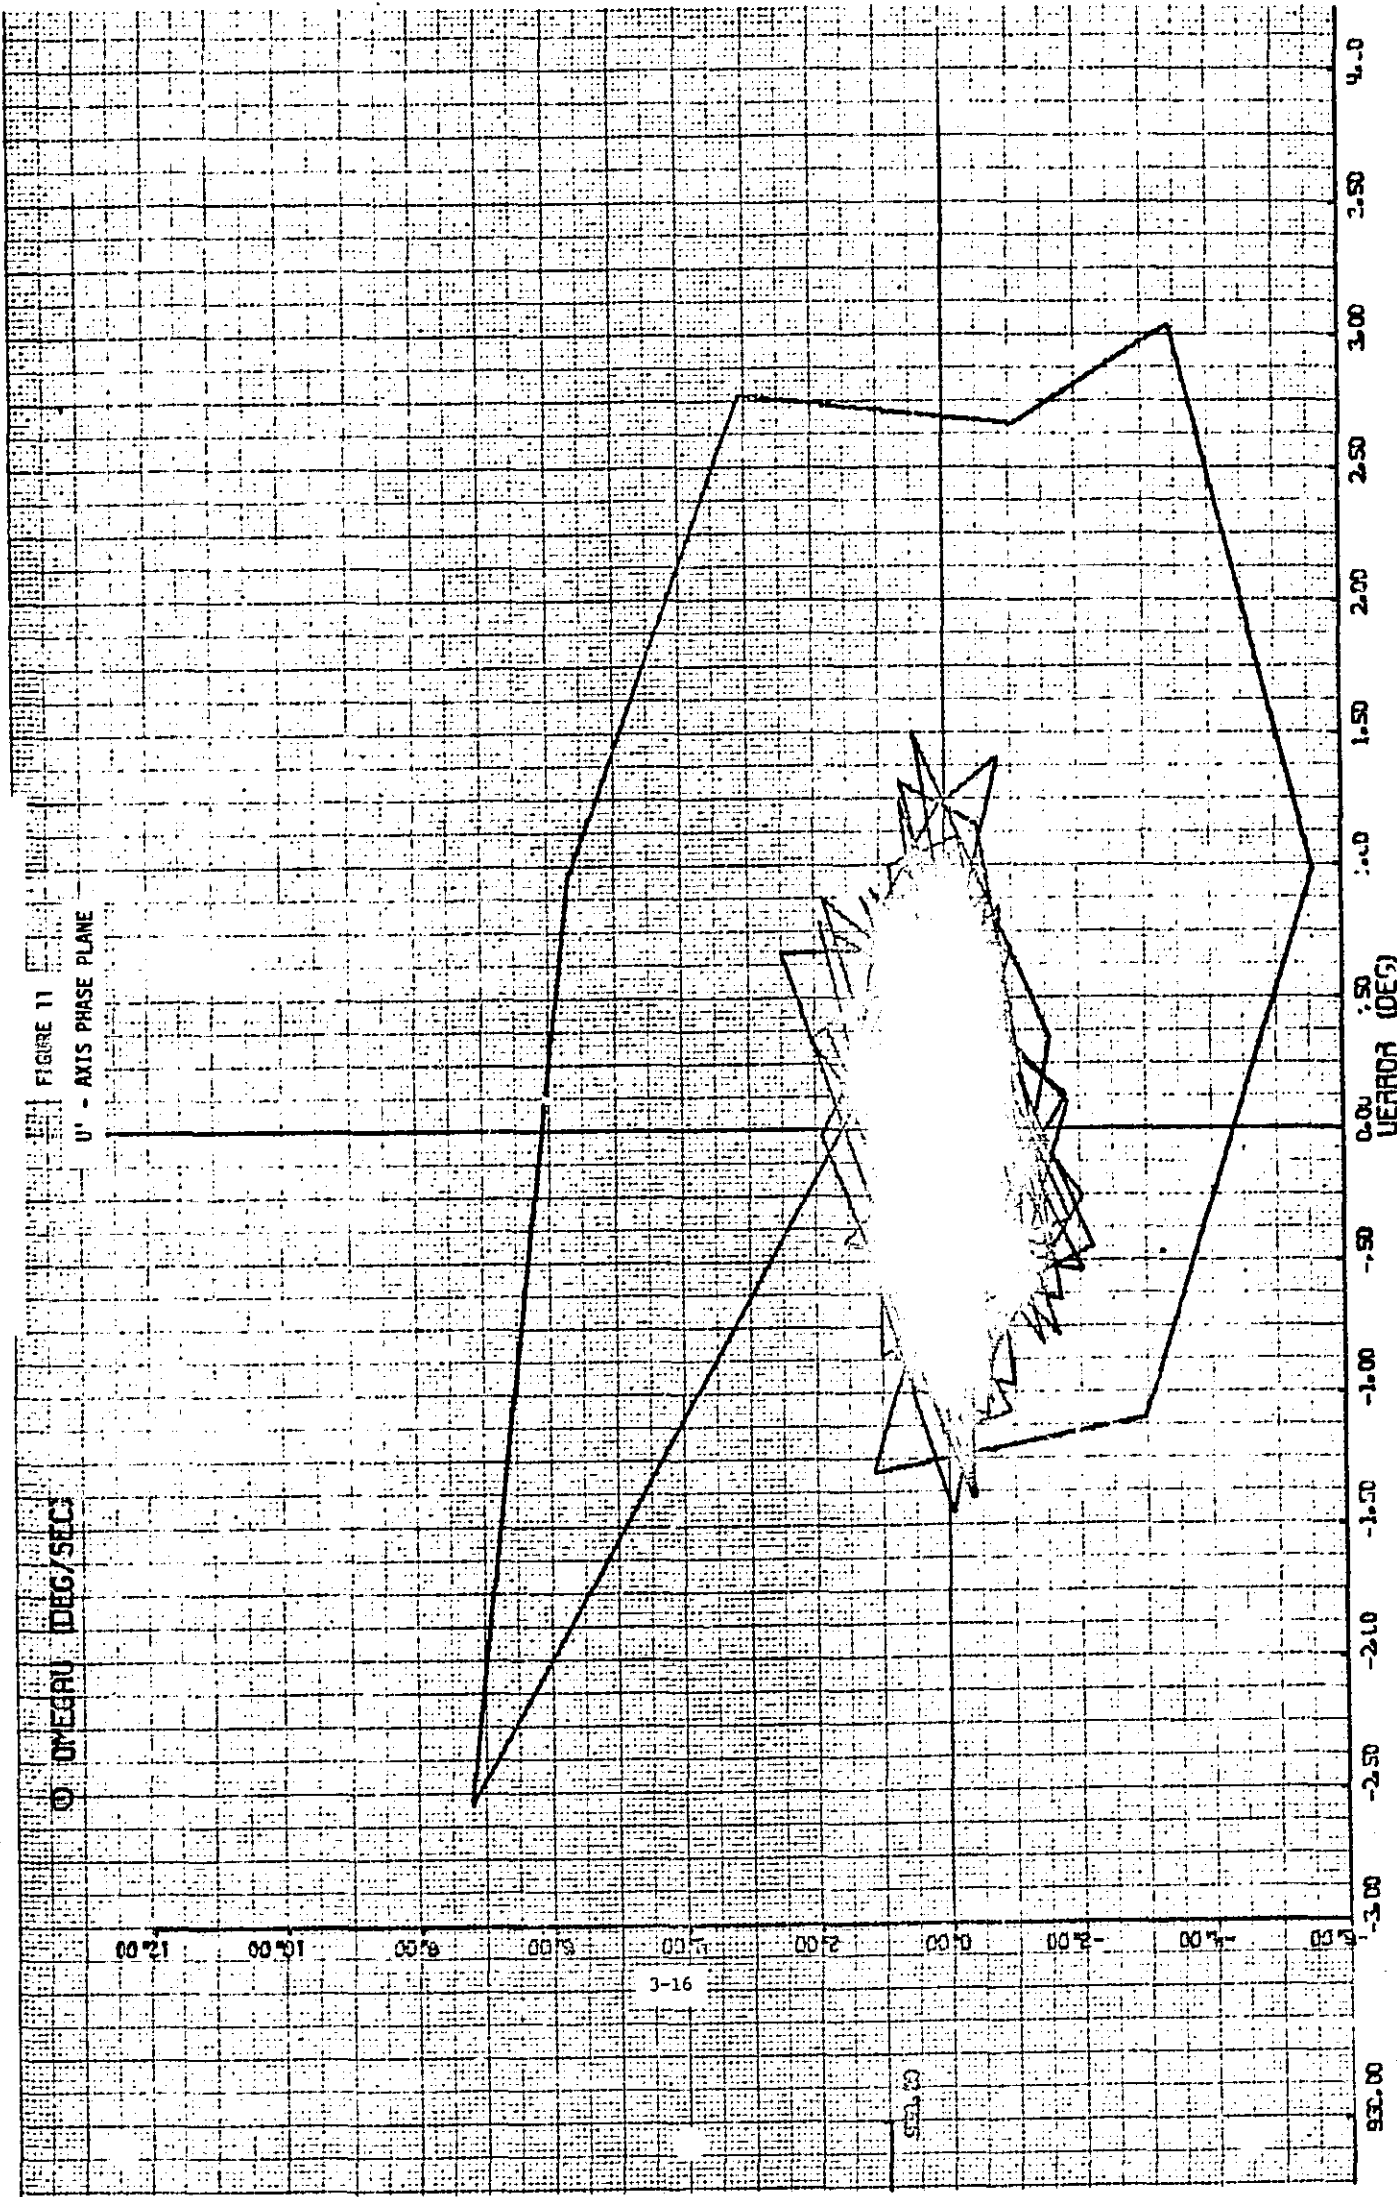
FIGURE 11
 ω - AXIS PHASE PLANE

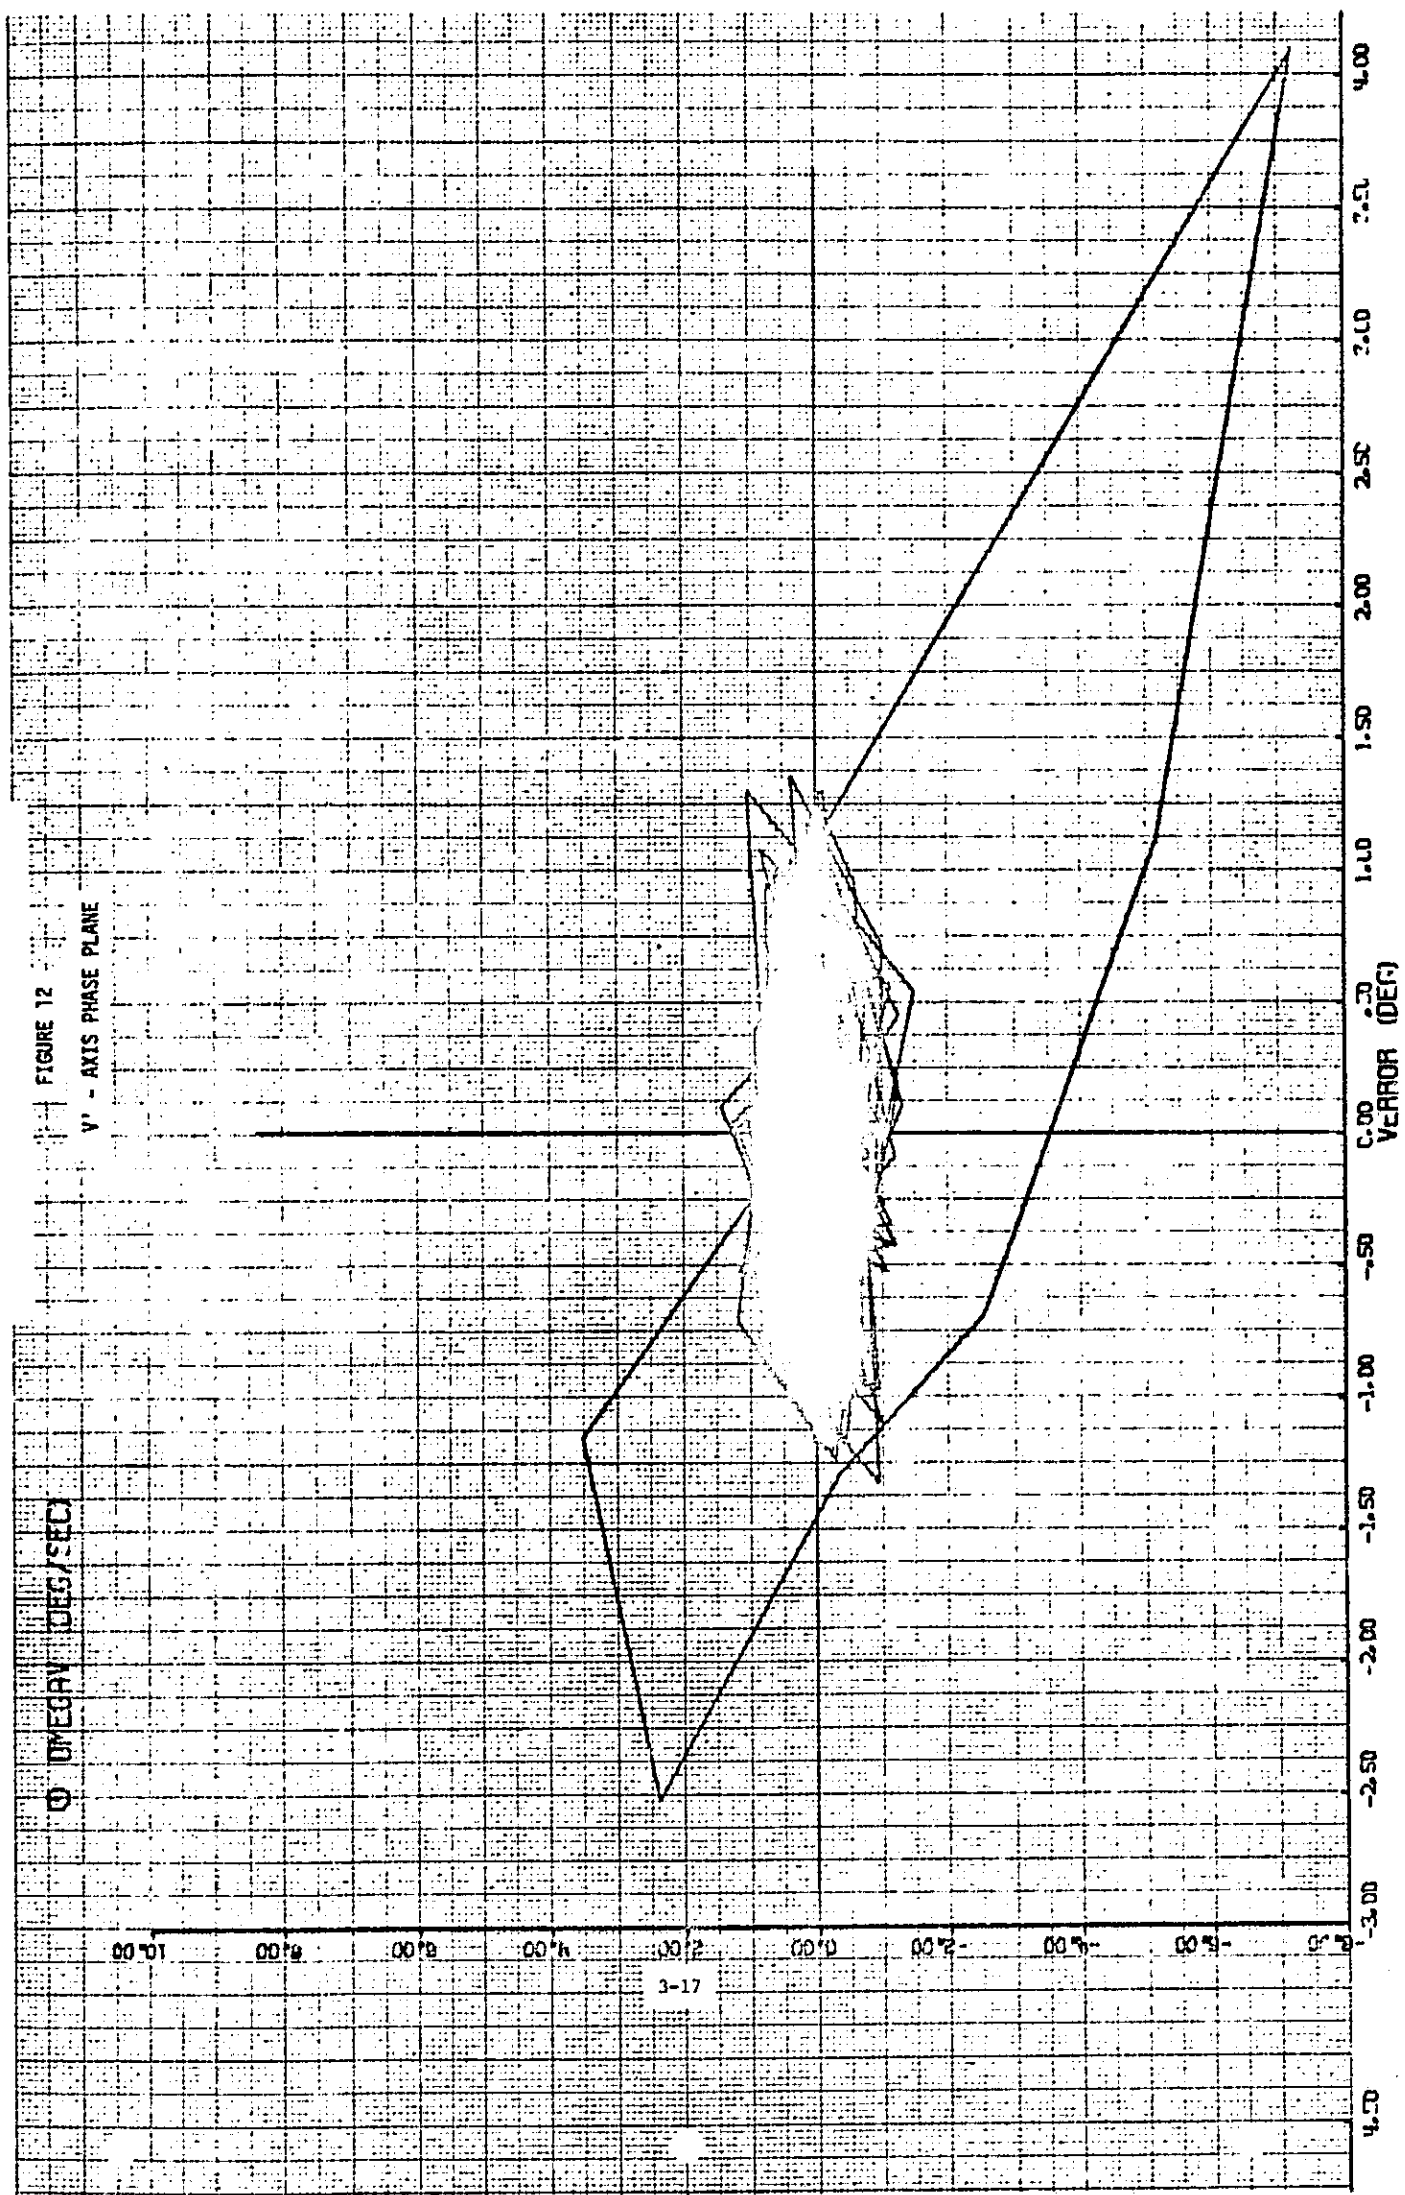
FIGURE 12
V' - AXIS PHASE PLANE

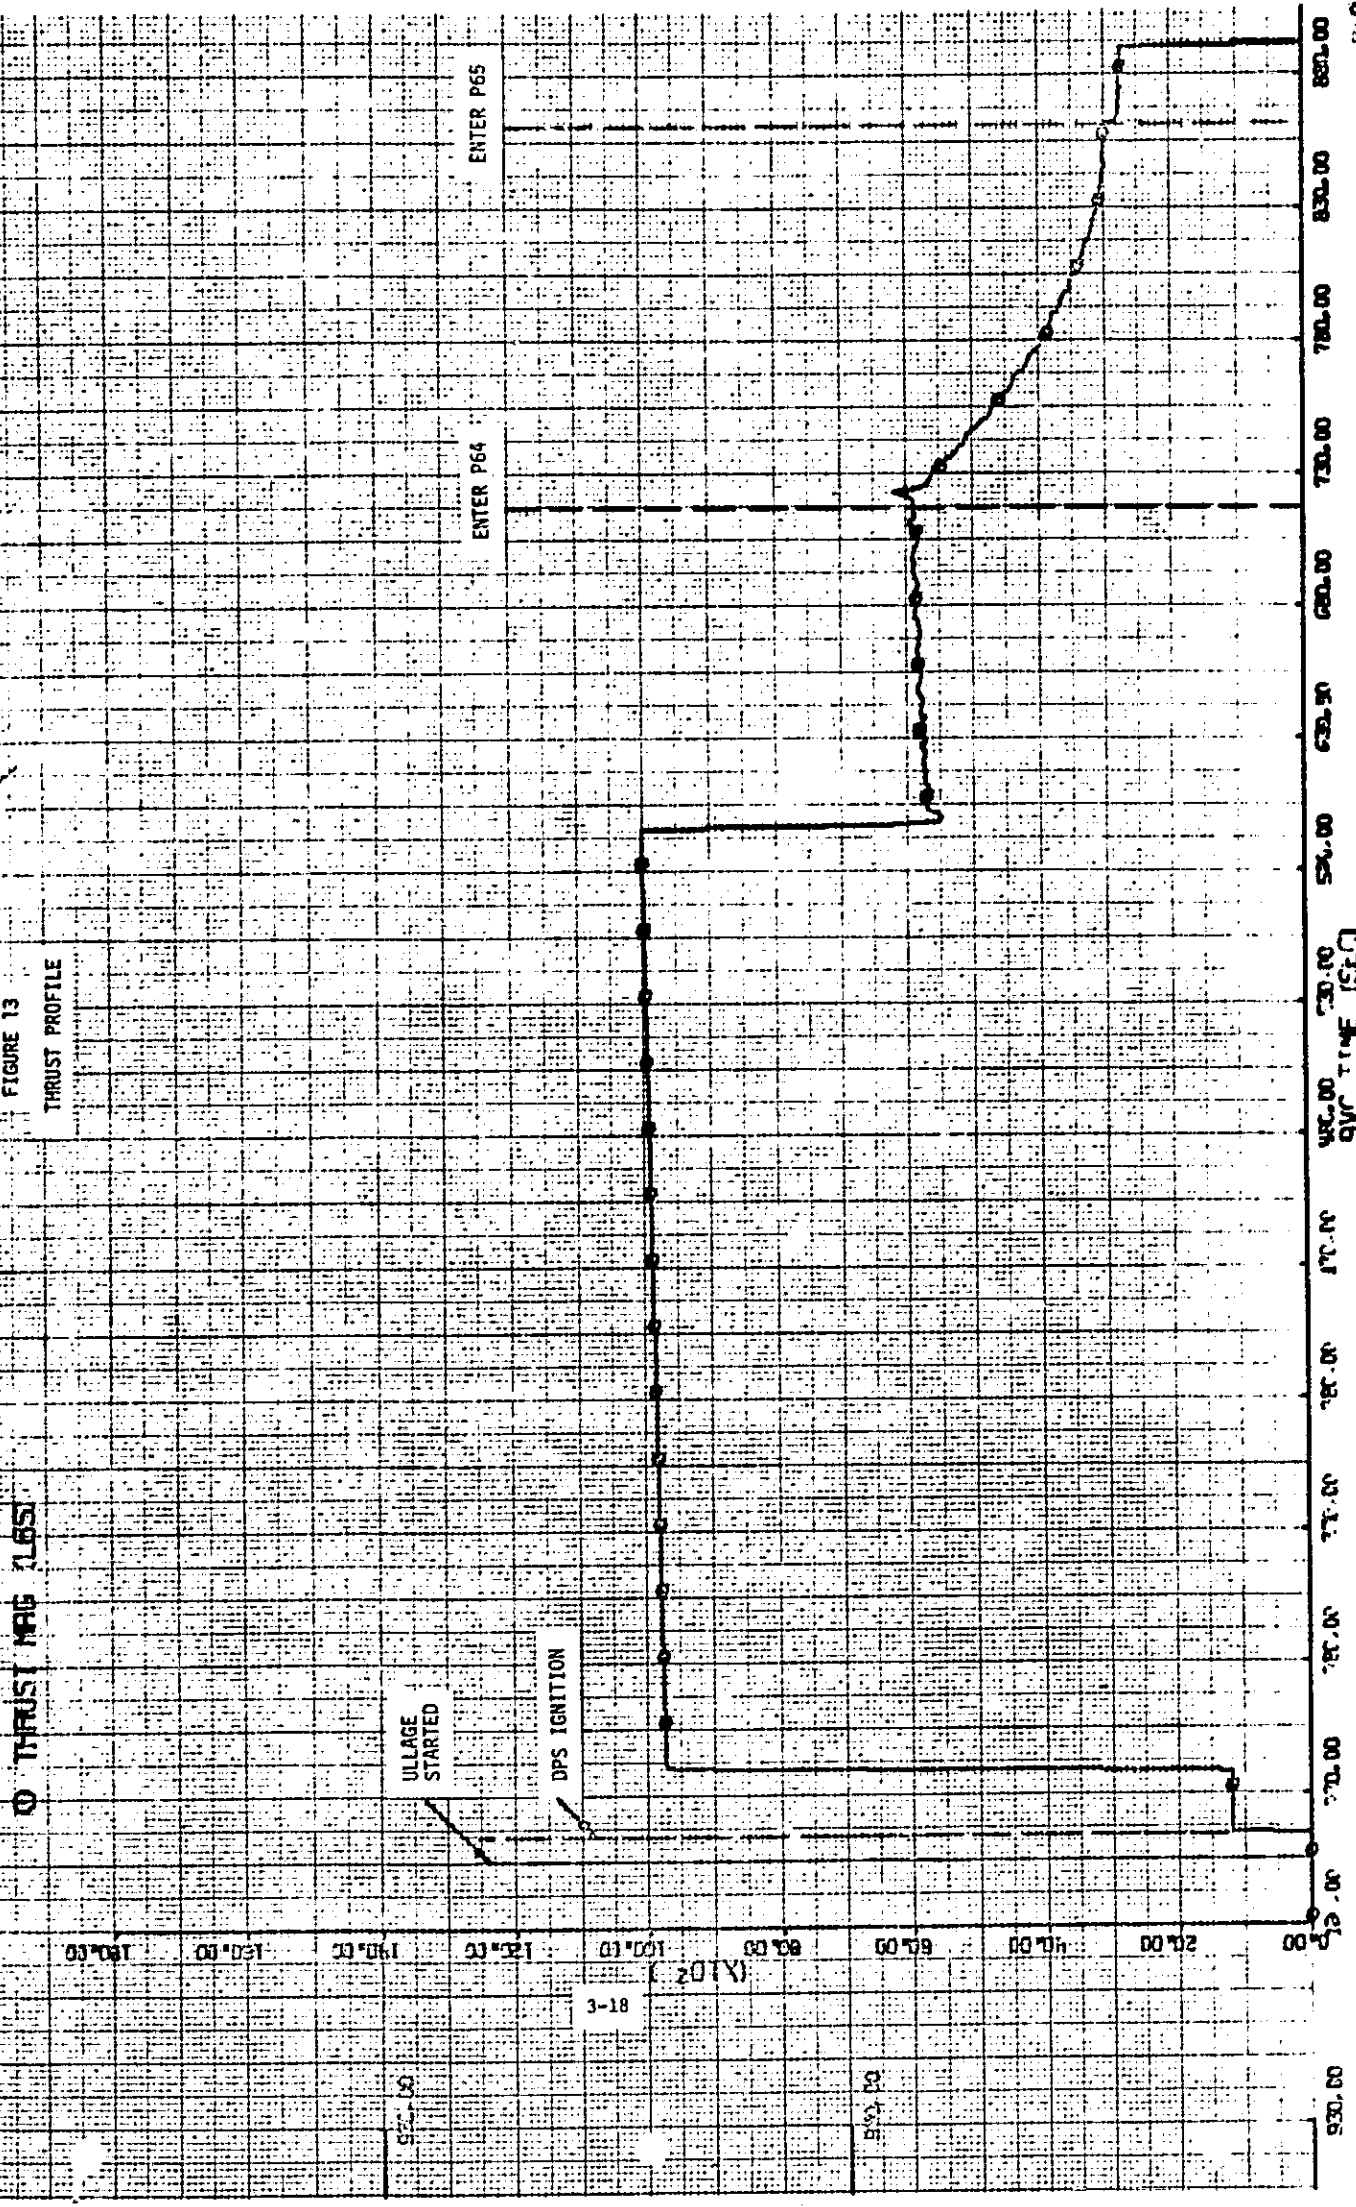
FIGURE 13
THRUST PROFILE

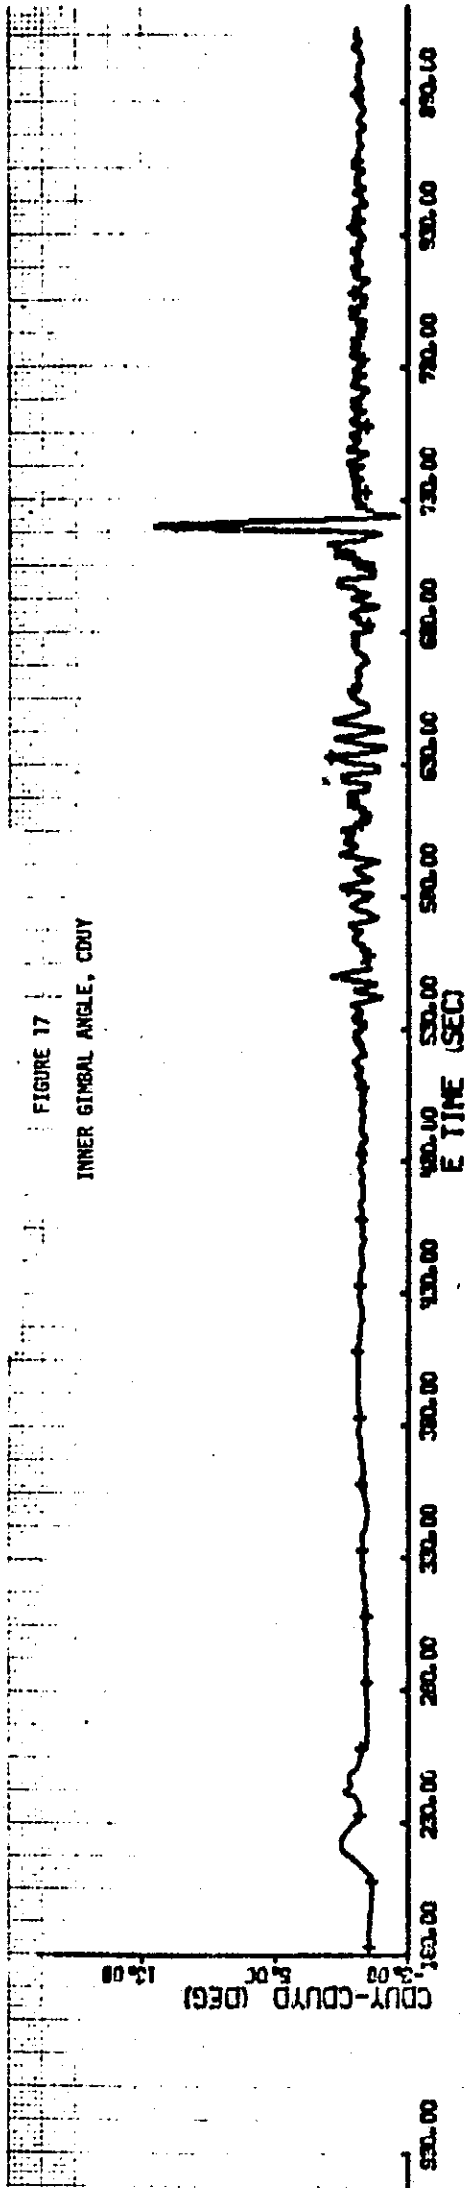
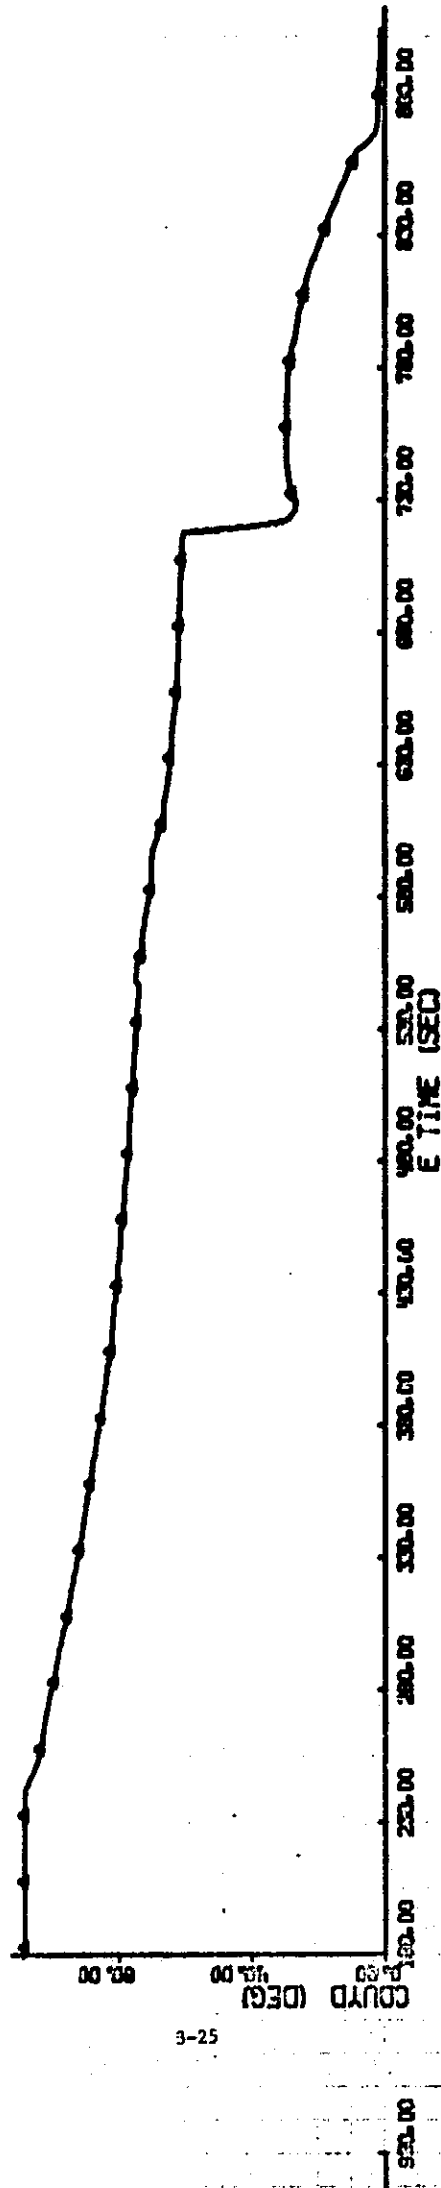
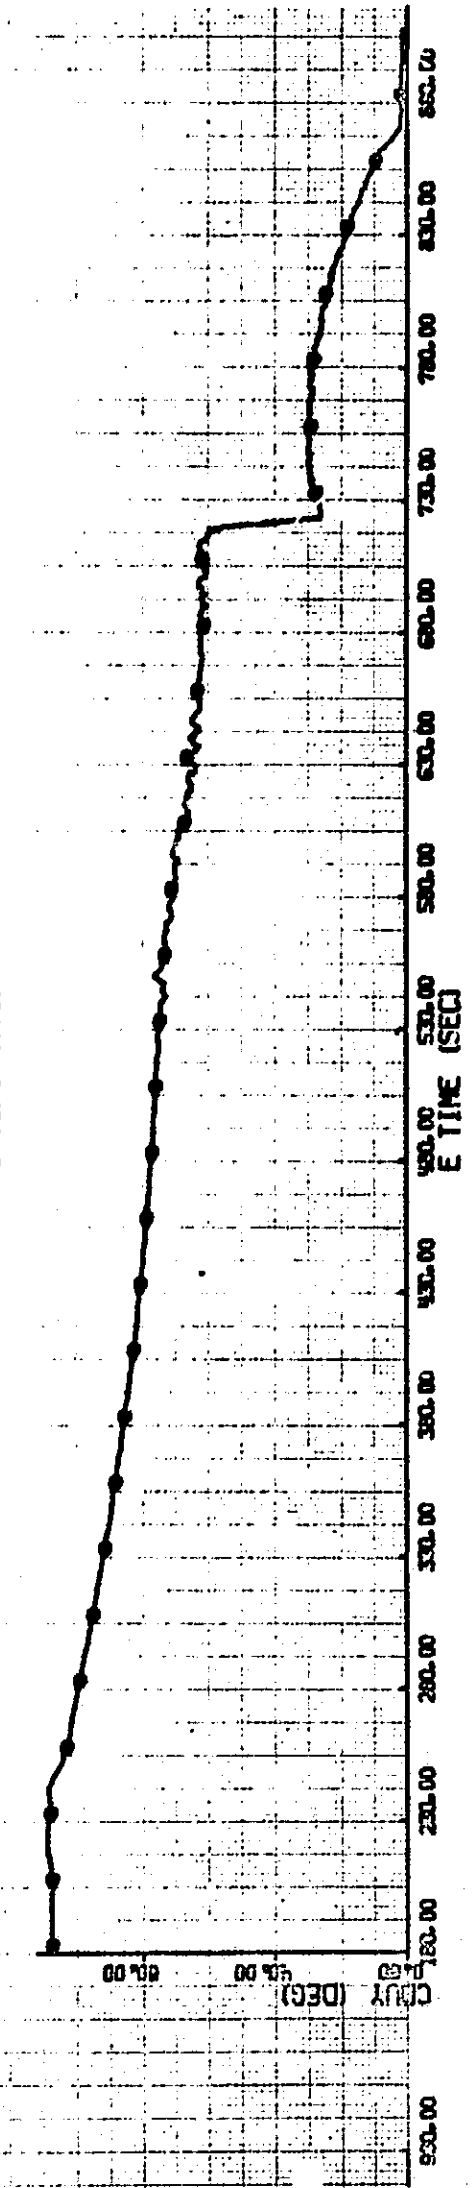
FIGURE 17
INNER GIMBAL ANGLE, CDUY

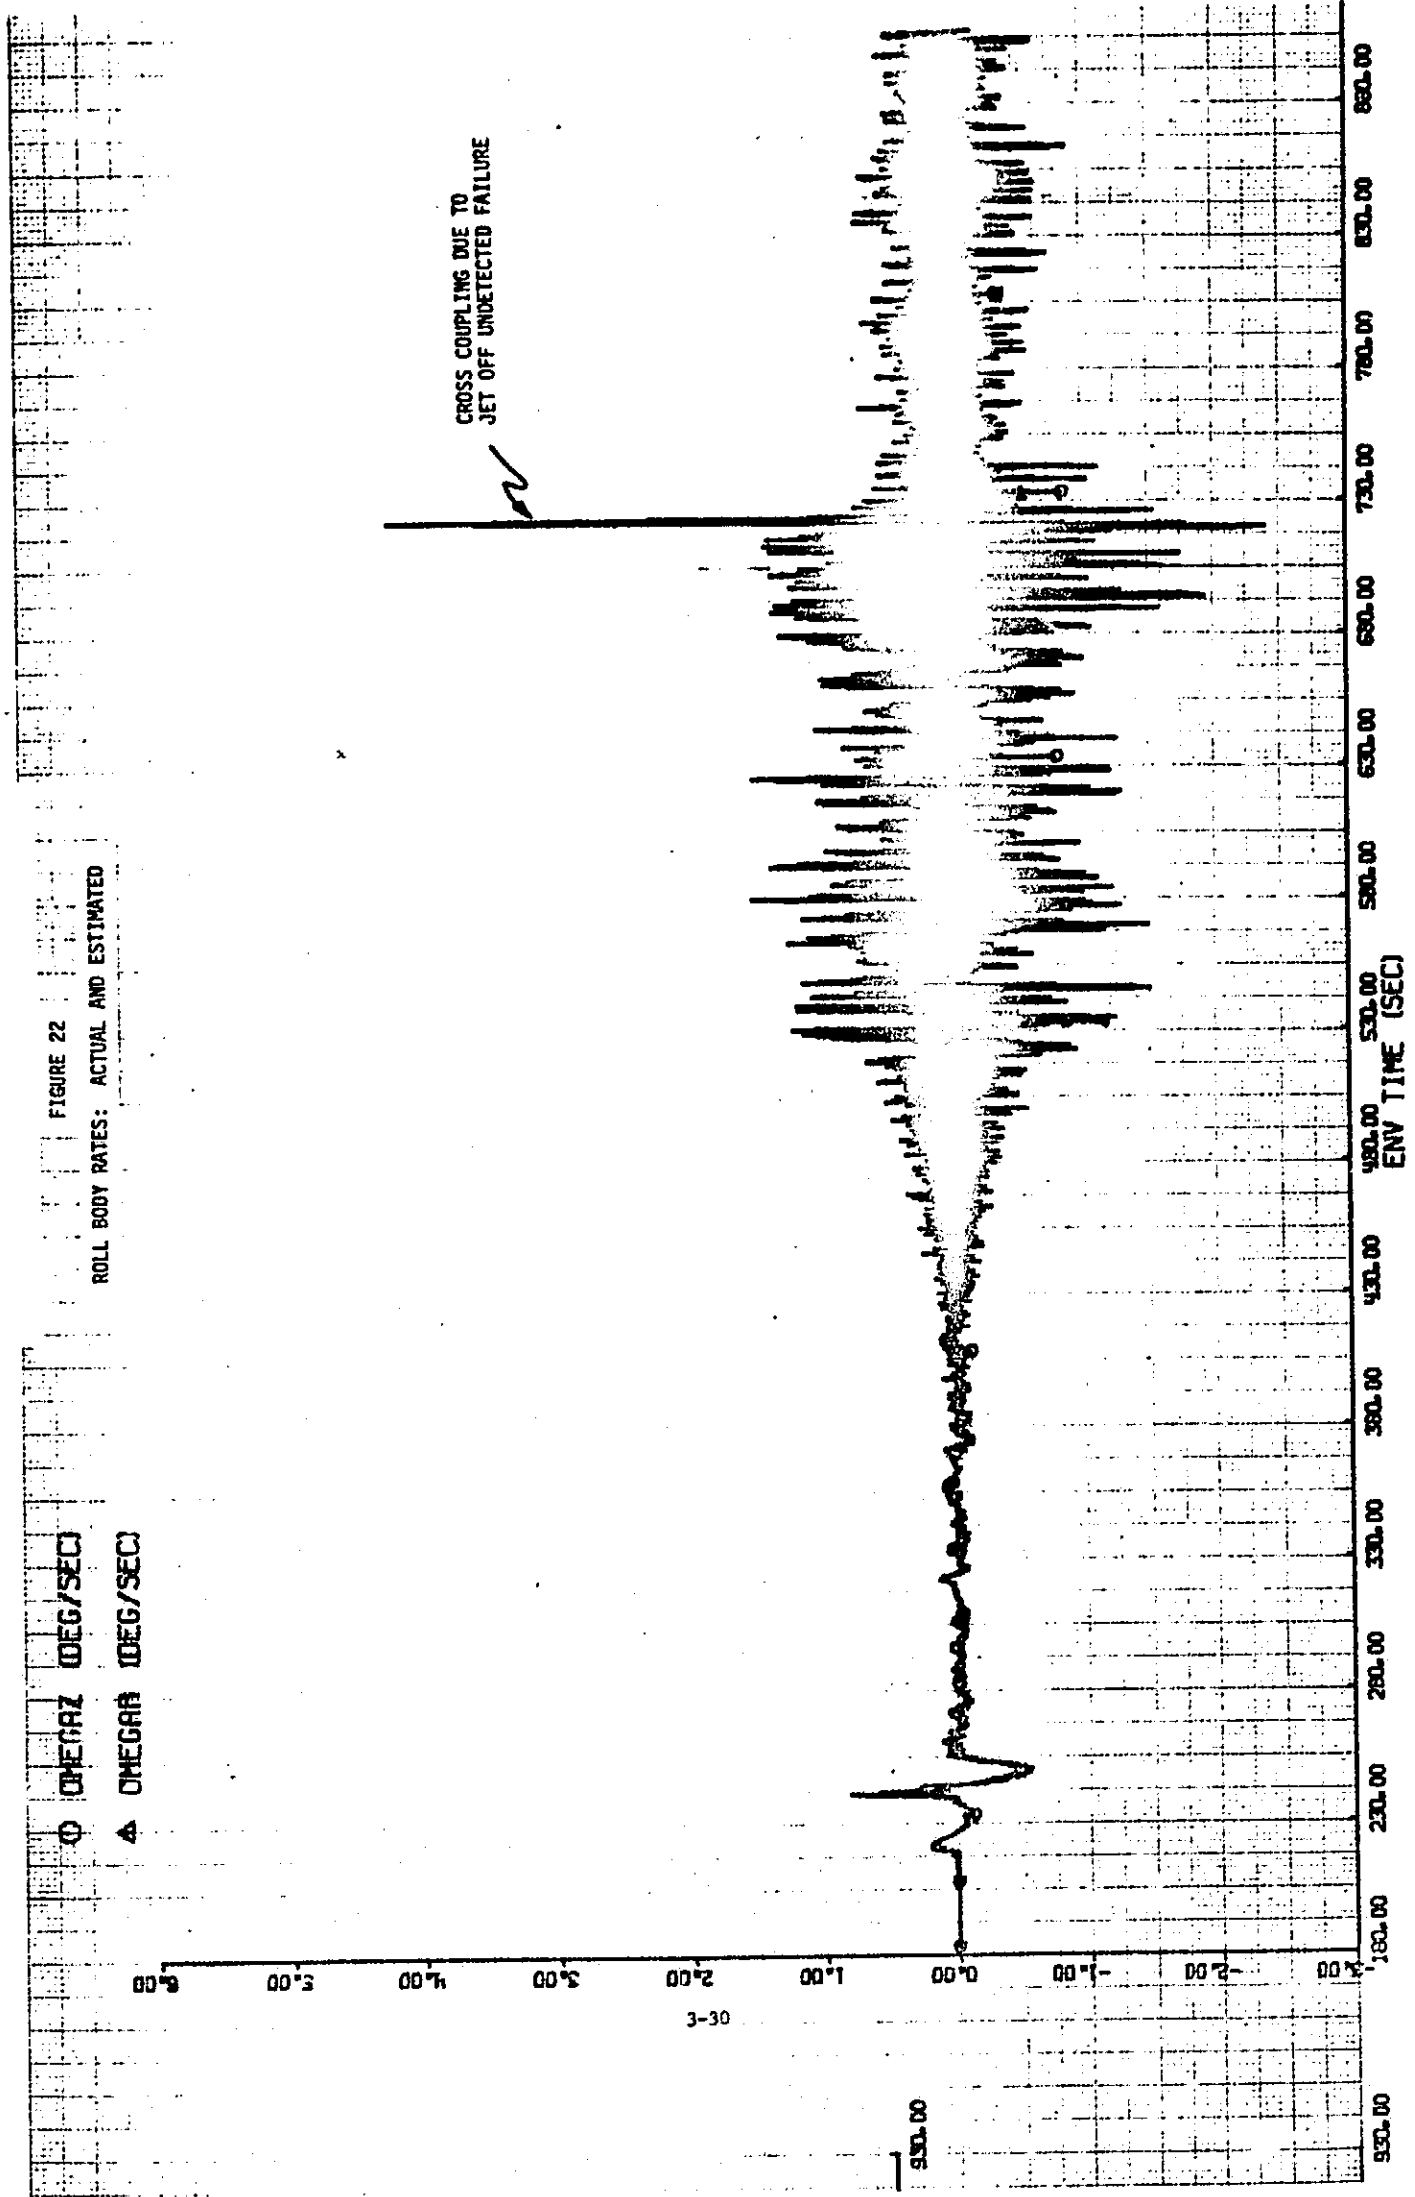
FIGURE 22
 ROLL BODY RATES: ACTUAL AND ESTIMATED

The pitchover maneuver for this test case was performed slower and at a lower rate than the nominal case because of the failed-off jet. Figure 22 shows that a sizeable rate was induced in the roll axis during pitchover. This was due to the moment imbalance caused by the failed jet and the cross coupling between the axes. The pitchover maneuver was accomplished satisfactorily and the remaining portion of the burn was very similar to the nominal case. The DAP tried to use Jet 1 a total of nine times during the period in which it was failed.
