PROJECT TECHNICAL REPORT
TASK E-72B

LUMINARY 1B DAP PREFLIGHT PERFORMANCE
EVALUATION

NAS 9-8166

13 November 1969

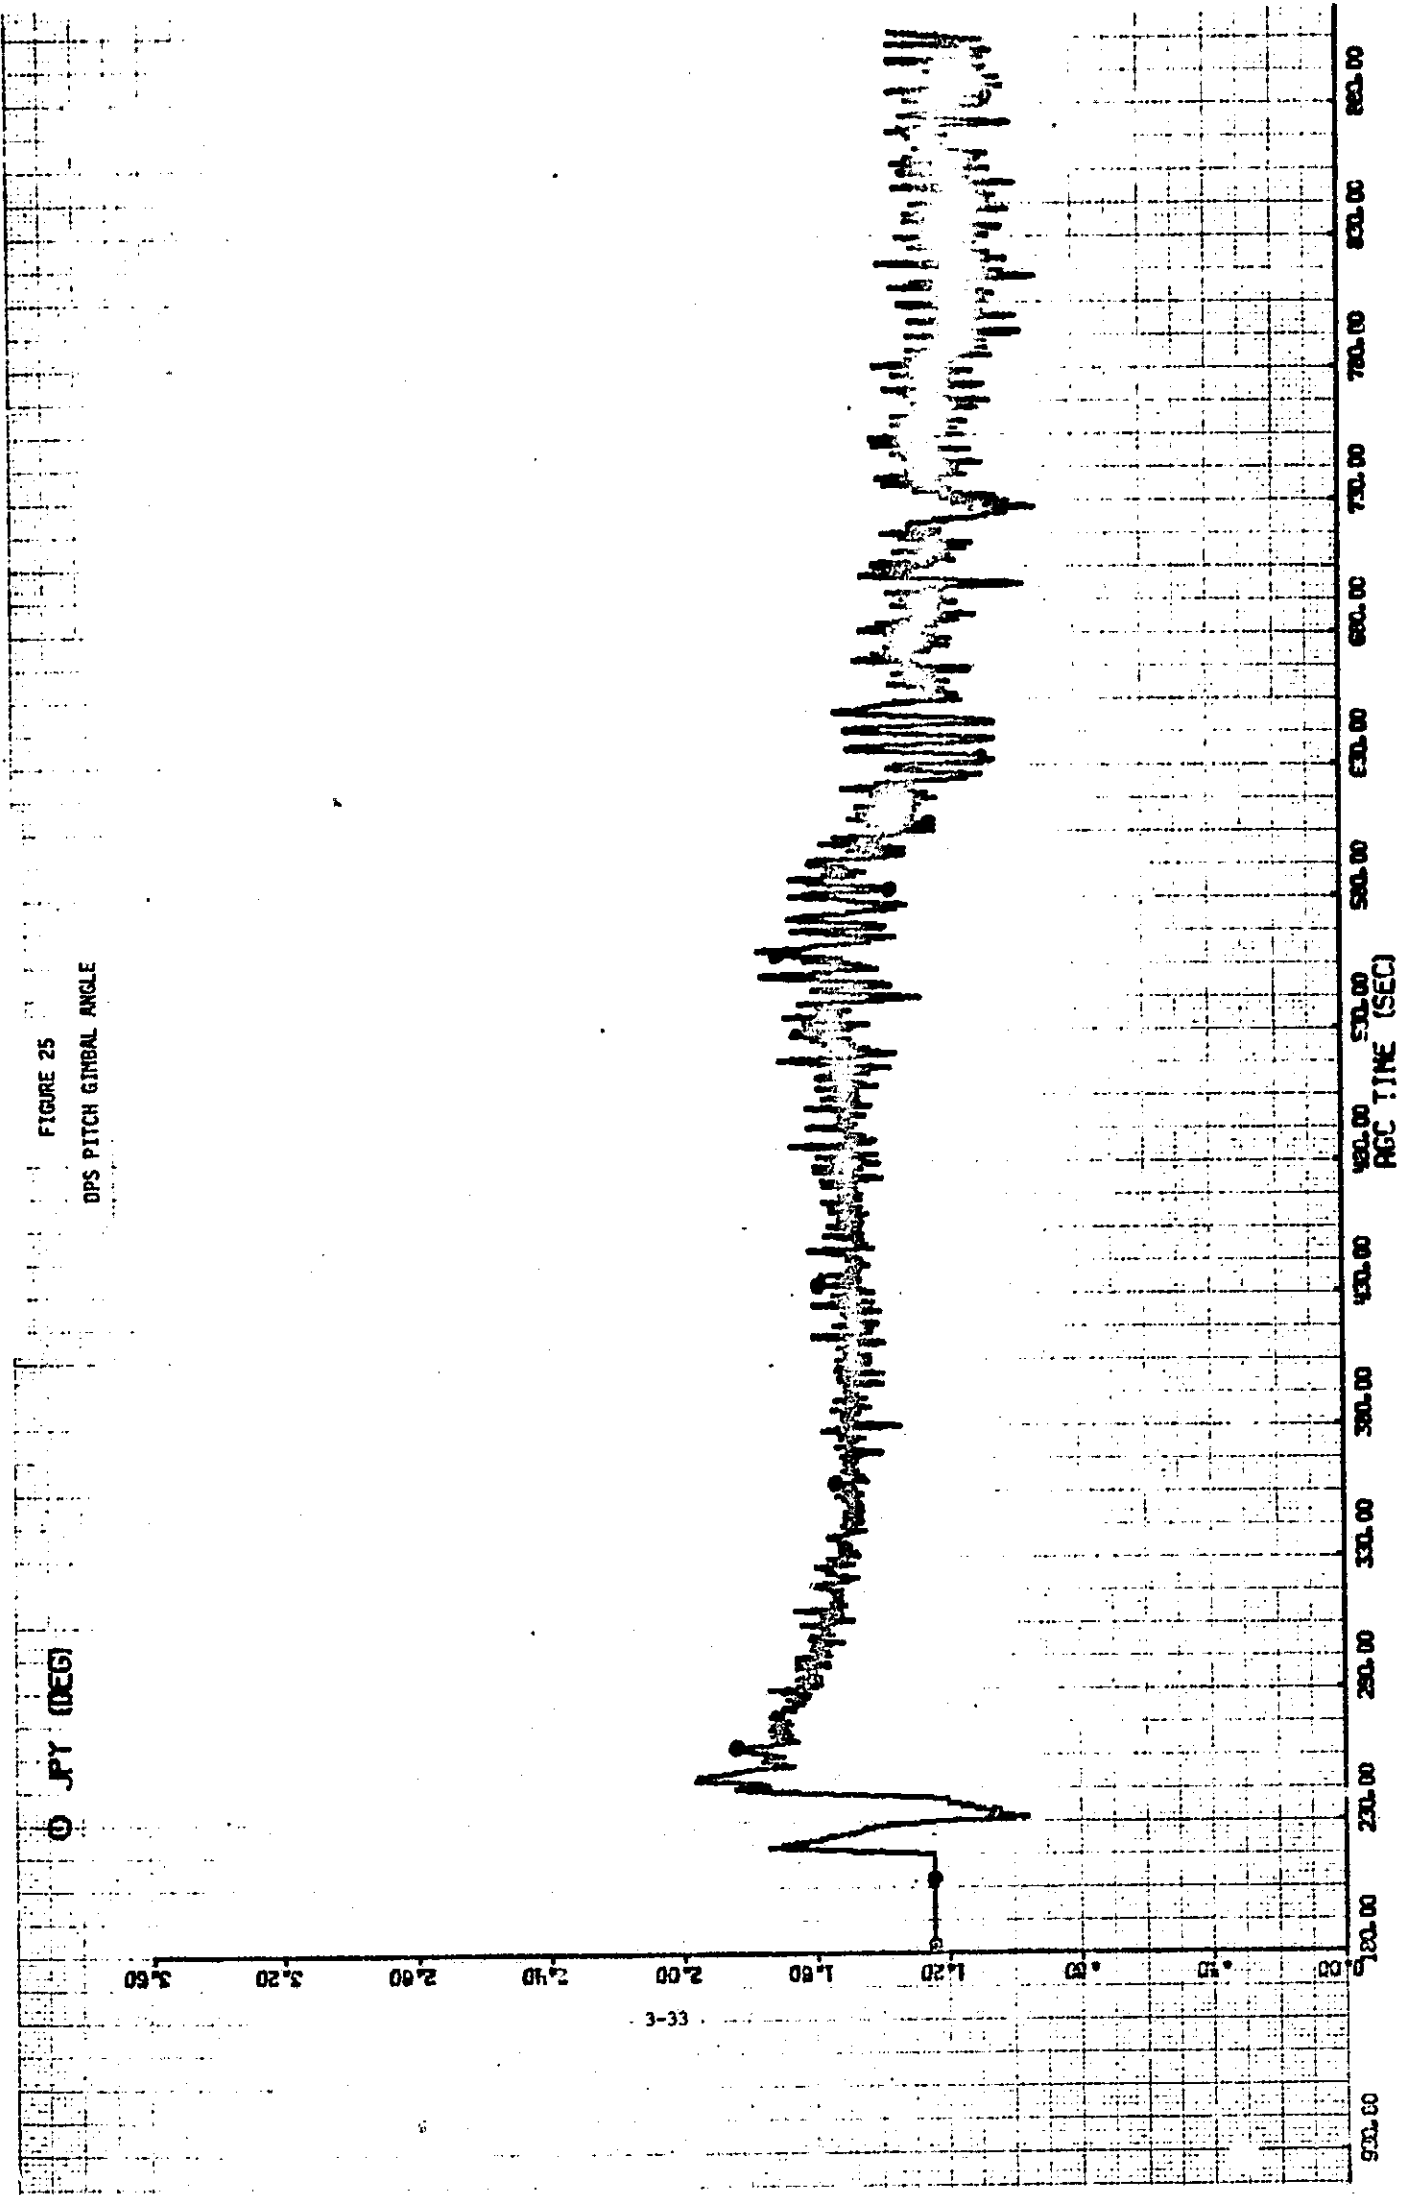
FIGURE 25
DPS PITCH GIMBAL ANGLE

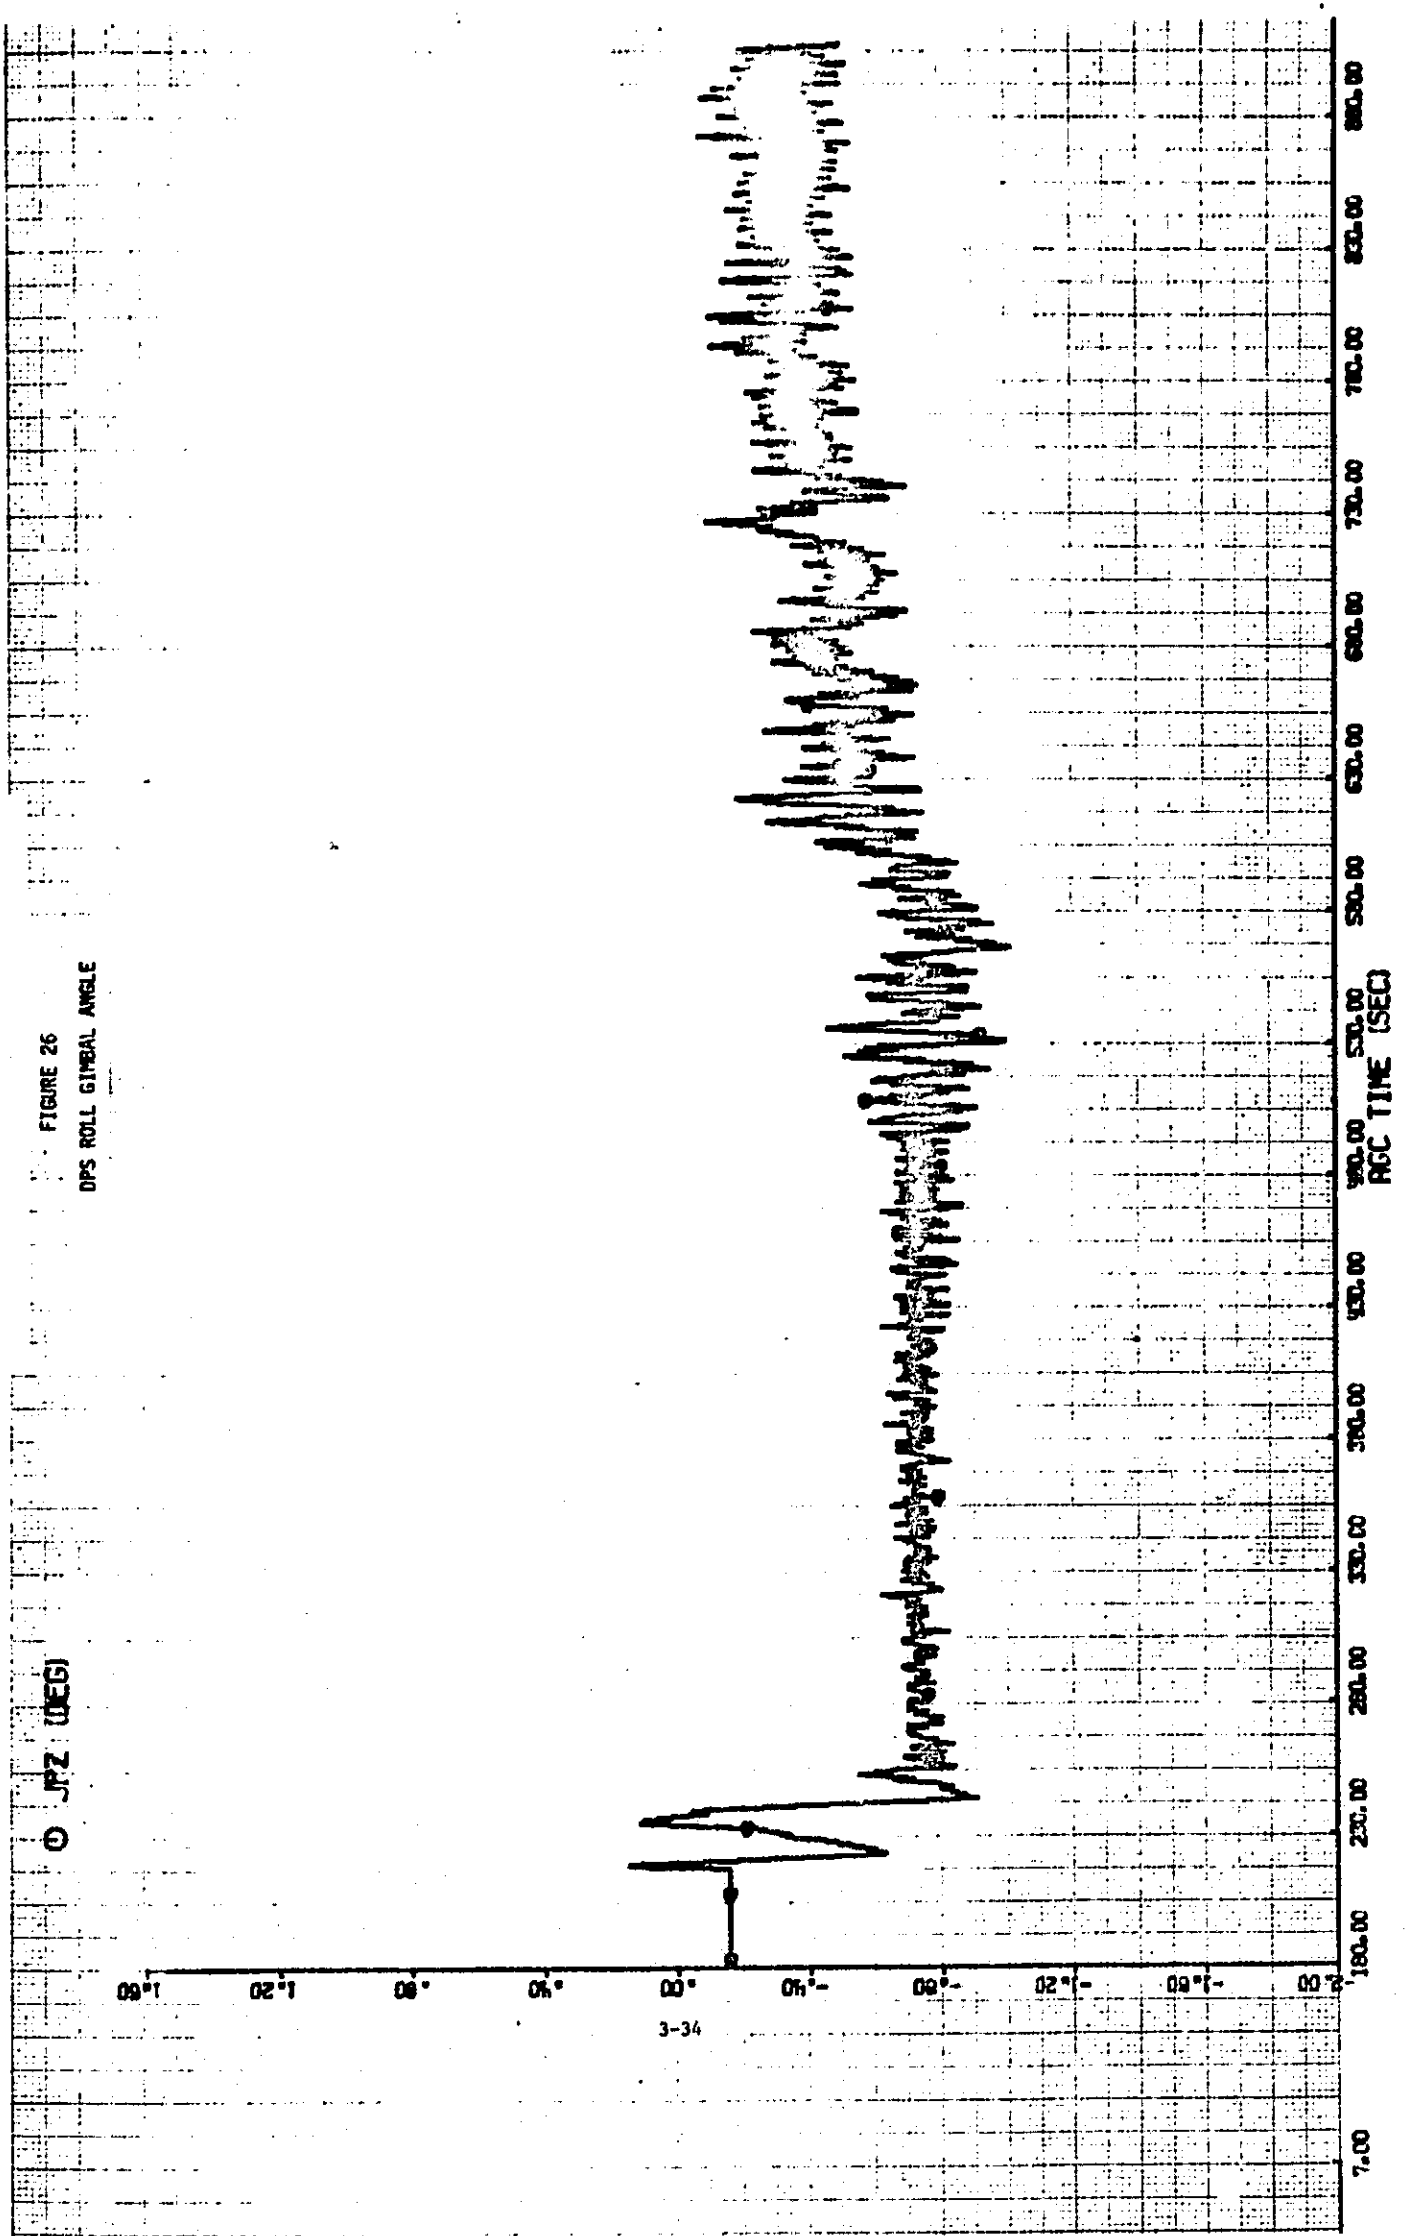
FIGURE 26
DPS ROLL GIMBAL ANGLE

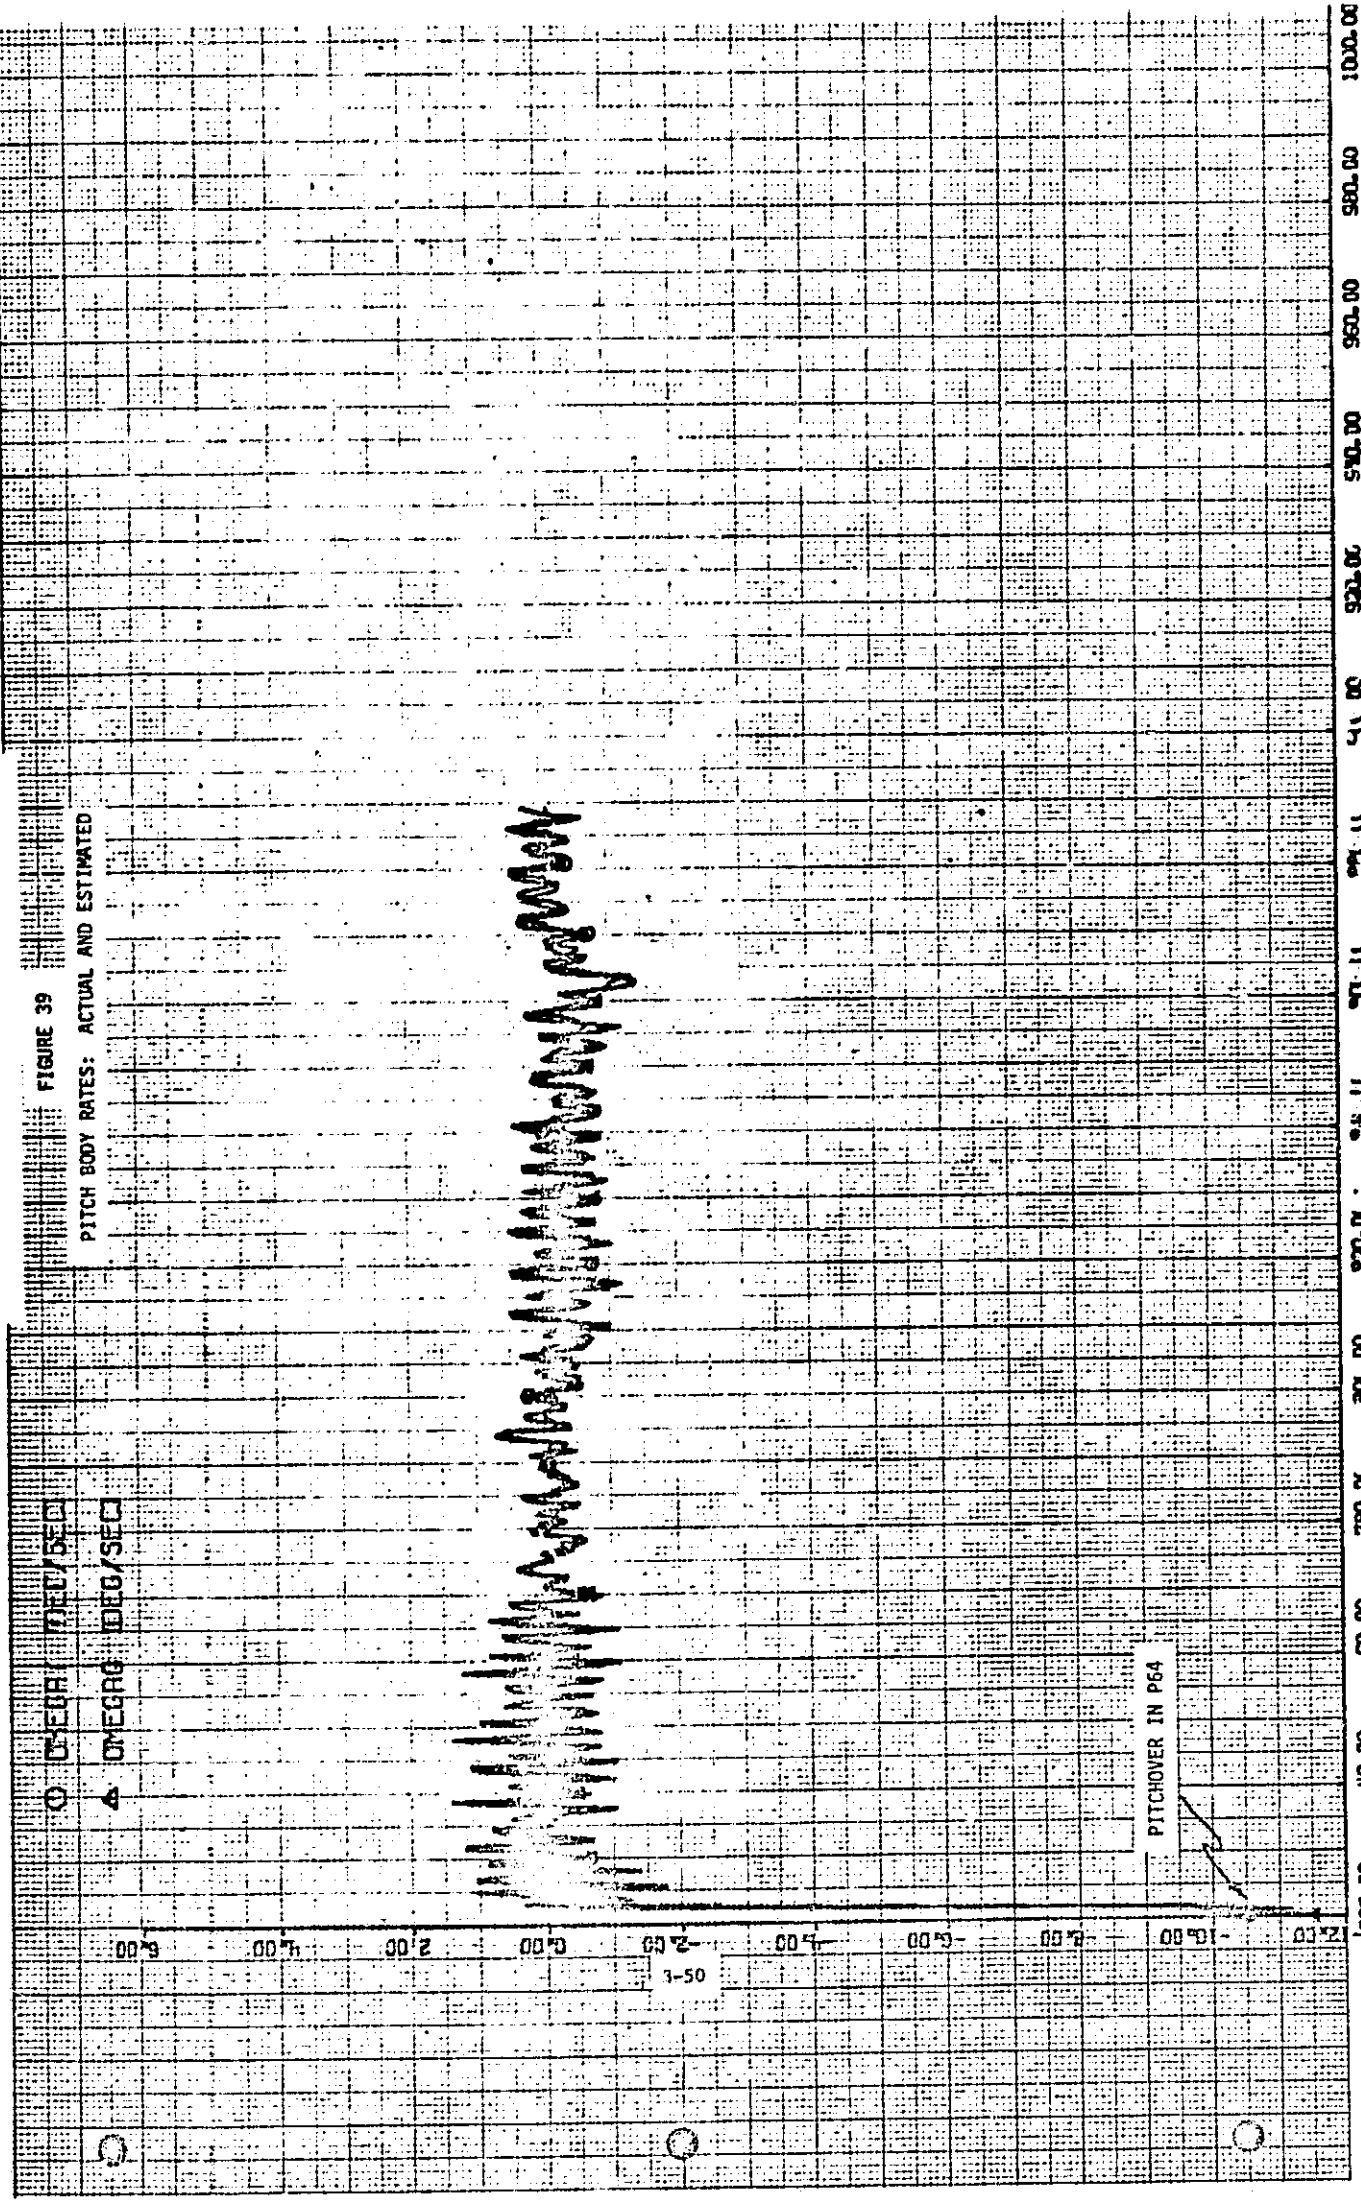
FIGURE 39

PITCH BODY RATES: ACTUAL AND ESTIMATED

PITCHOVER IN P64

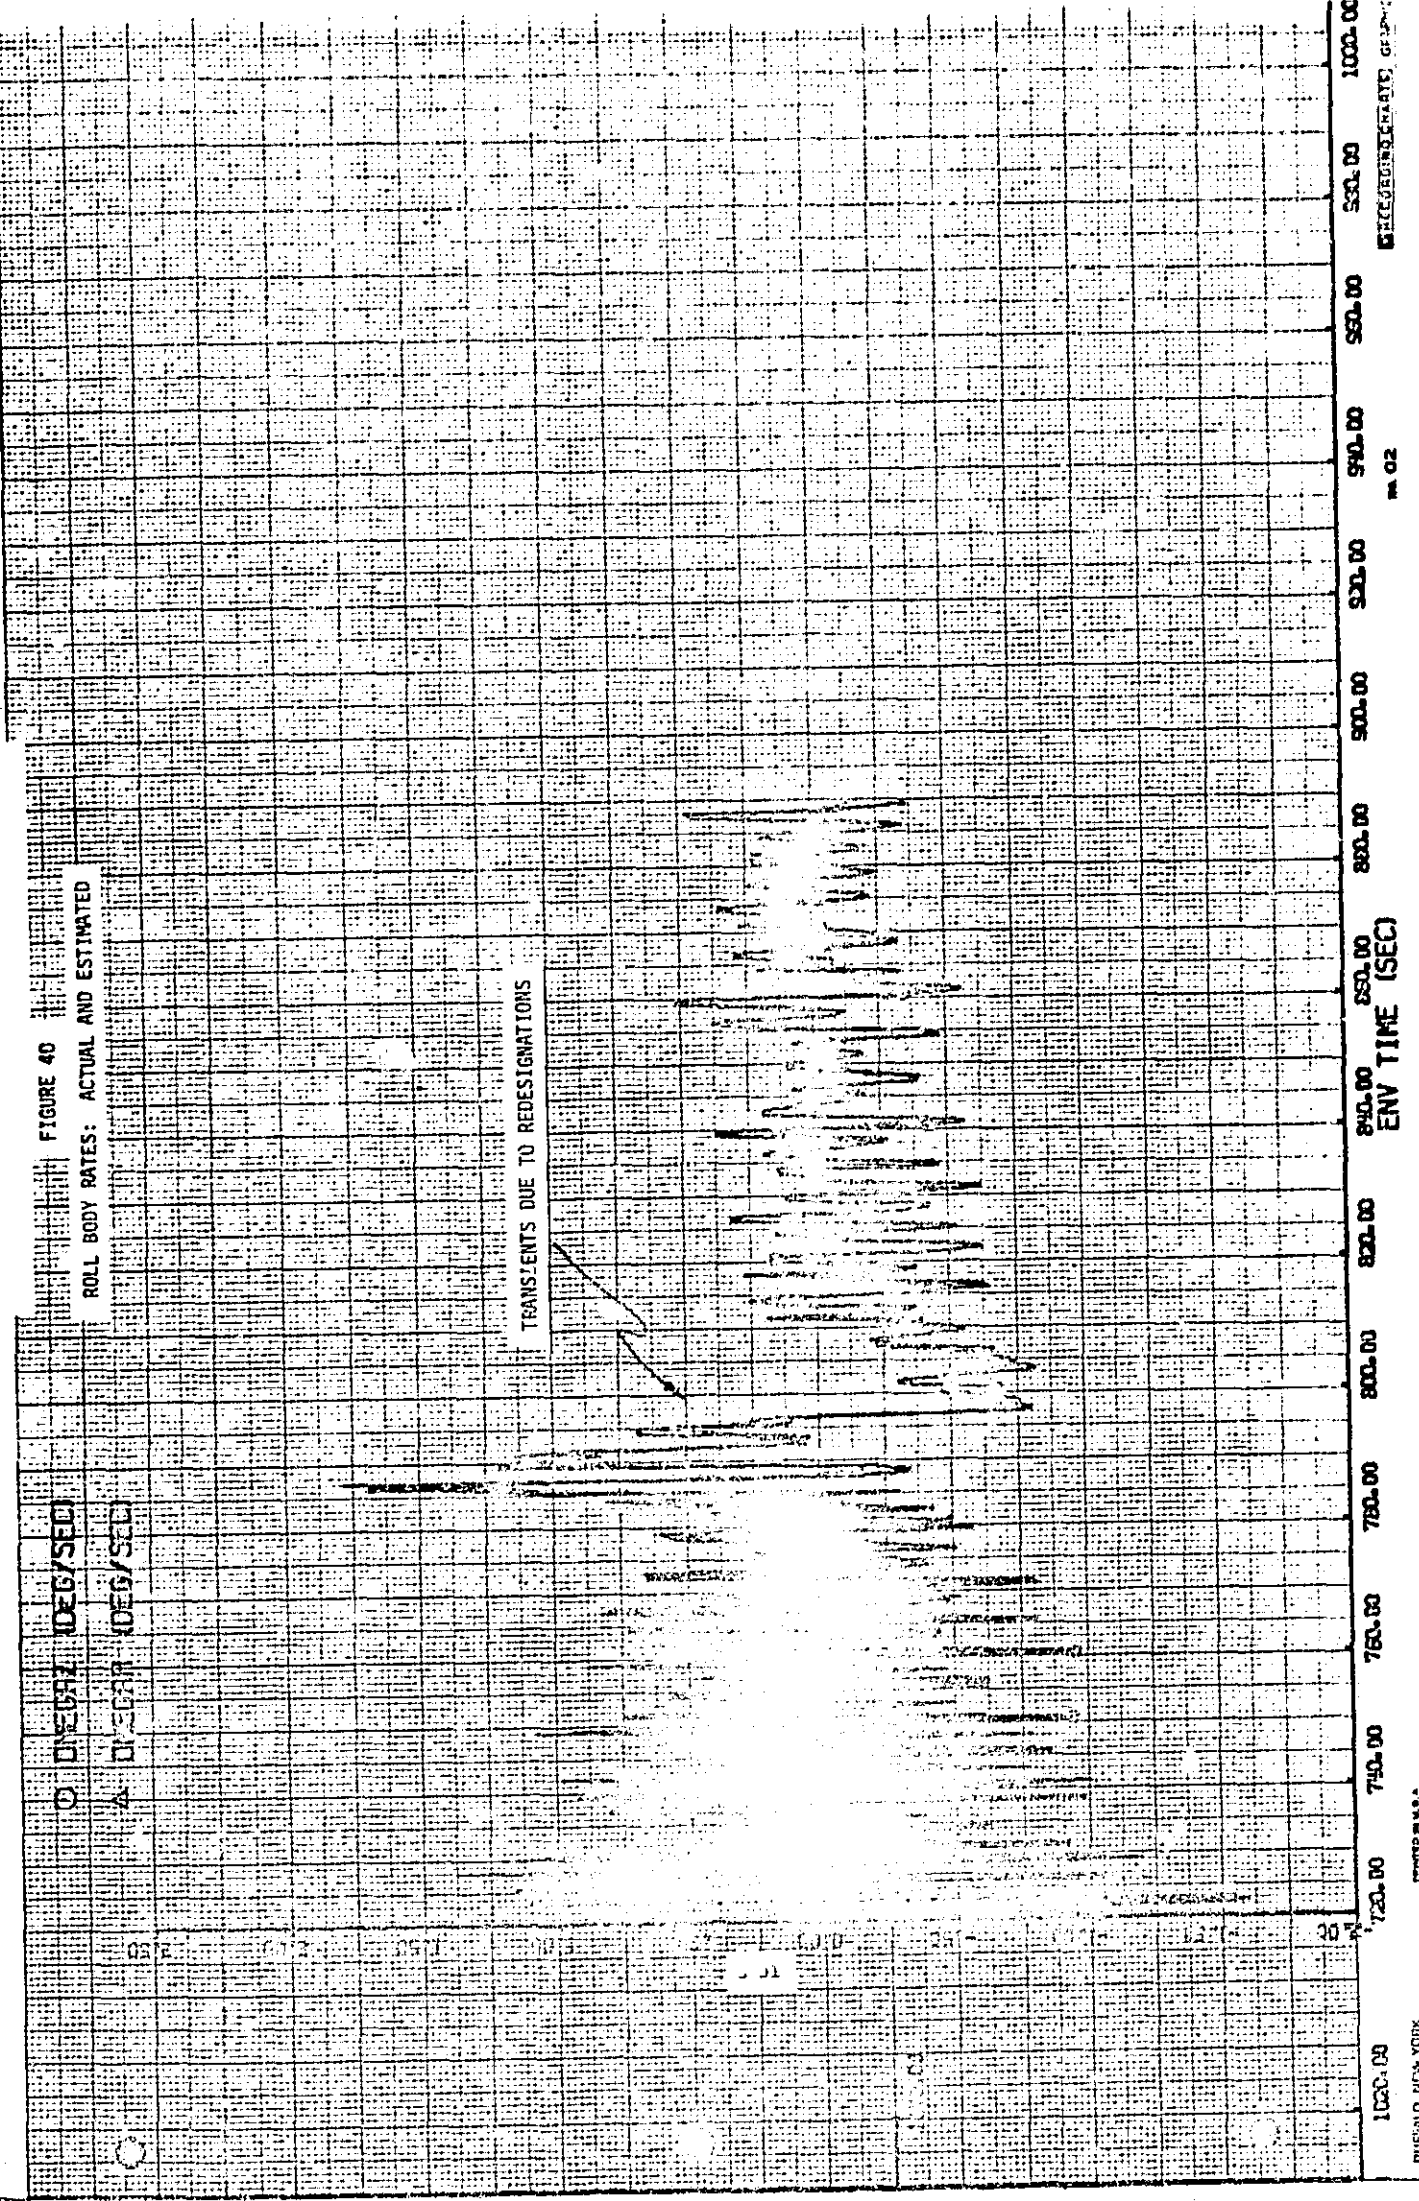
FIGURE 40
ROLL BODY RATES: ACTUAL AND ESTIMATED

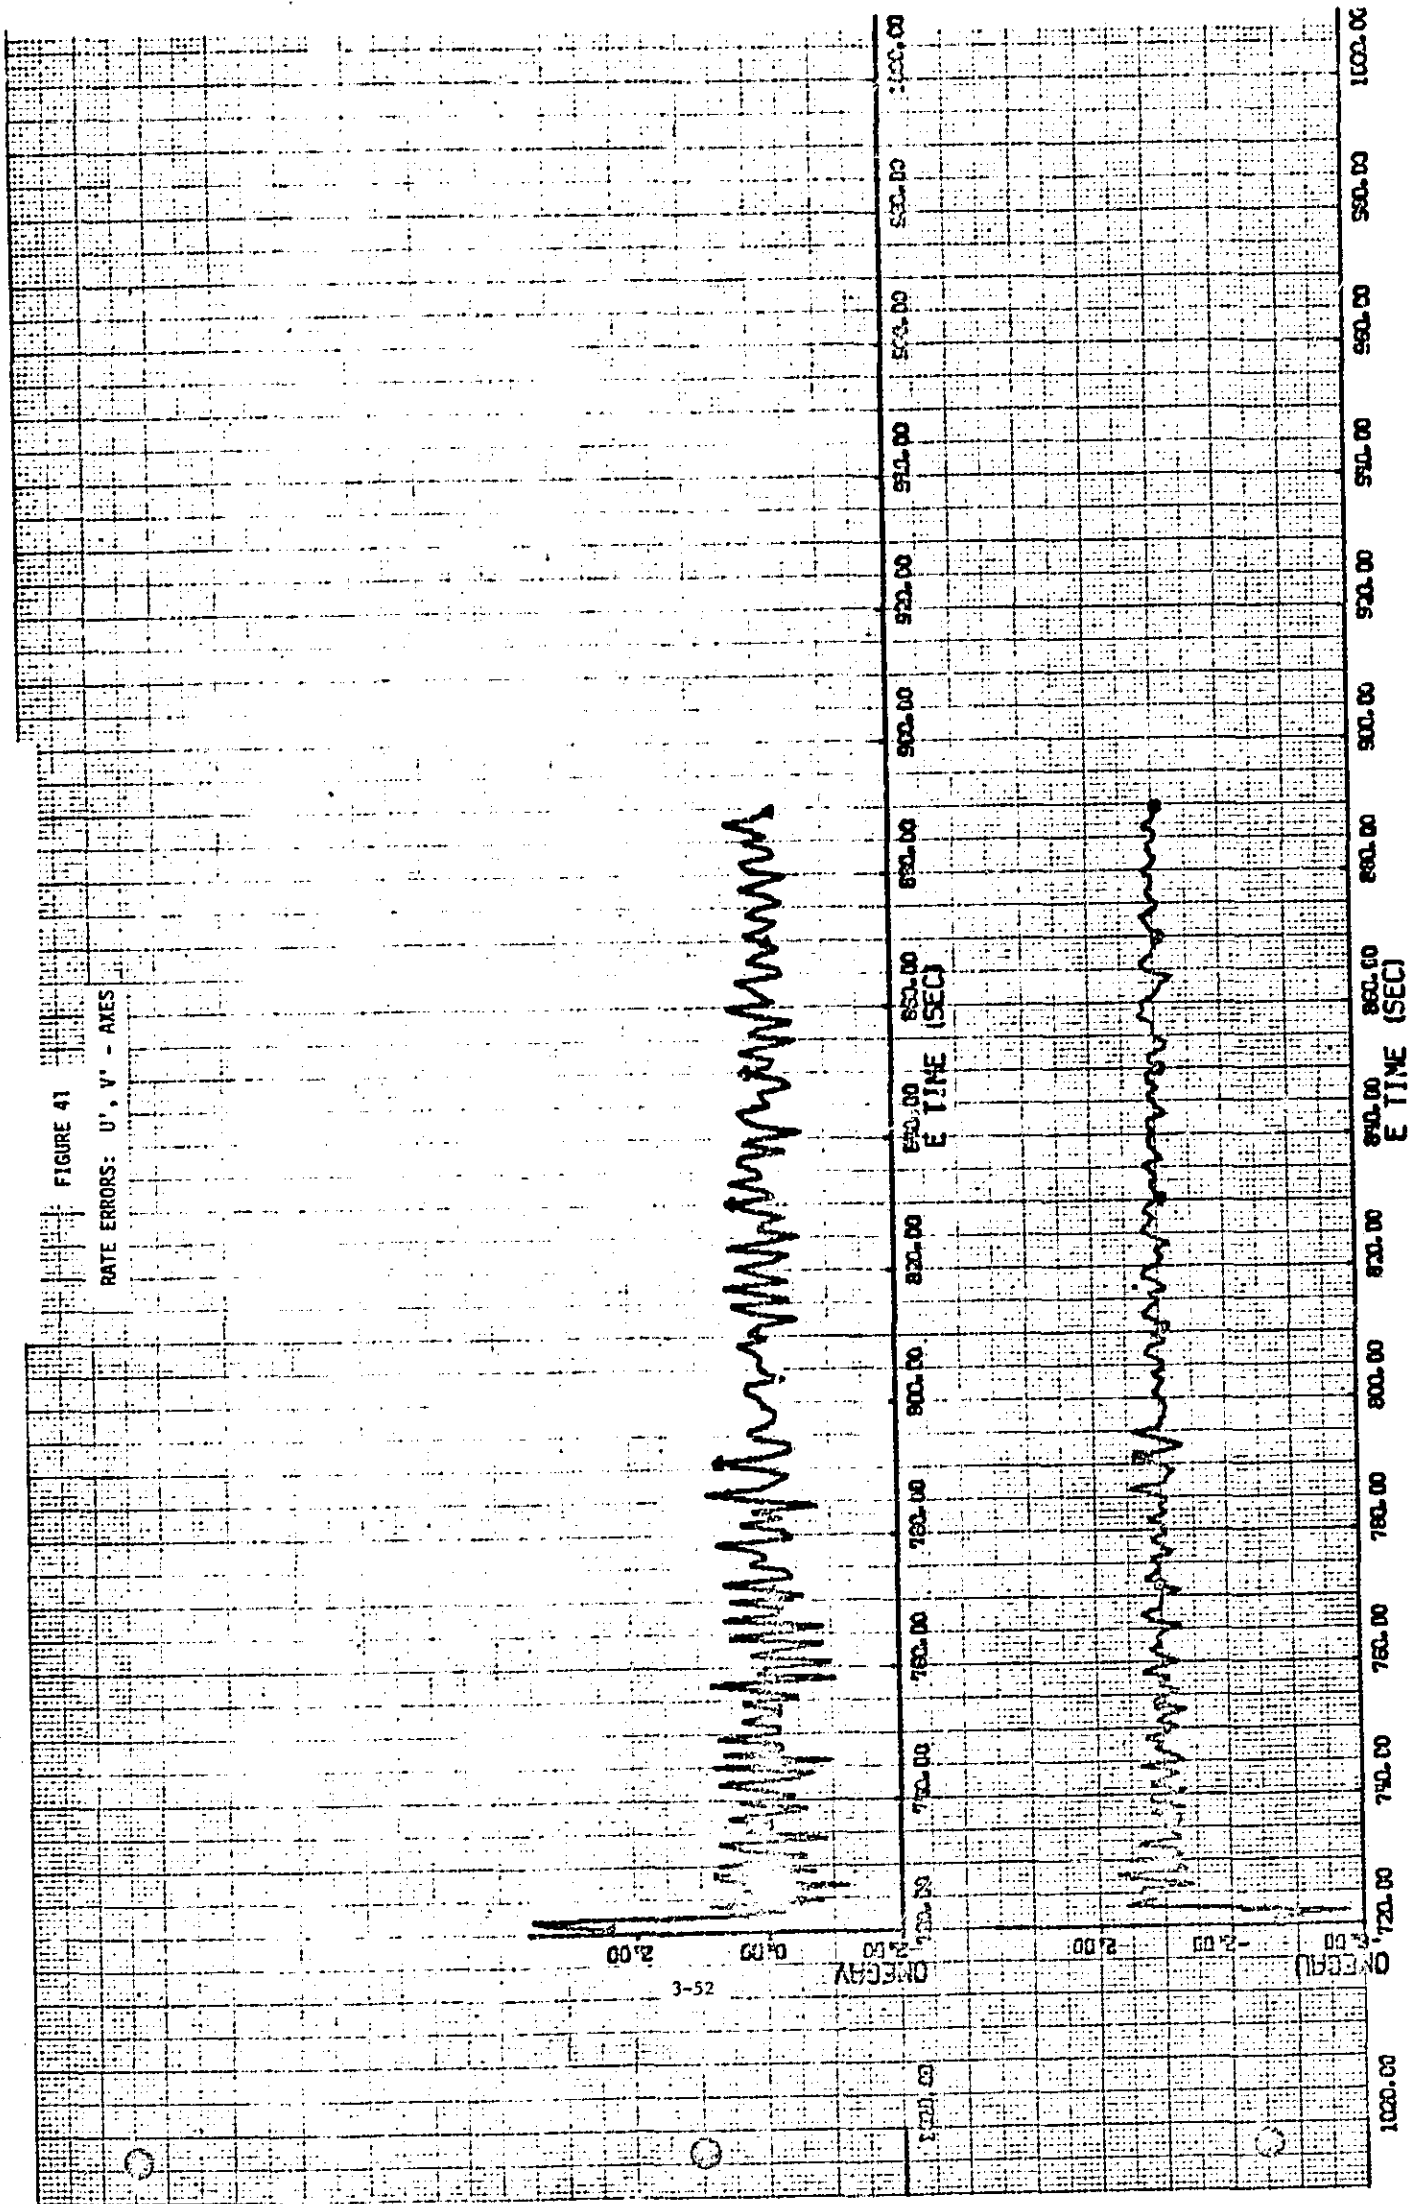
FIGURE 41

RATE ERRORS: U', V' - AXES

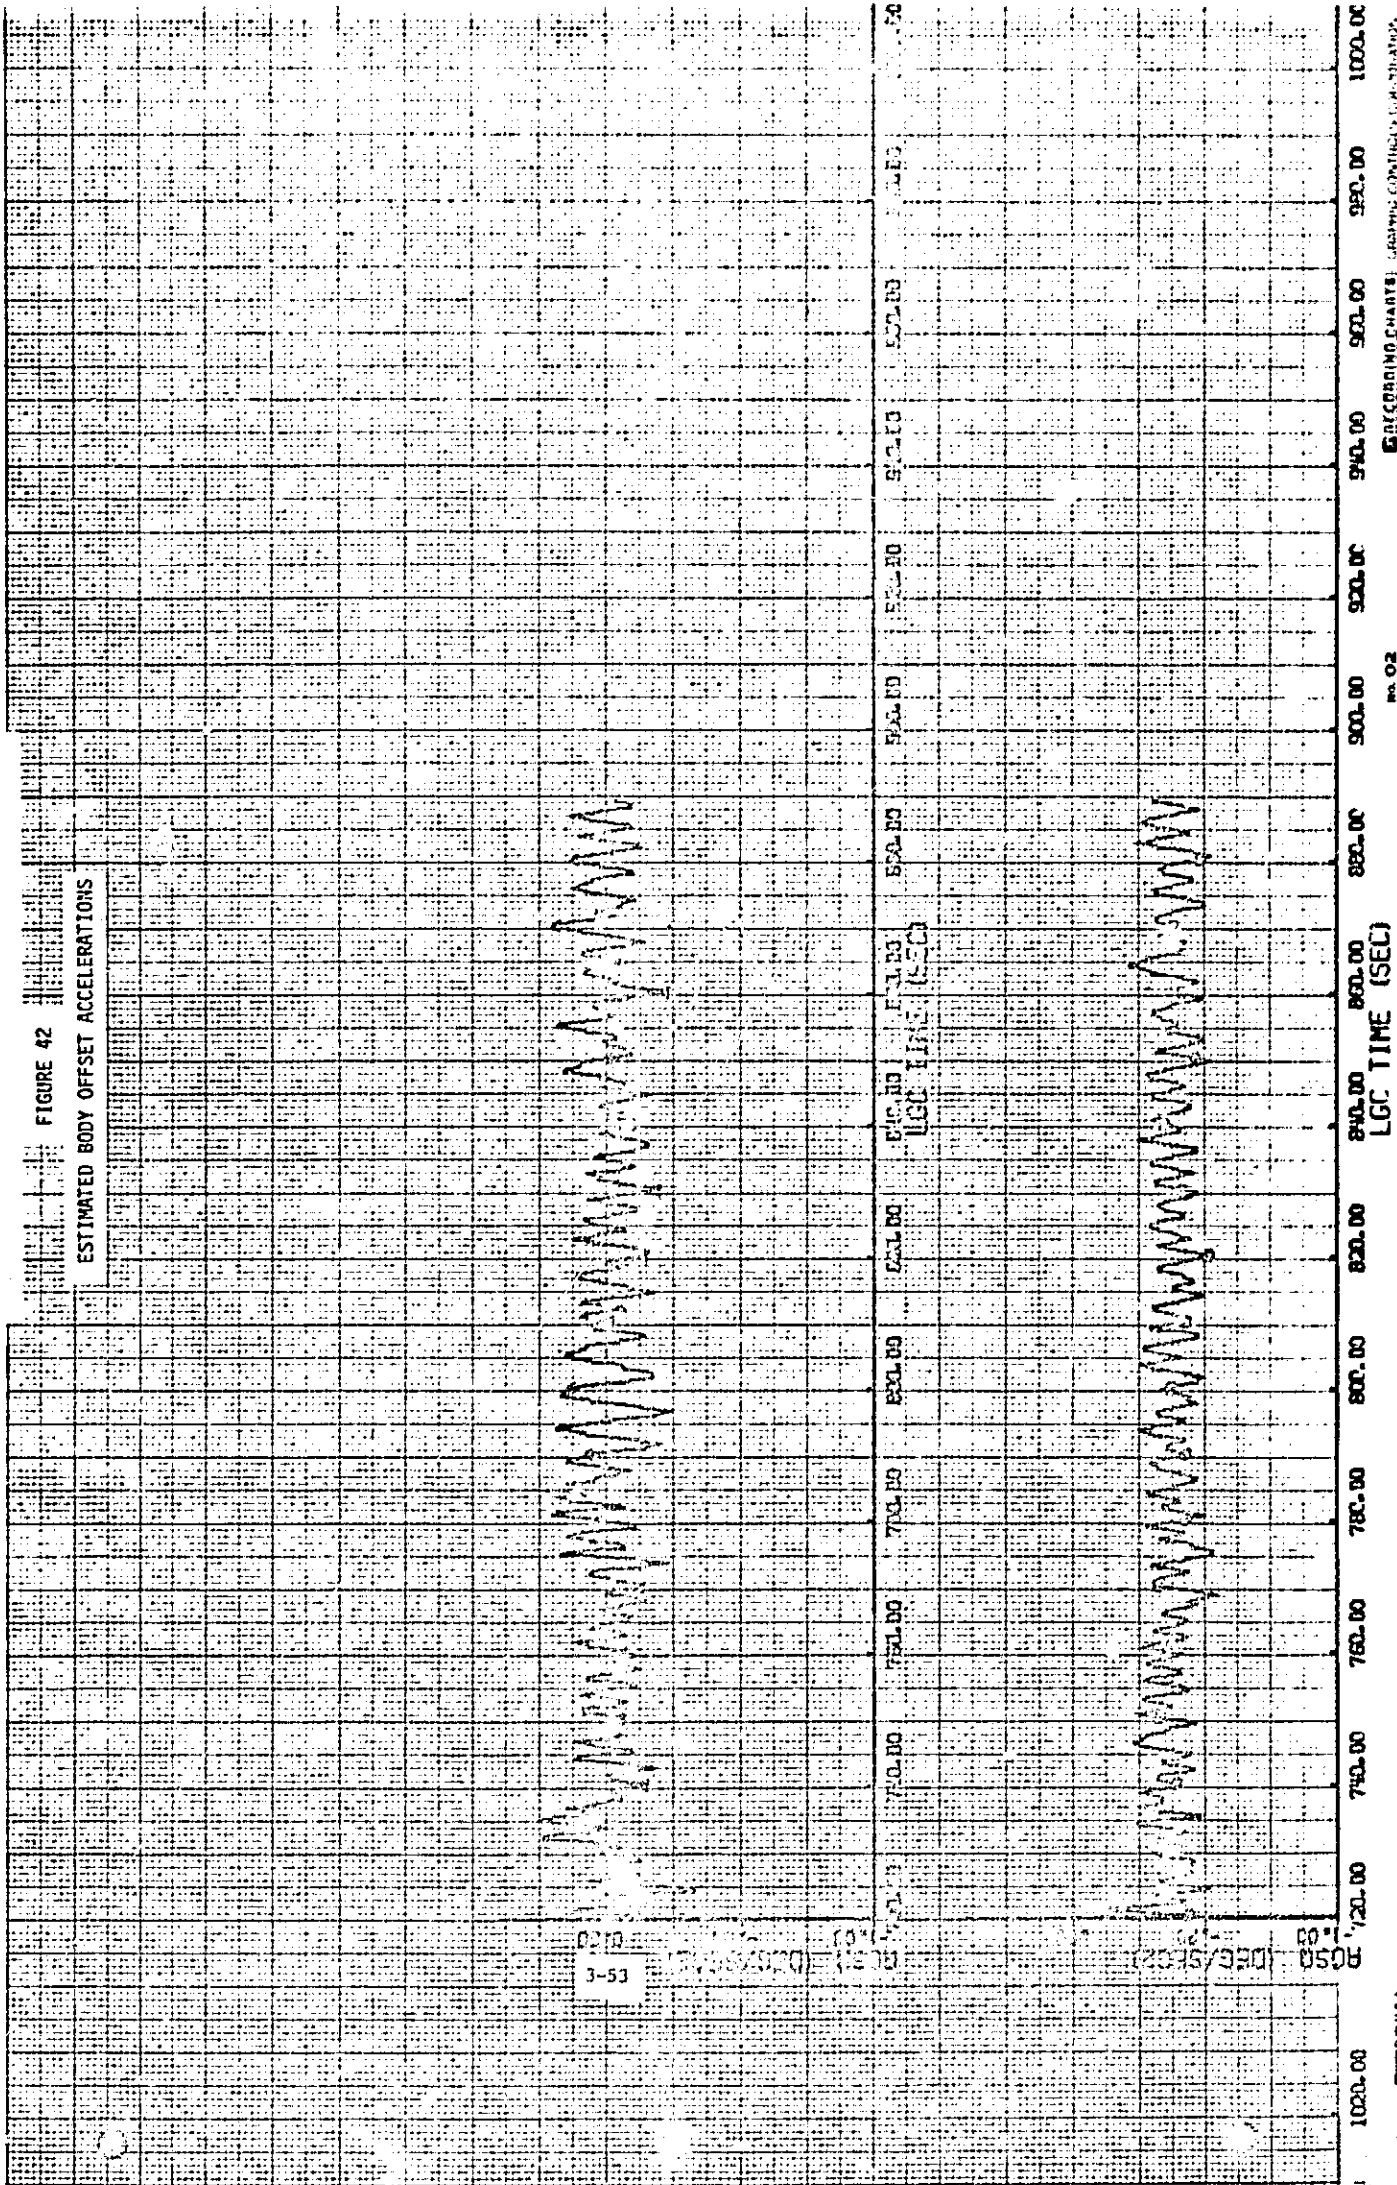
FIGURE 42
ESTIMATED BODY OFFSET ACCELERATIONS

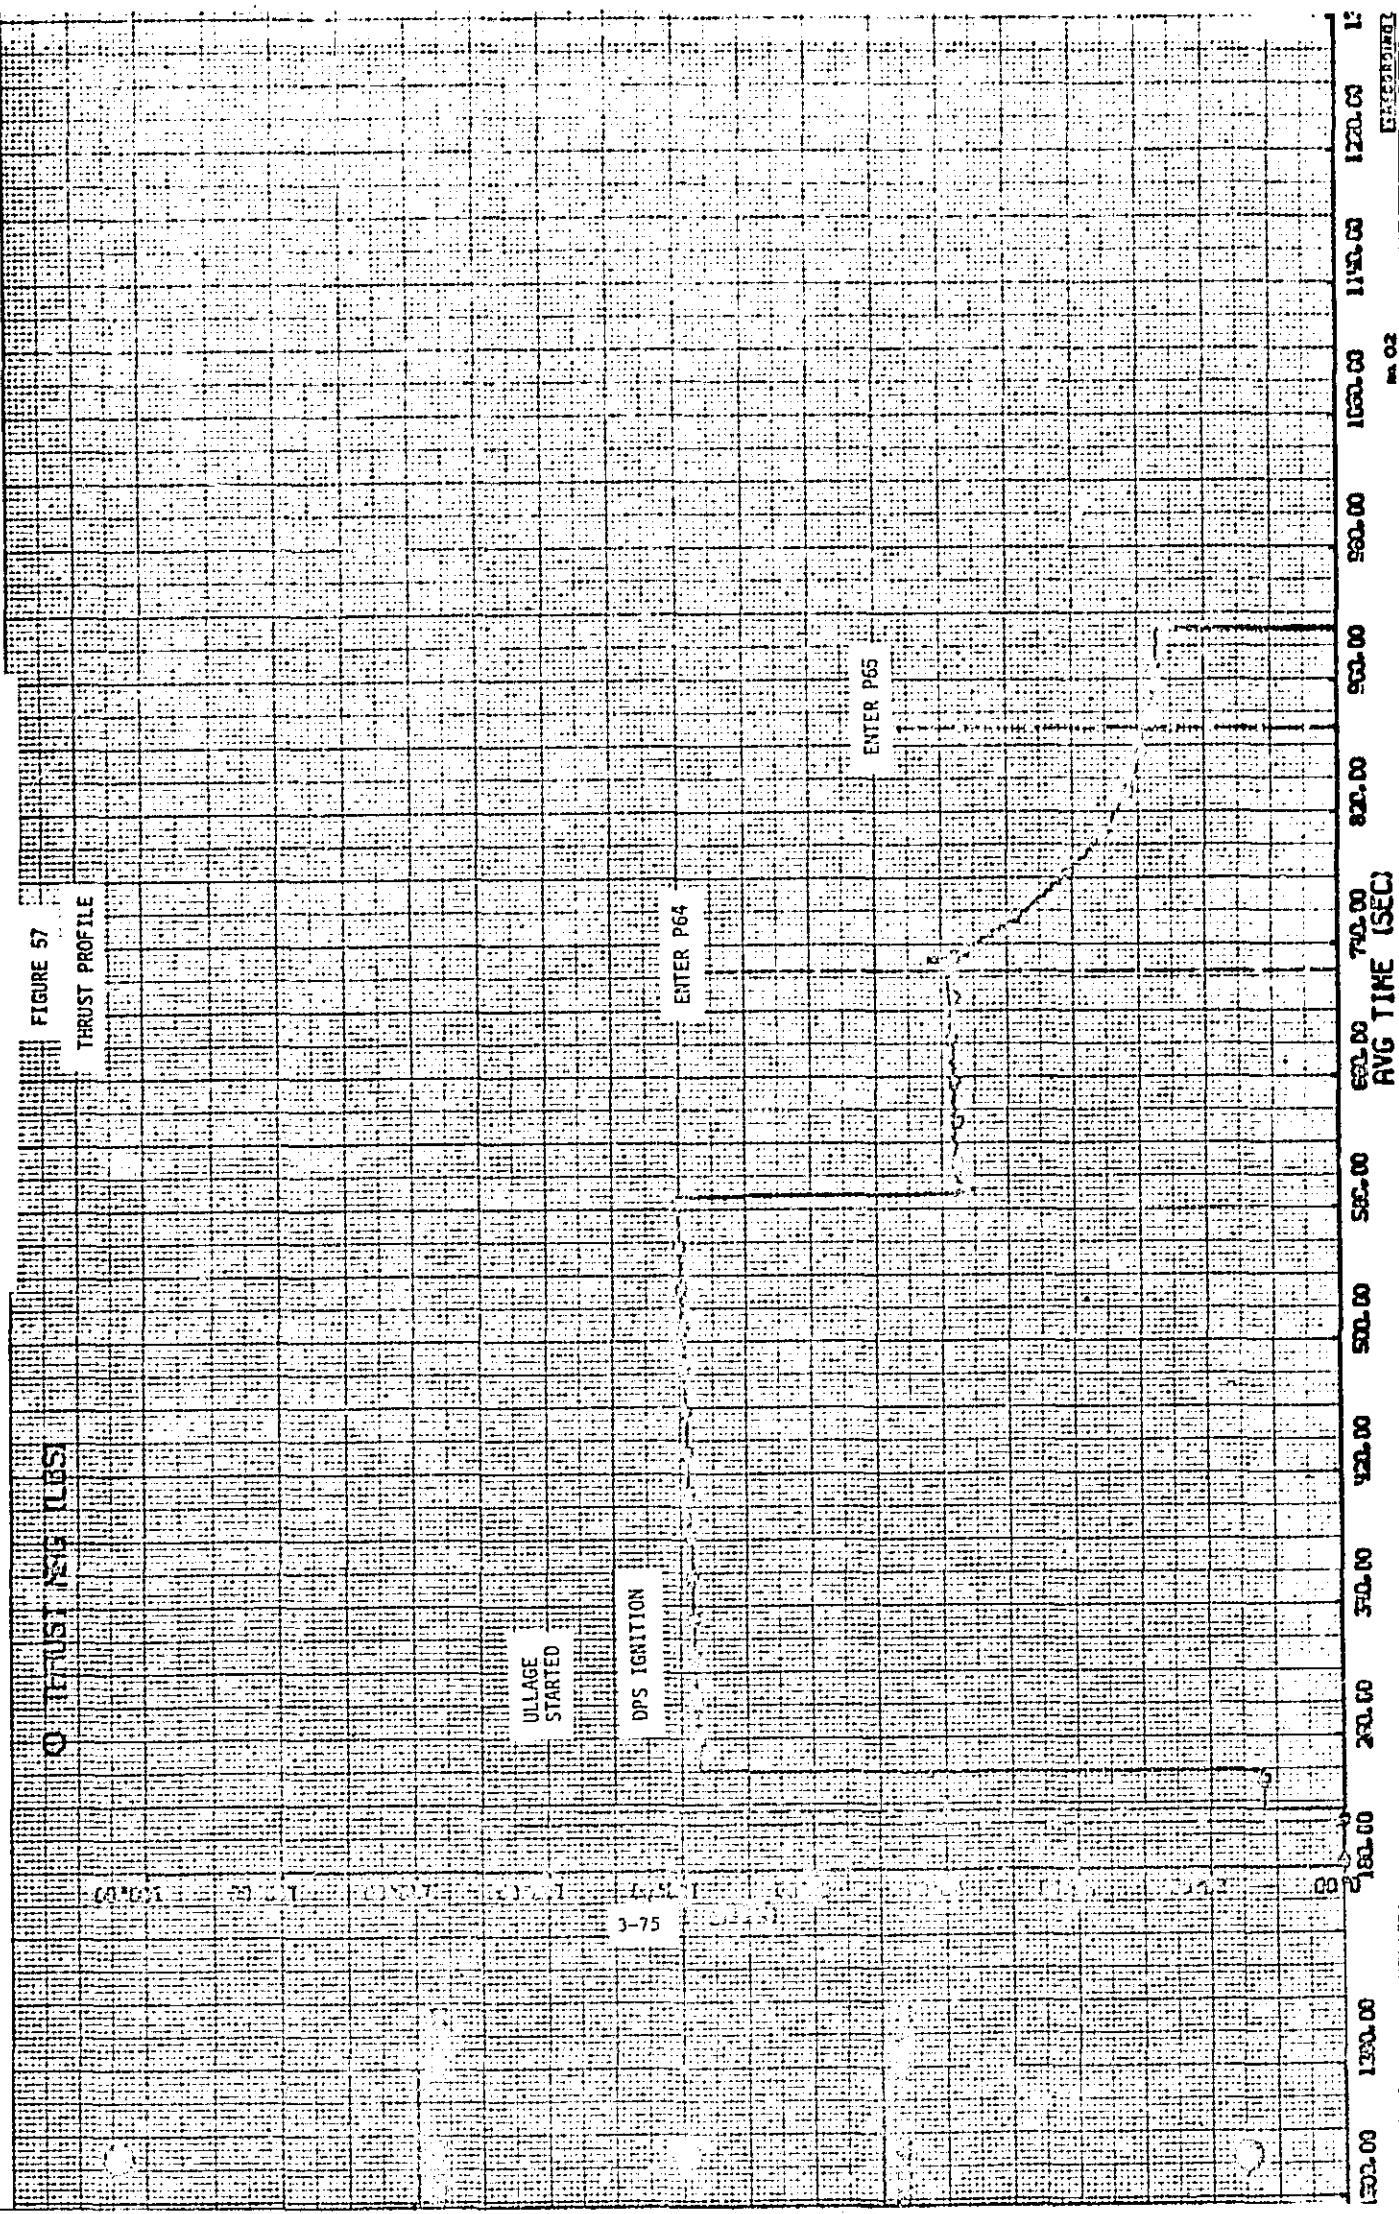
FIGURE 57
THRUST PROFILE
