PROJECT TECHNICAL REPORT
TASK E-72B

LUMINARY 1B DAP PREFLIGHT PERFORMANCE
EVALUATION

NAS 9-8166

13 November 1969

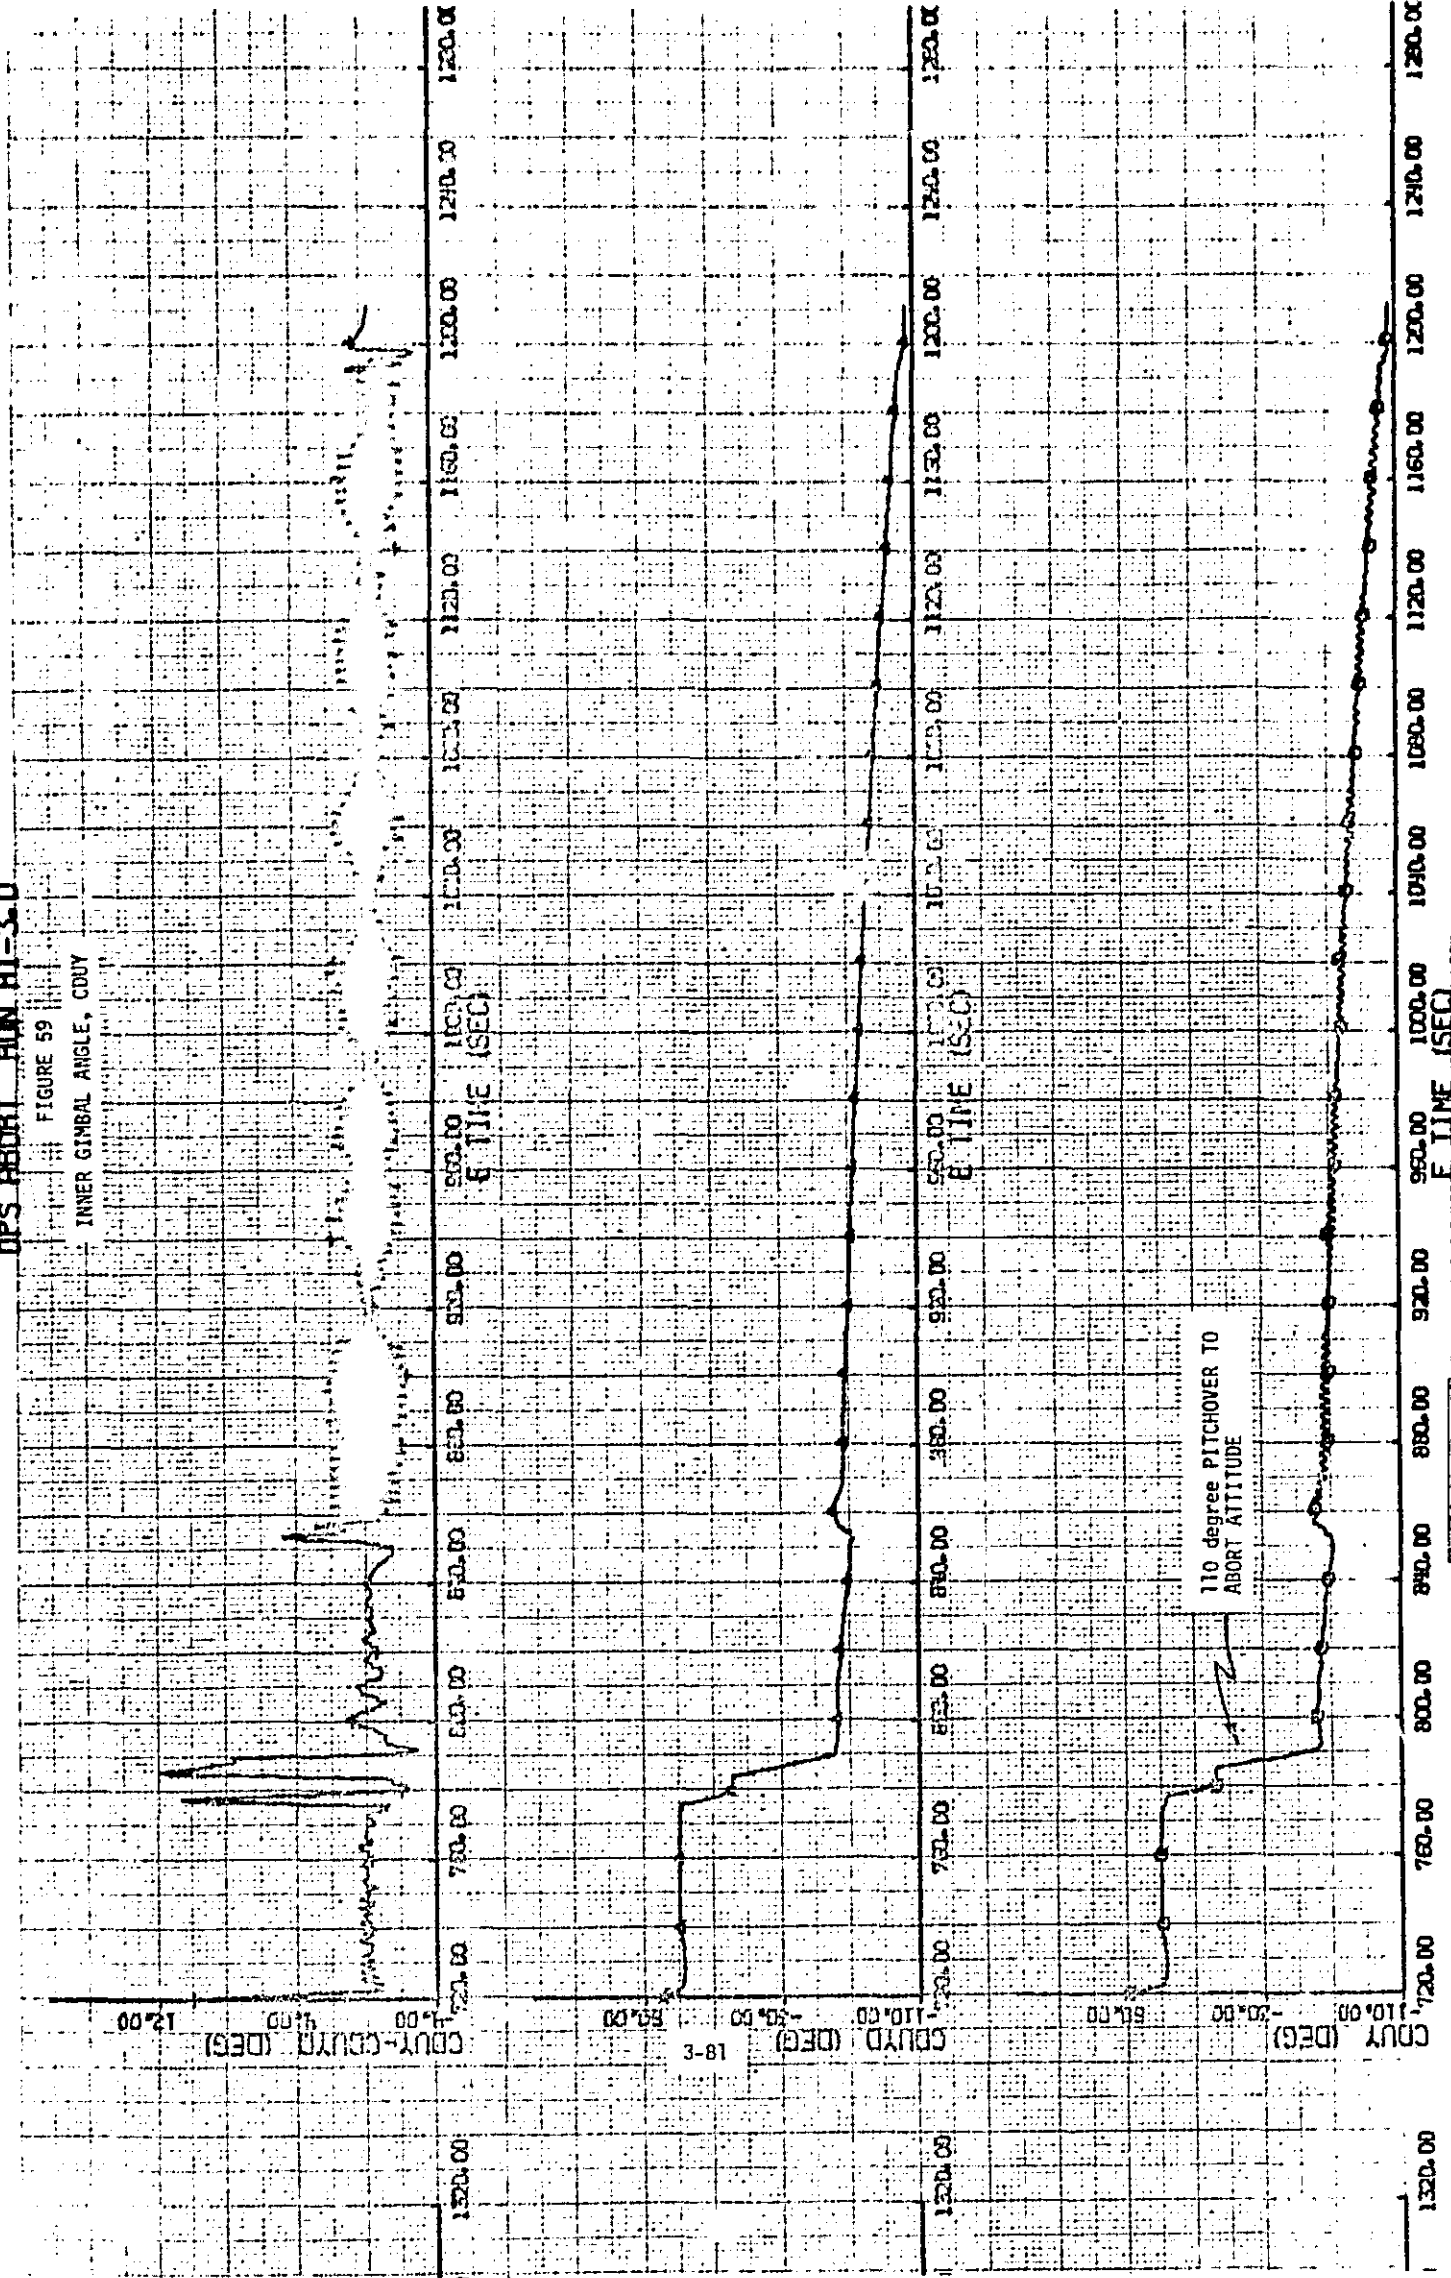
FIGURE 59
INNER GIMBAL ANGLE, CDUY

Upon entering the abort program P70, large guidance commands are issued to adjust the spacecraft attitude to a burn attitude necessary to achieve safe orbit. The requested change in attitude is essentially a large pitch-over. Figures 59 and 60 show the desired gimbal angles (CDUD's) issued to the DAP during this period from the FINDCDUW ROUTINE and the guidance equa-

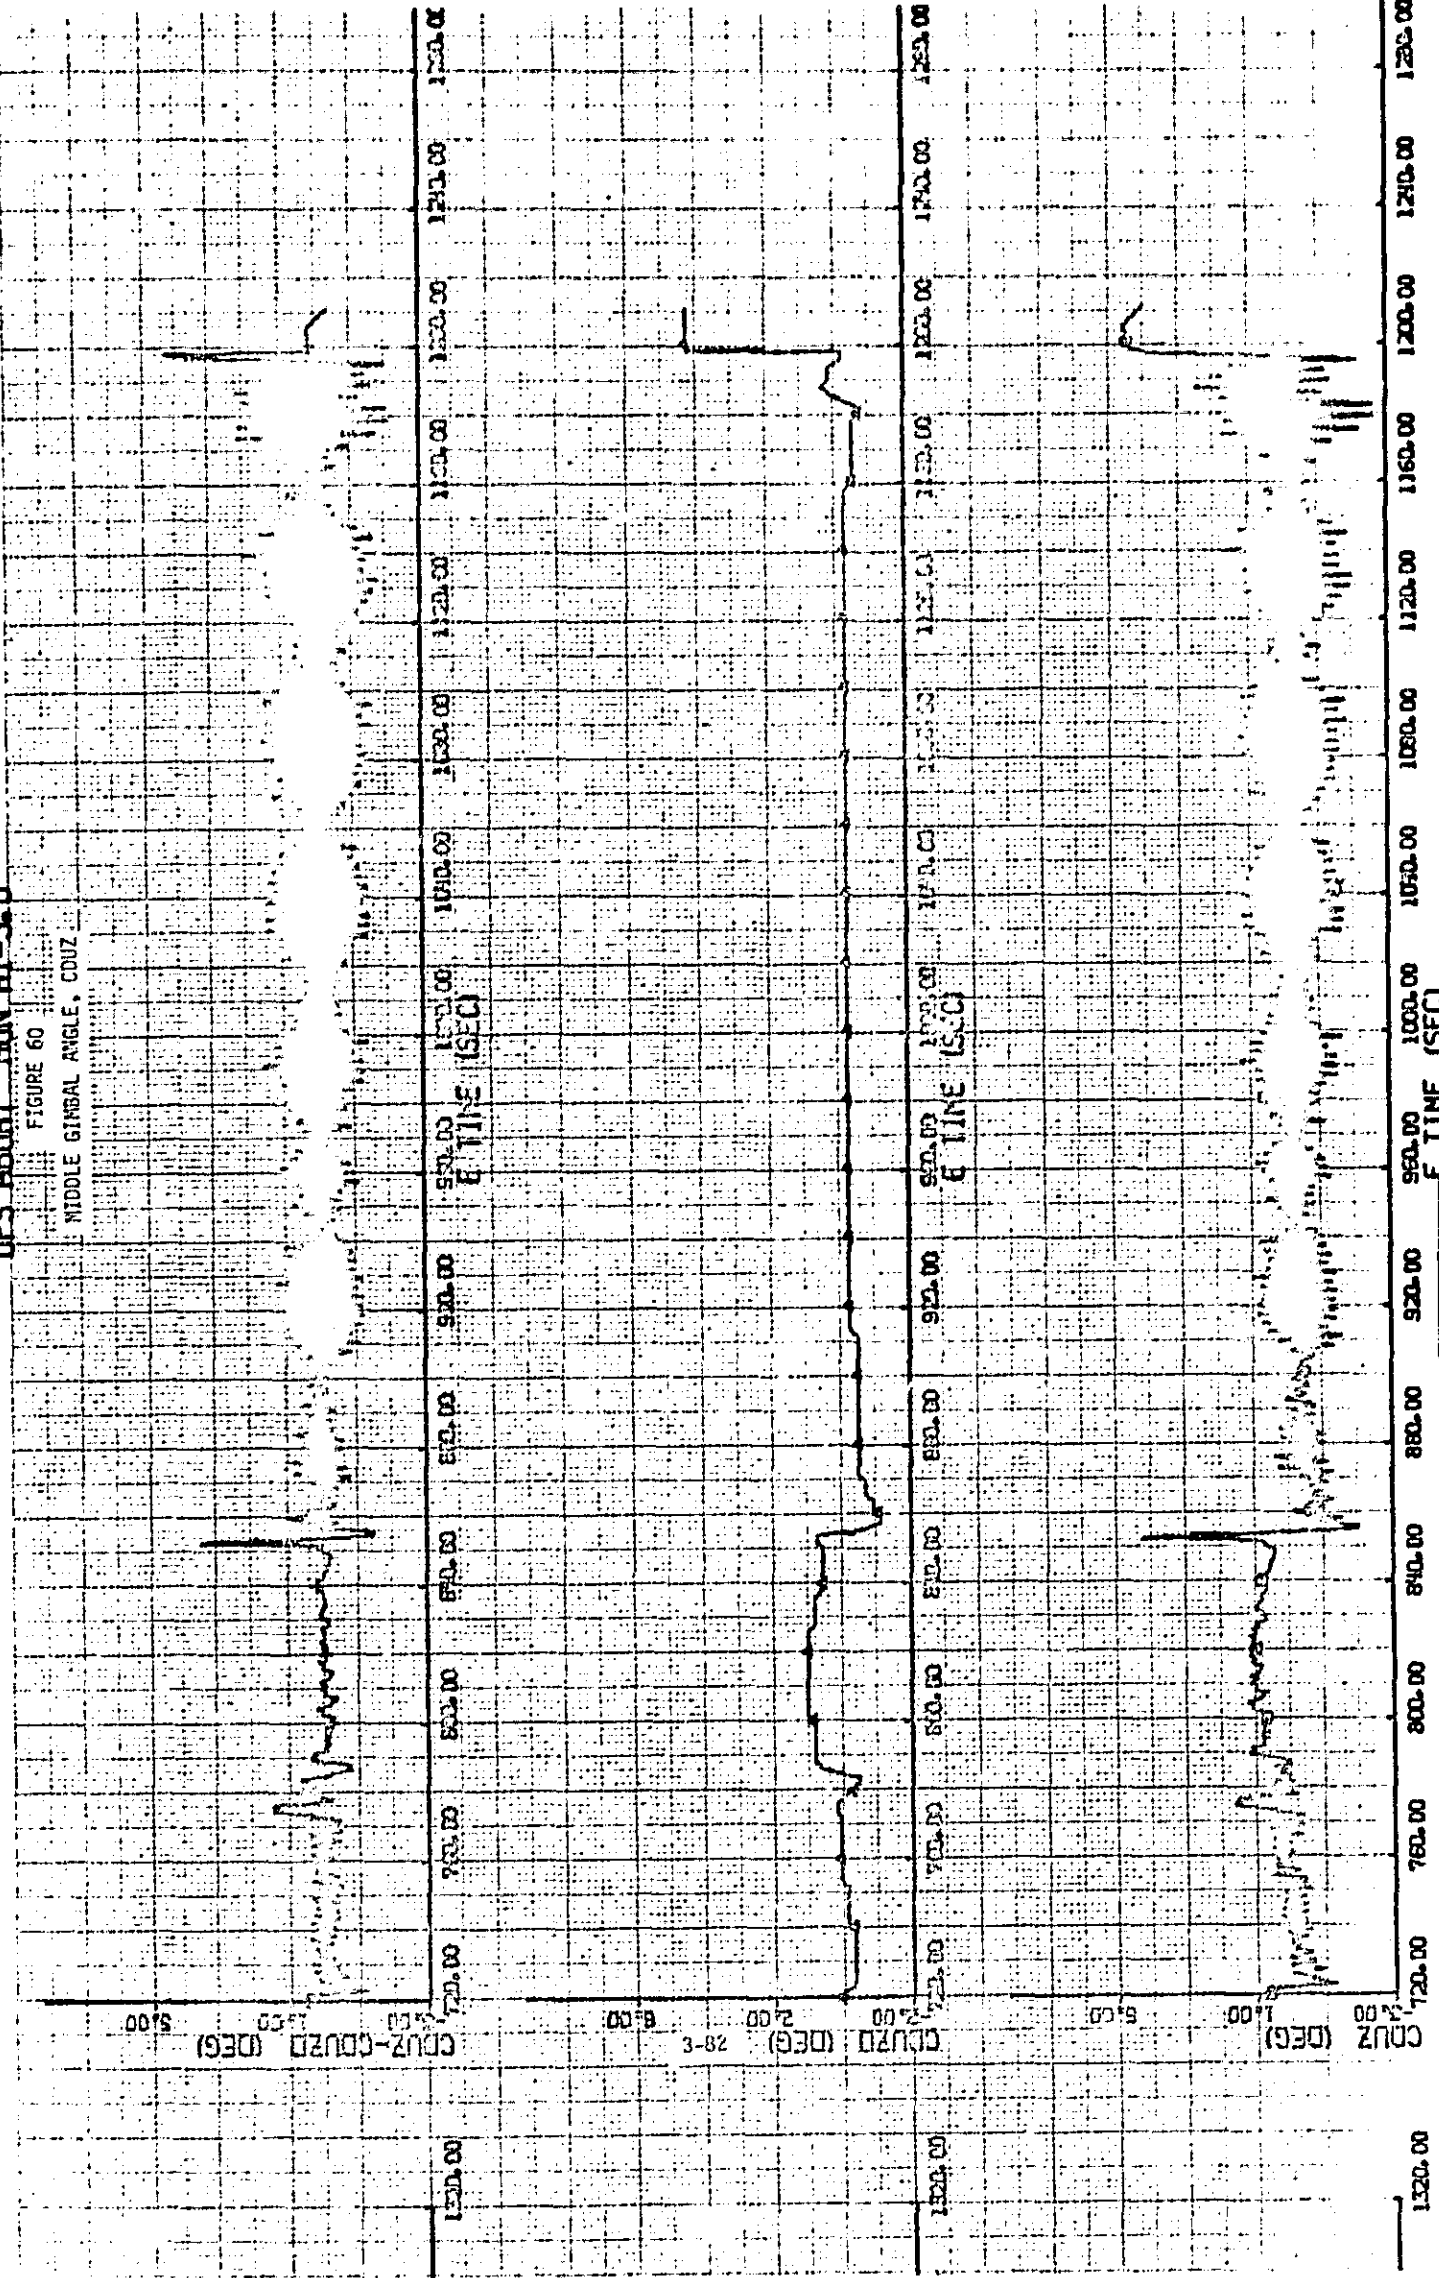
FIGURE 60
MIDDLE GIMBAL ANGLE, CUZ

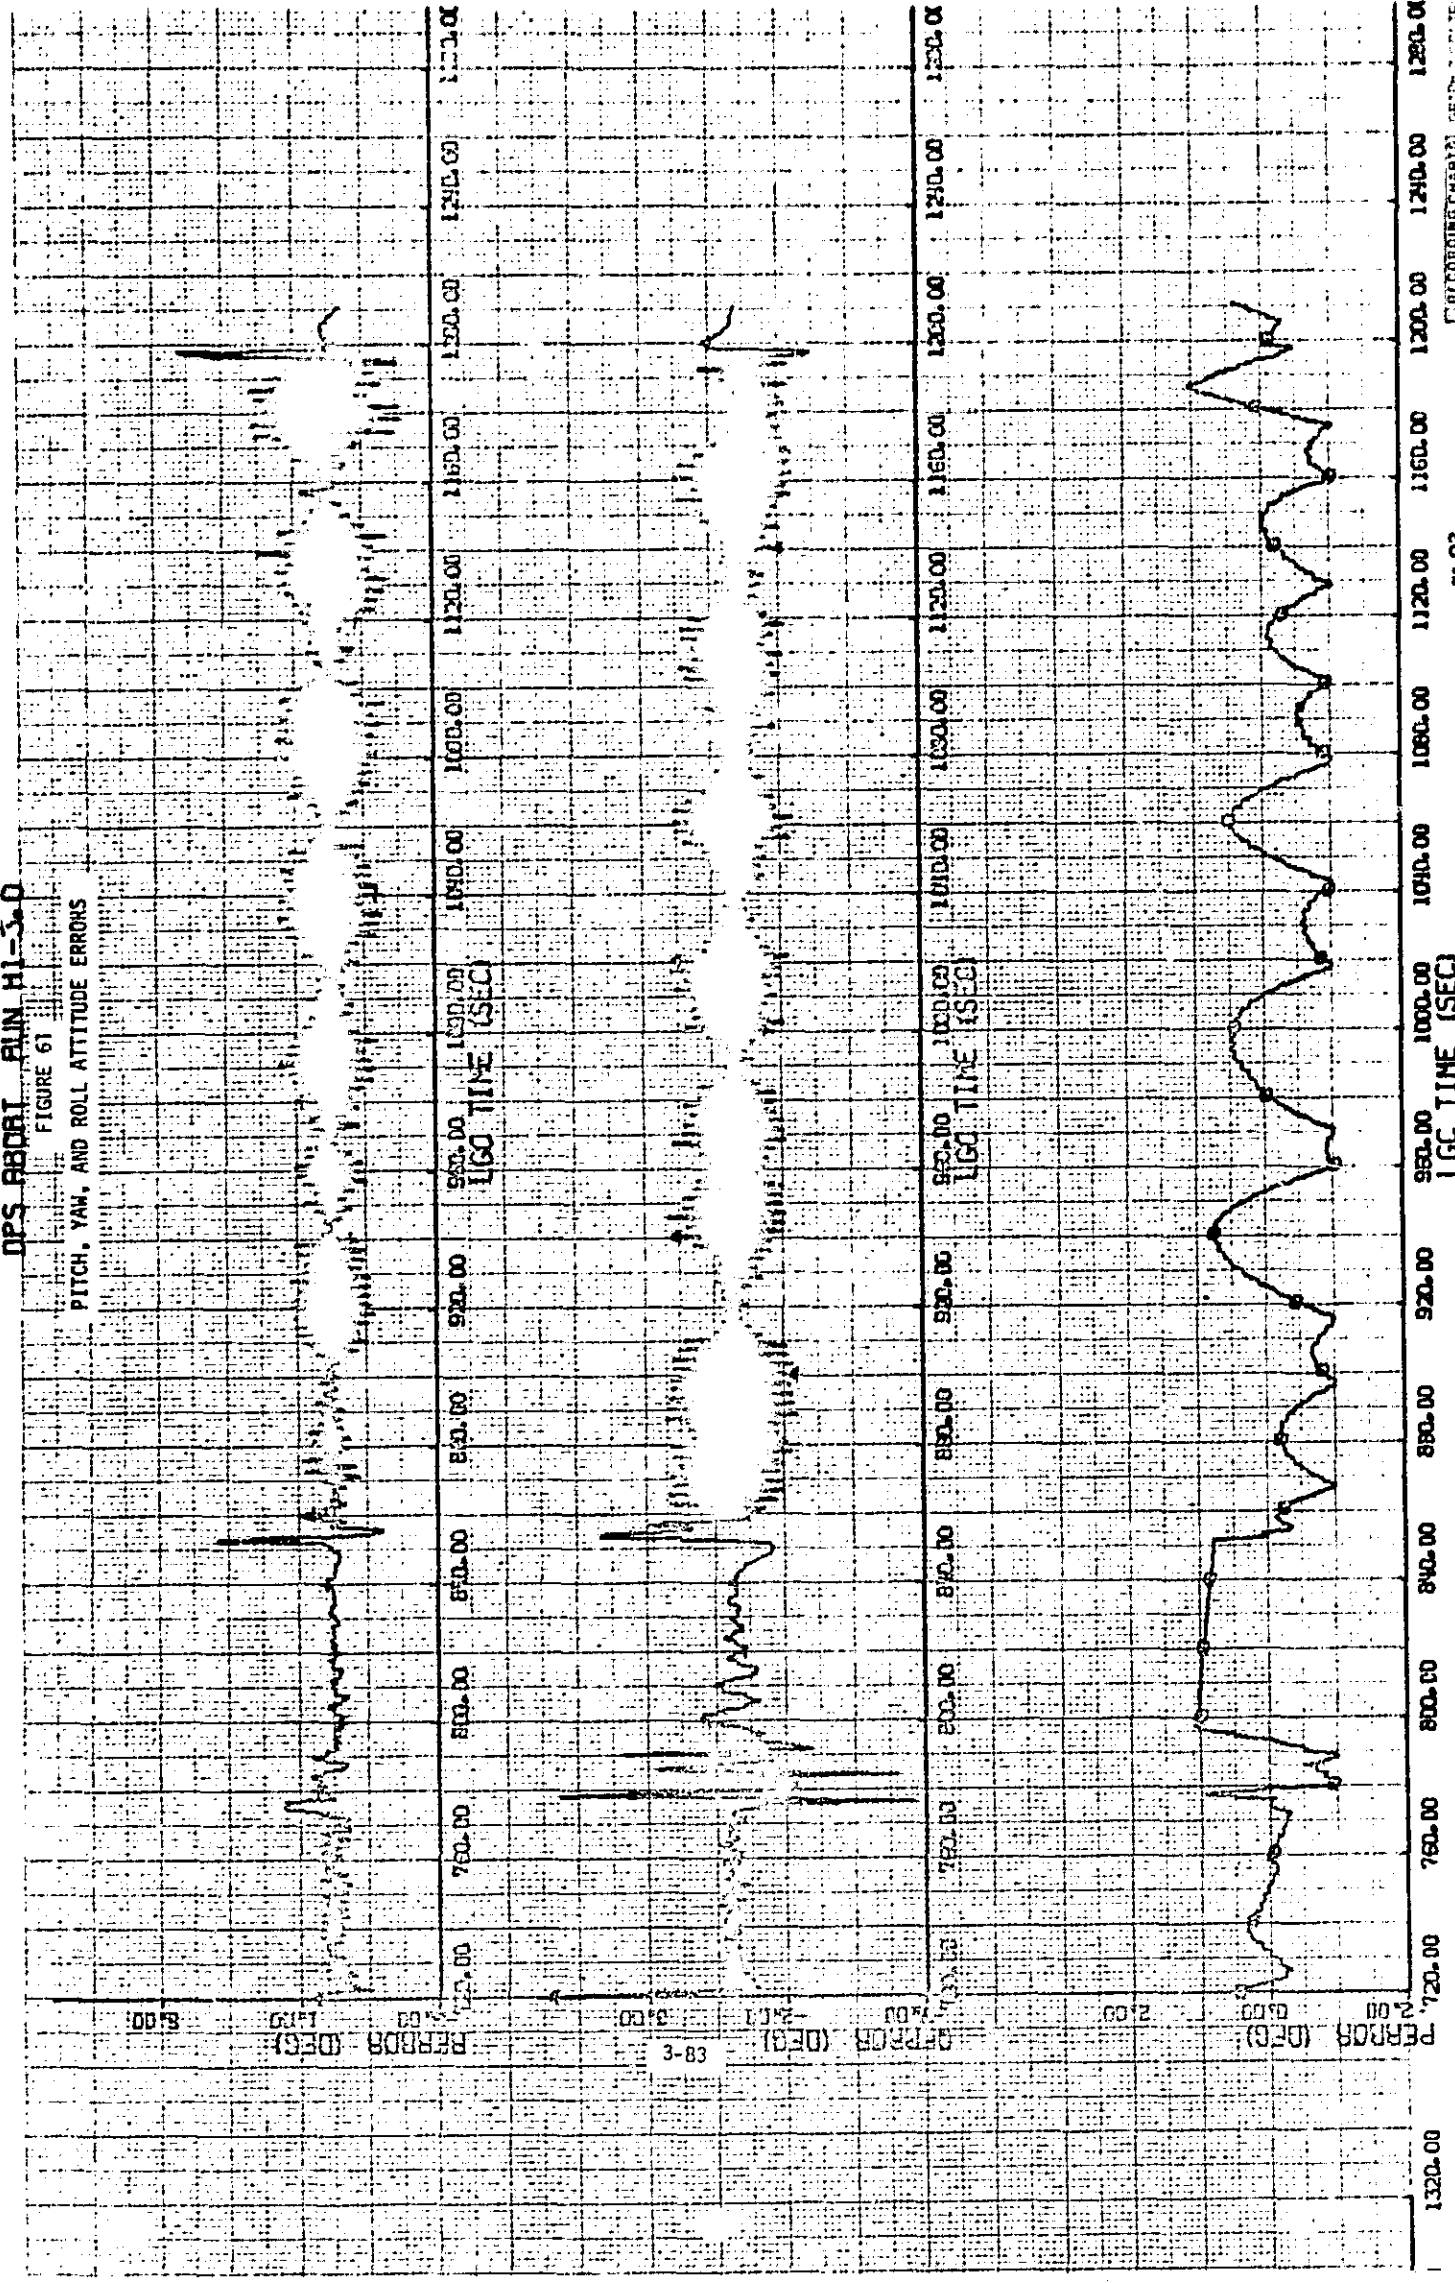
FIGURE 61

PITCH, YAW, AND ROLL ATTITUDE ERRORS

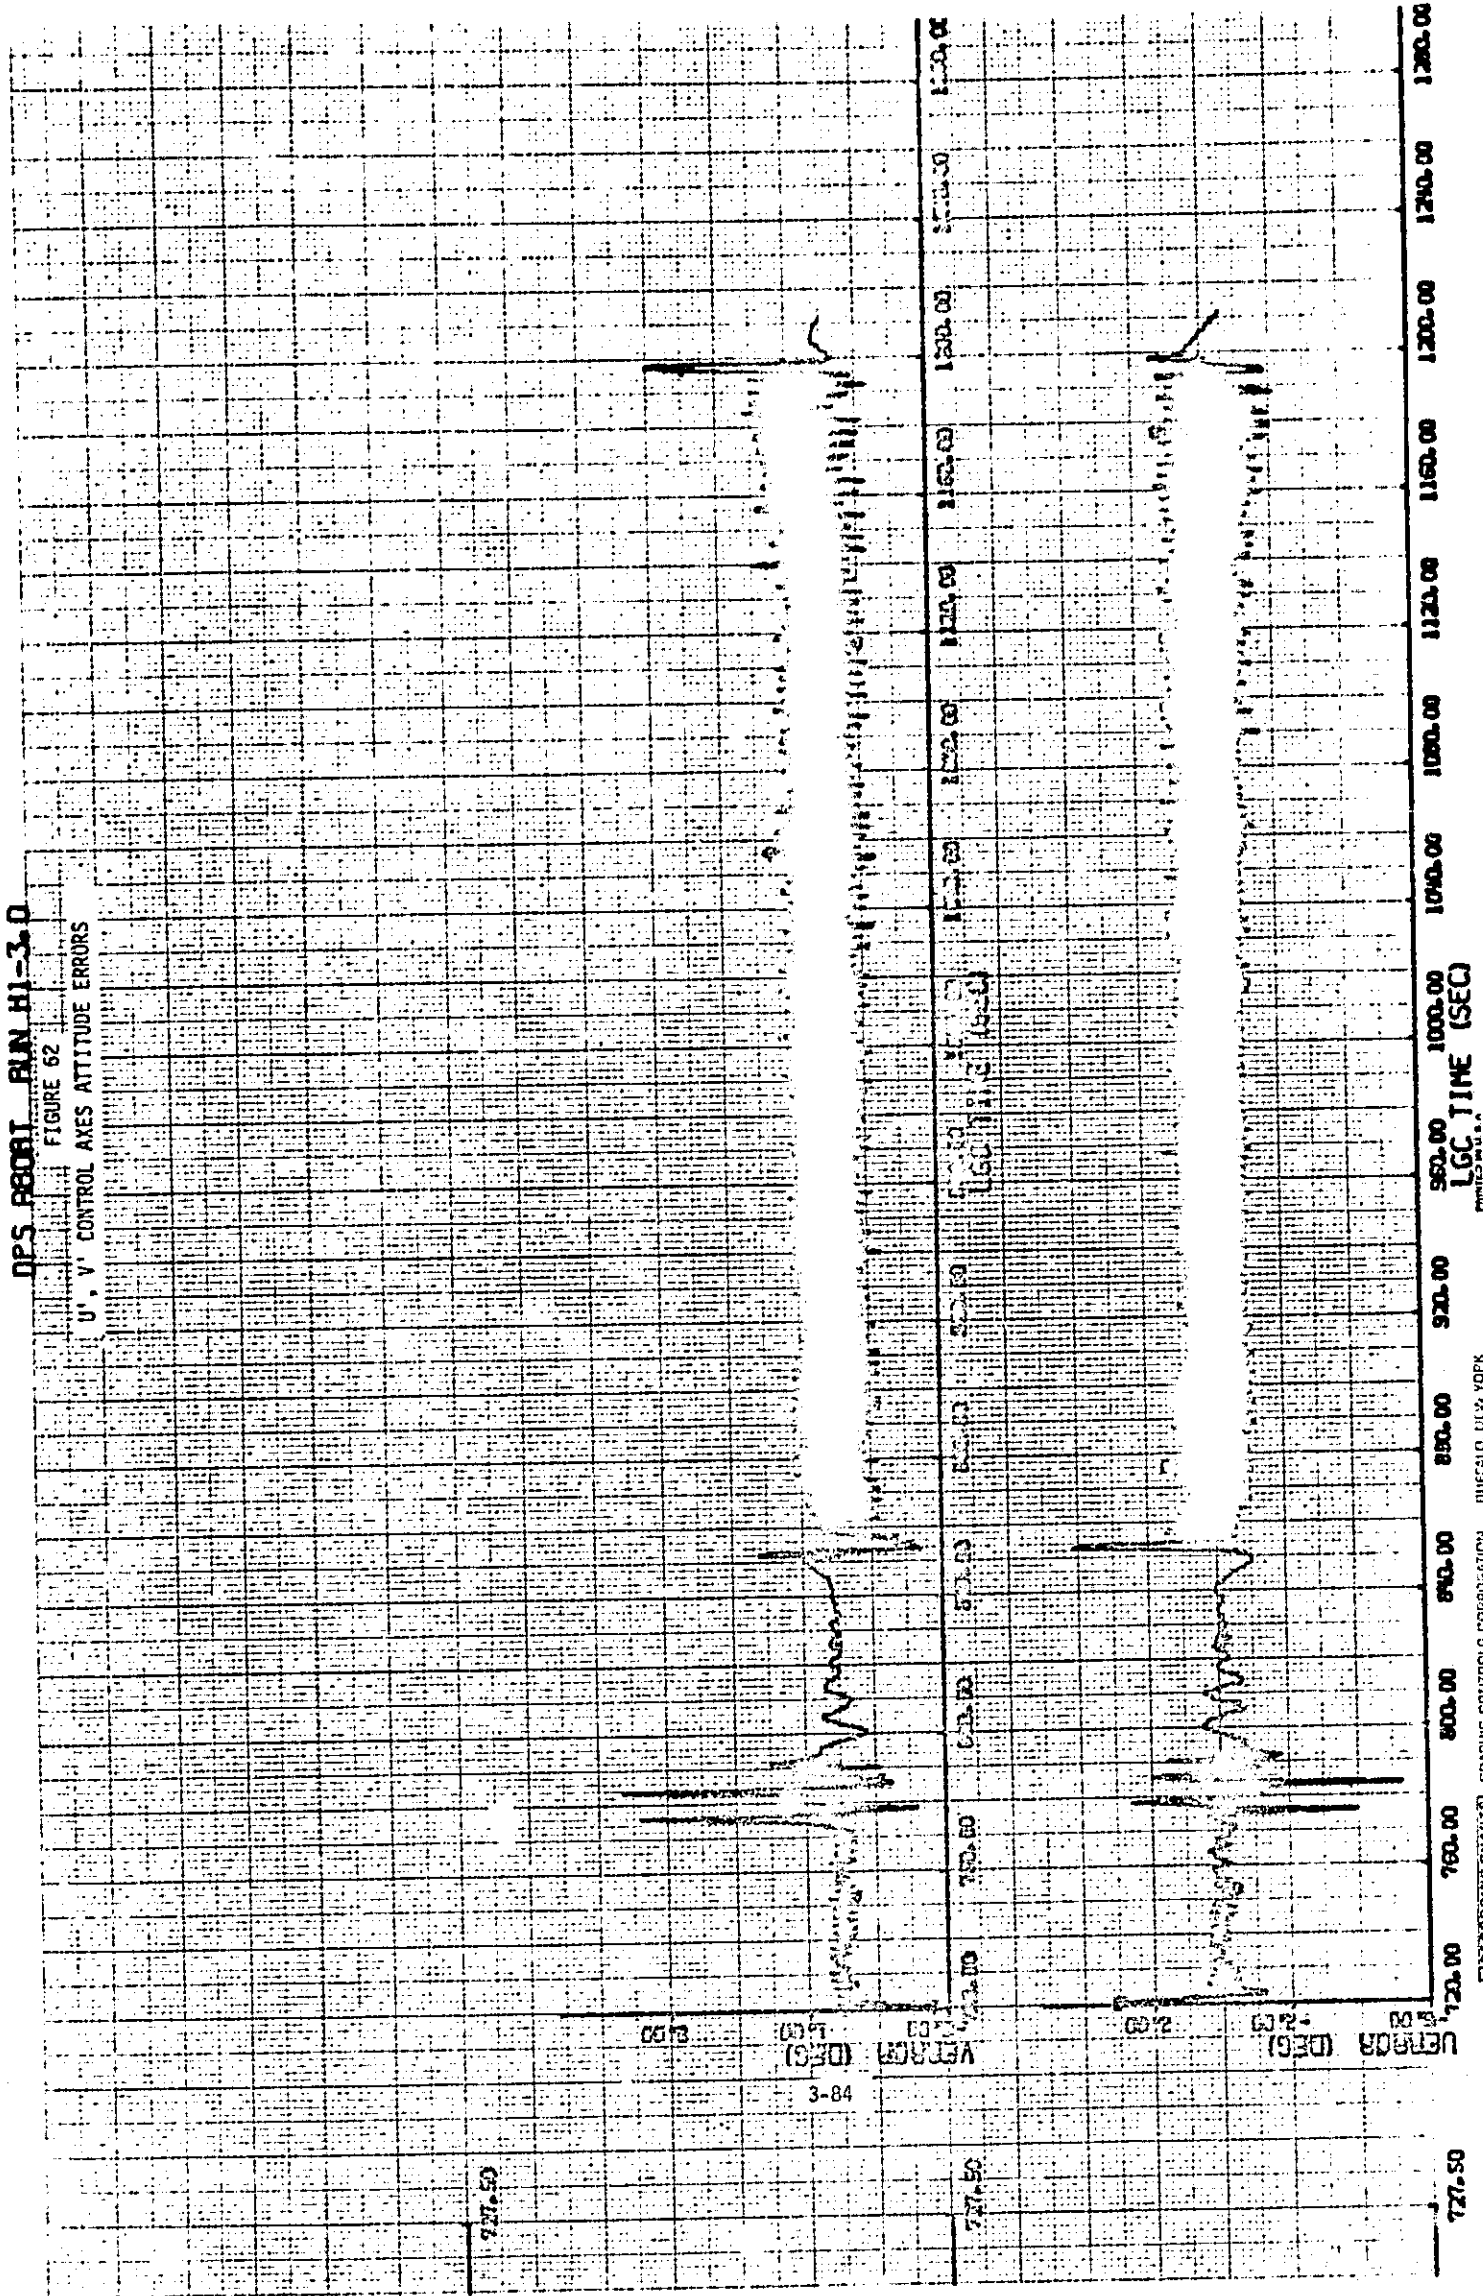
FIGURE 62
U, V CONTROL AXES ATTITUDE ERRORS

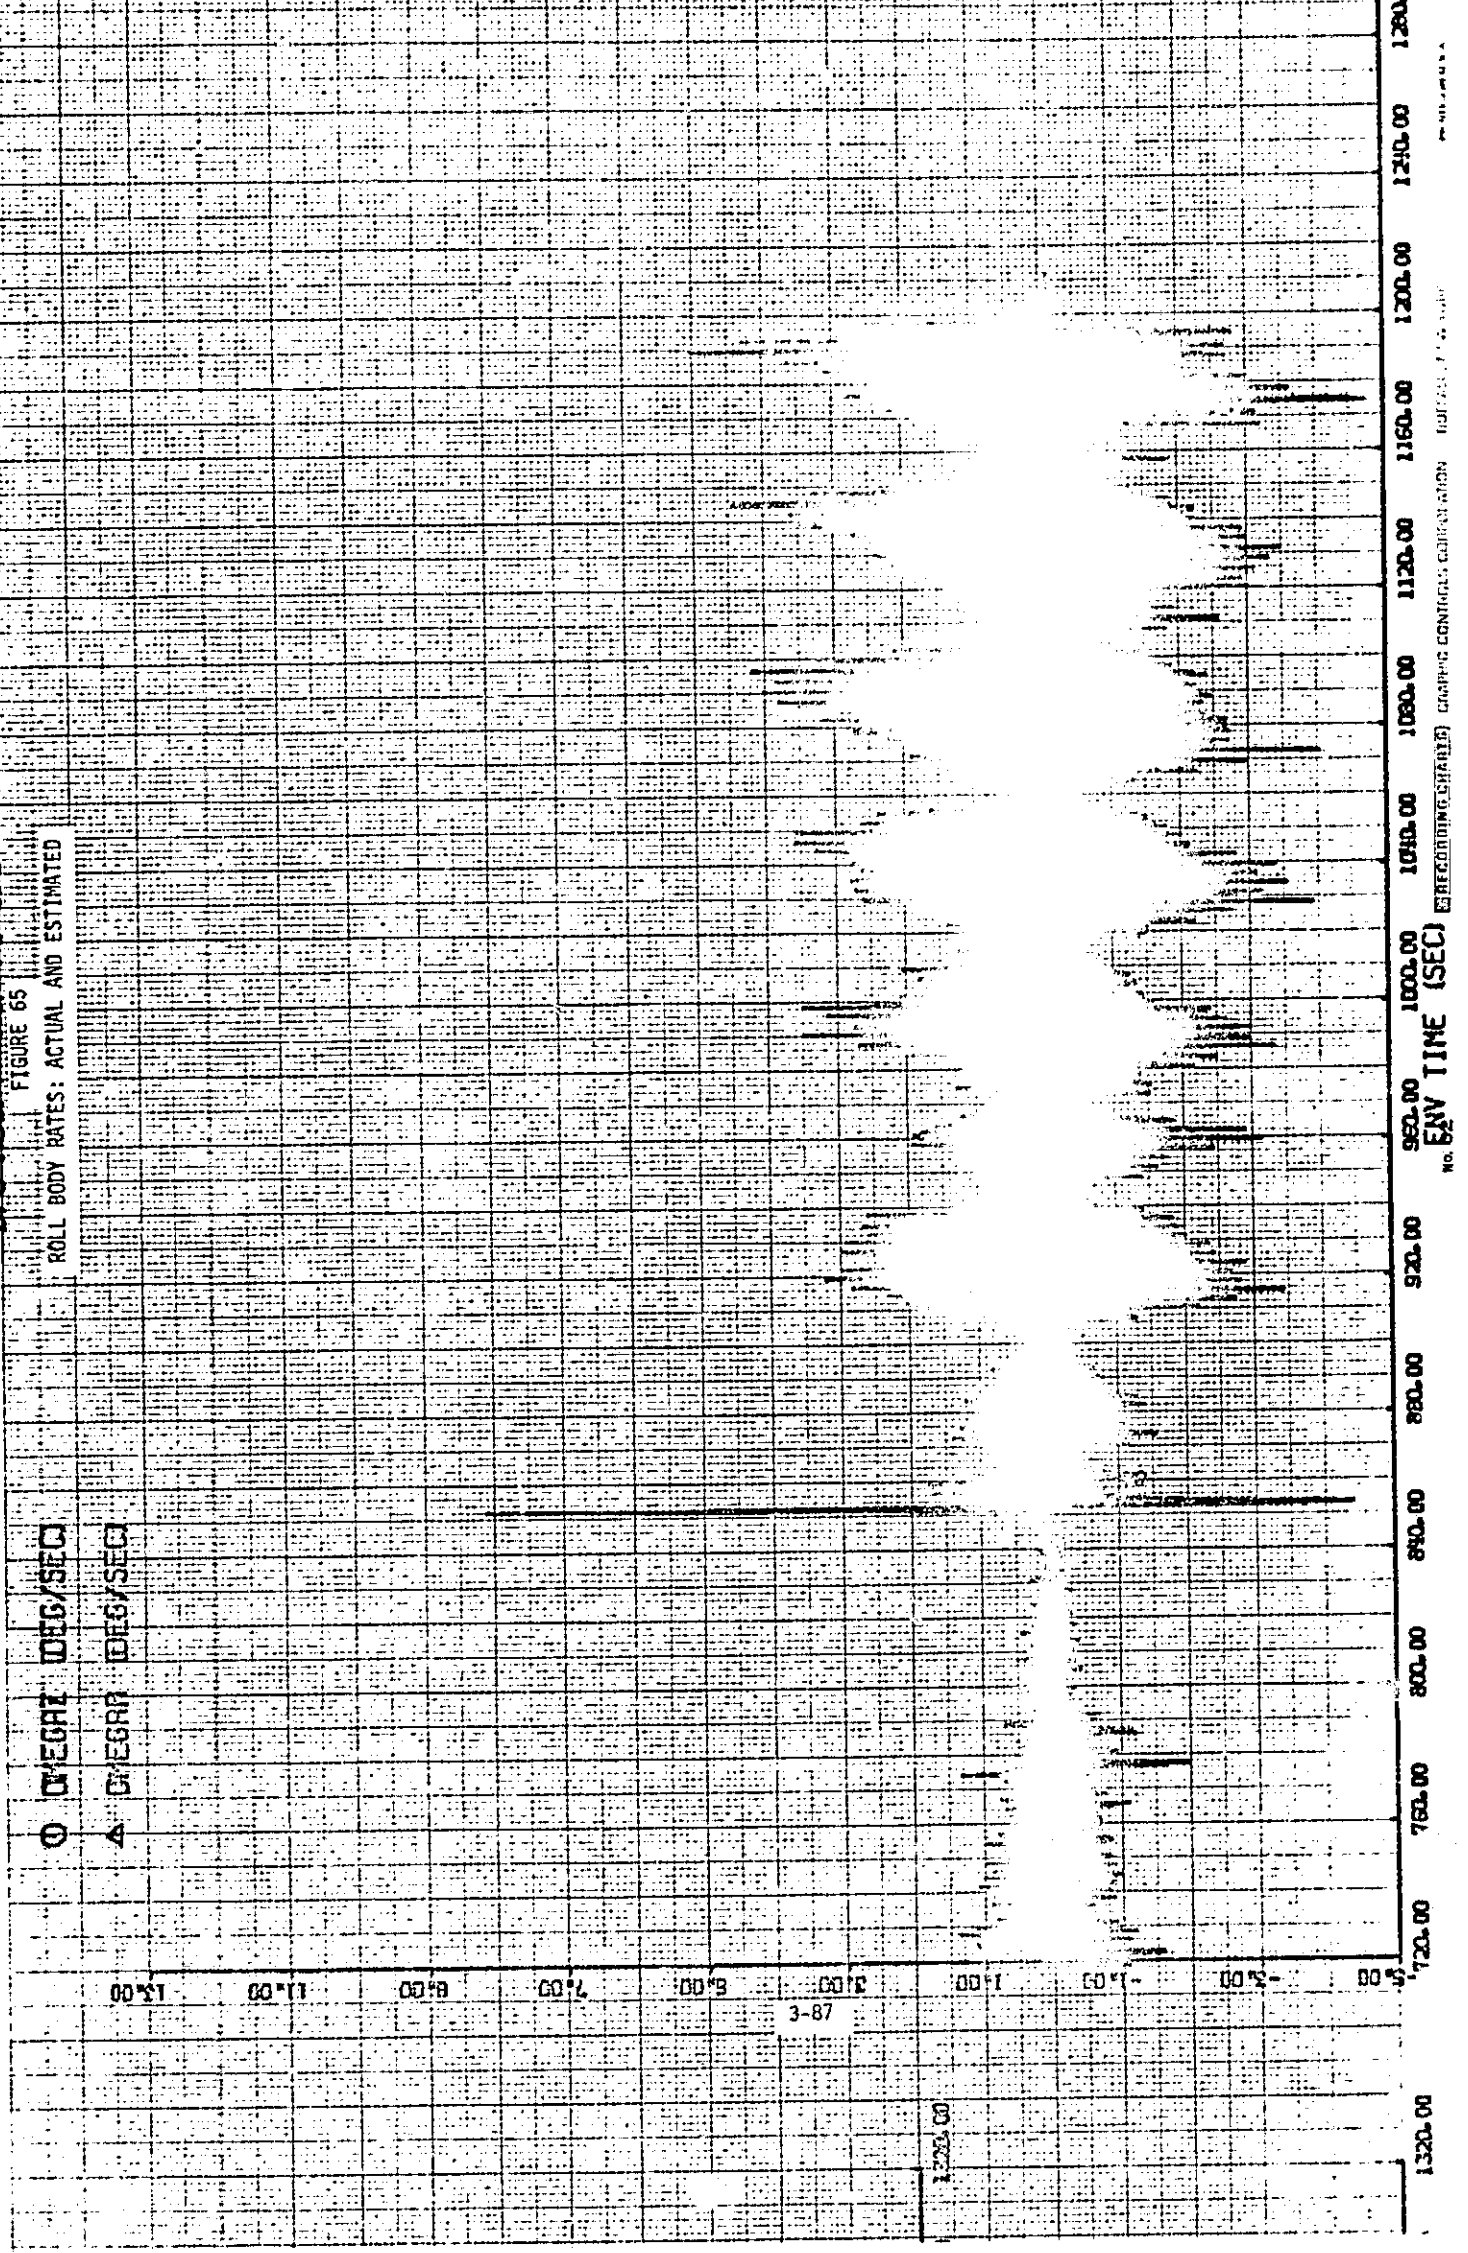
FIGURE 65
ROLL BODY RATES: ACTUAL AND ESTIMATED

quency of the rate limit cycle (see Figures 64 and 65) is 0.375-0.380 Hz and corresponds well with values observed in previous testing. Amplitude modulation of body rates and attitude errors as explained in Reference 2 are also present. The proper 1.0 degree deadband is also maintained during P71.

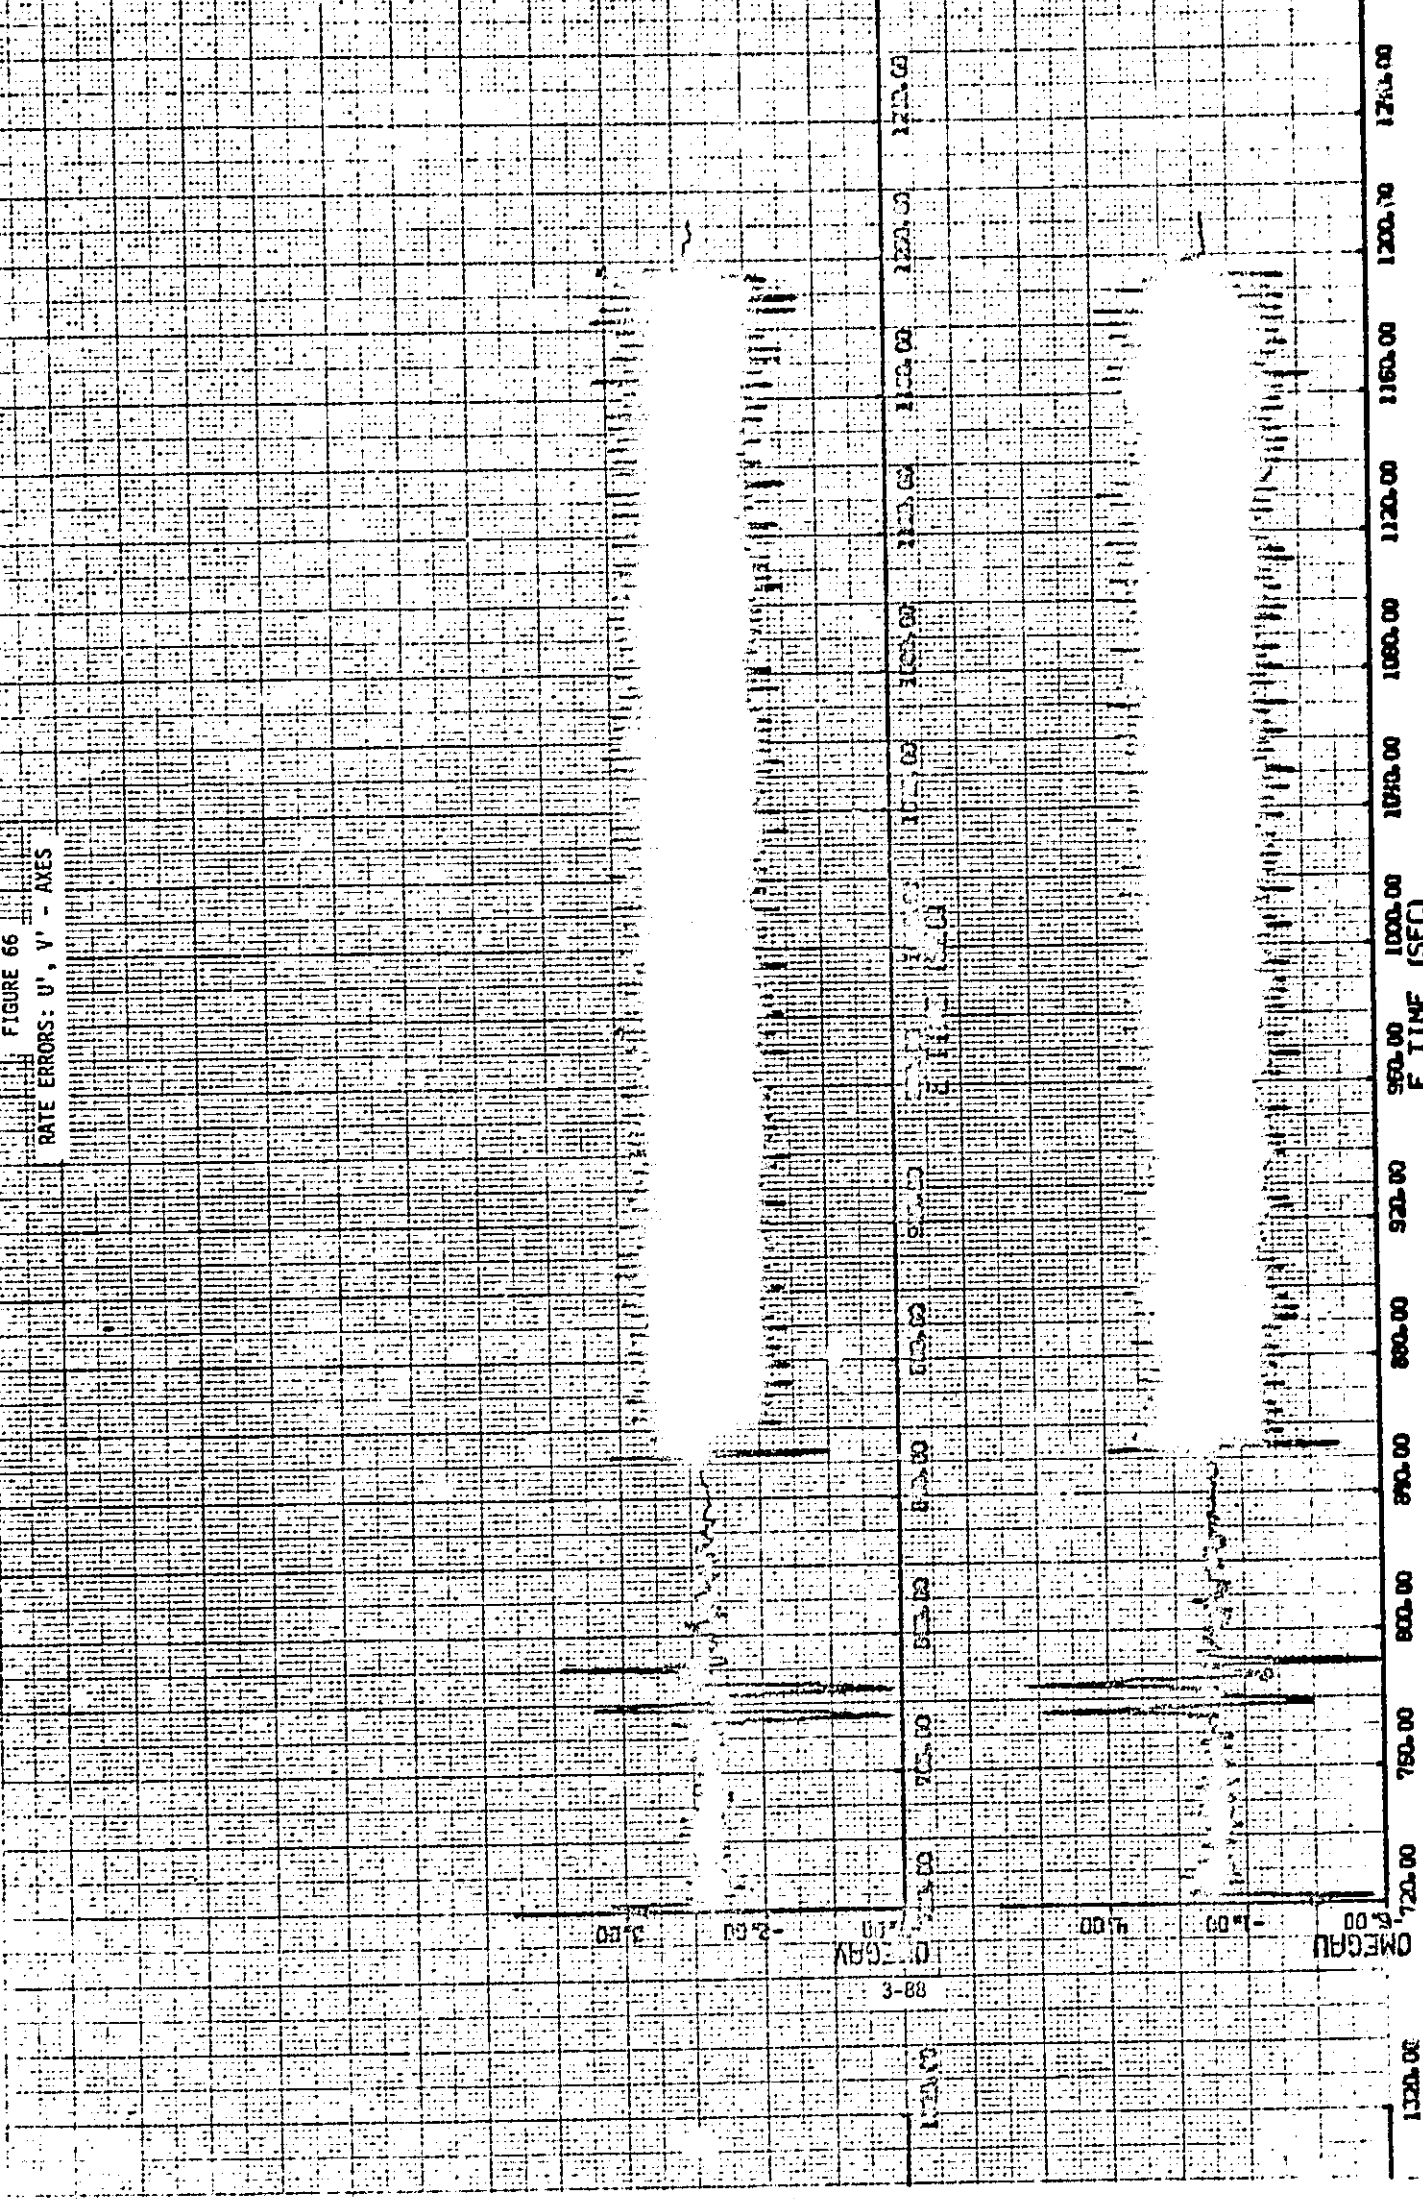
FIGURE 66

RATE ERRORS: U', V' - AXES

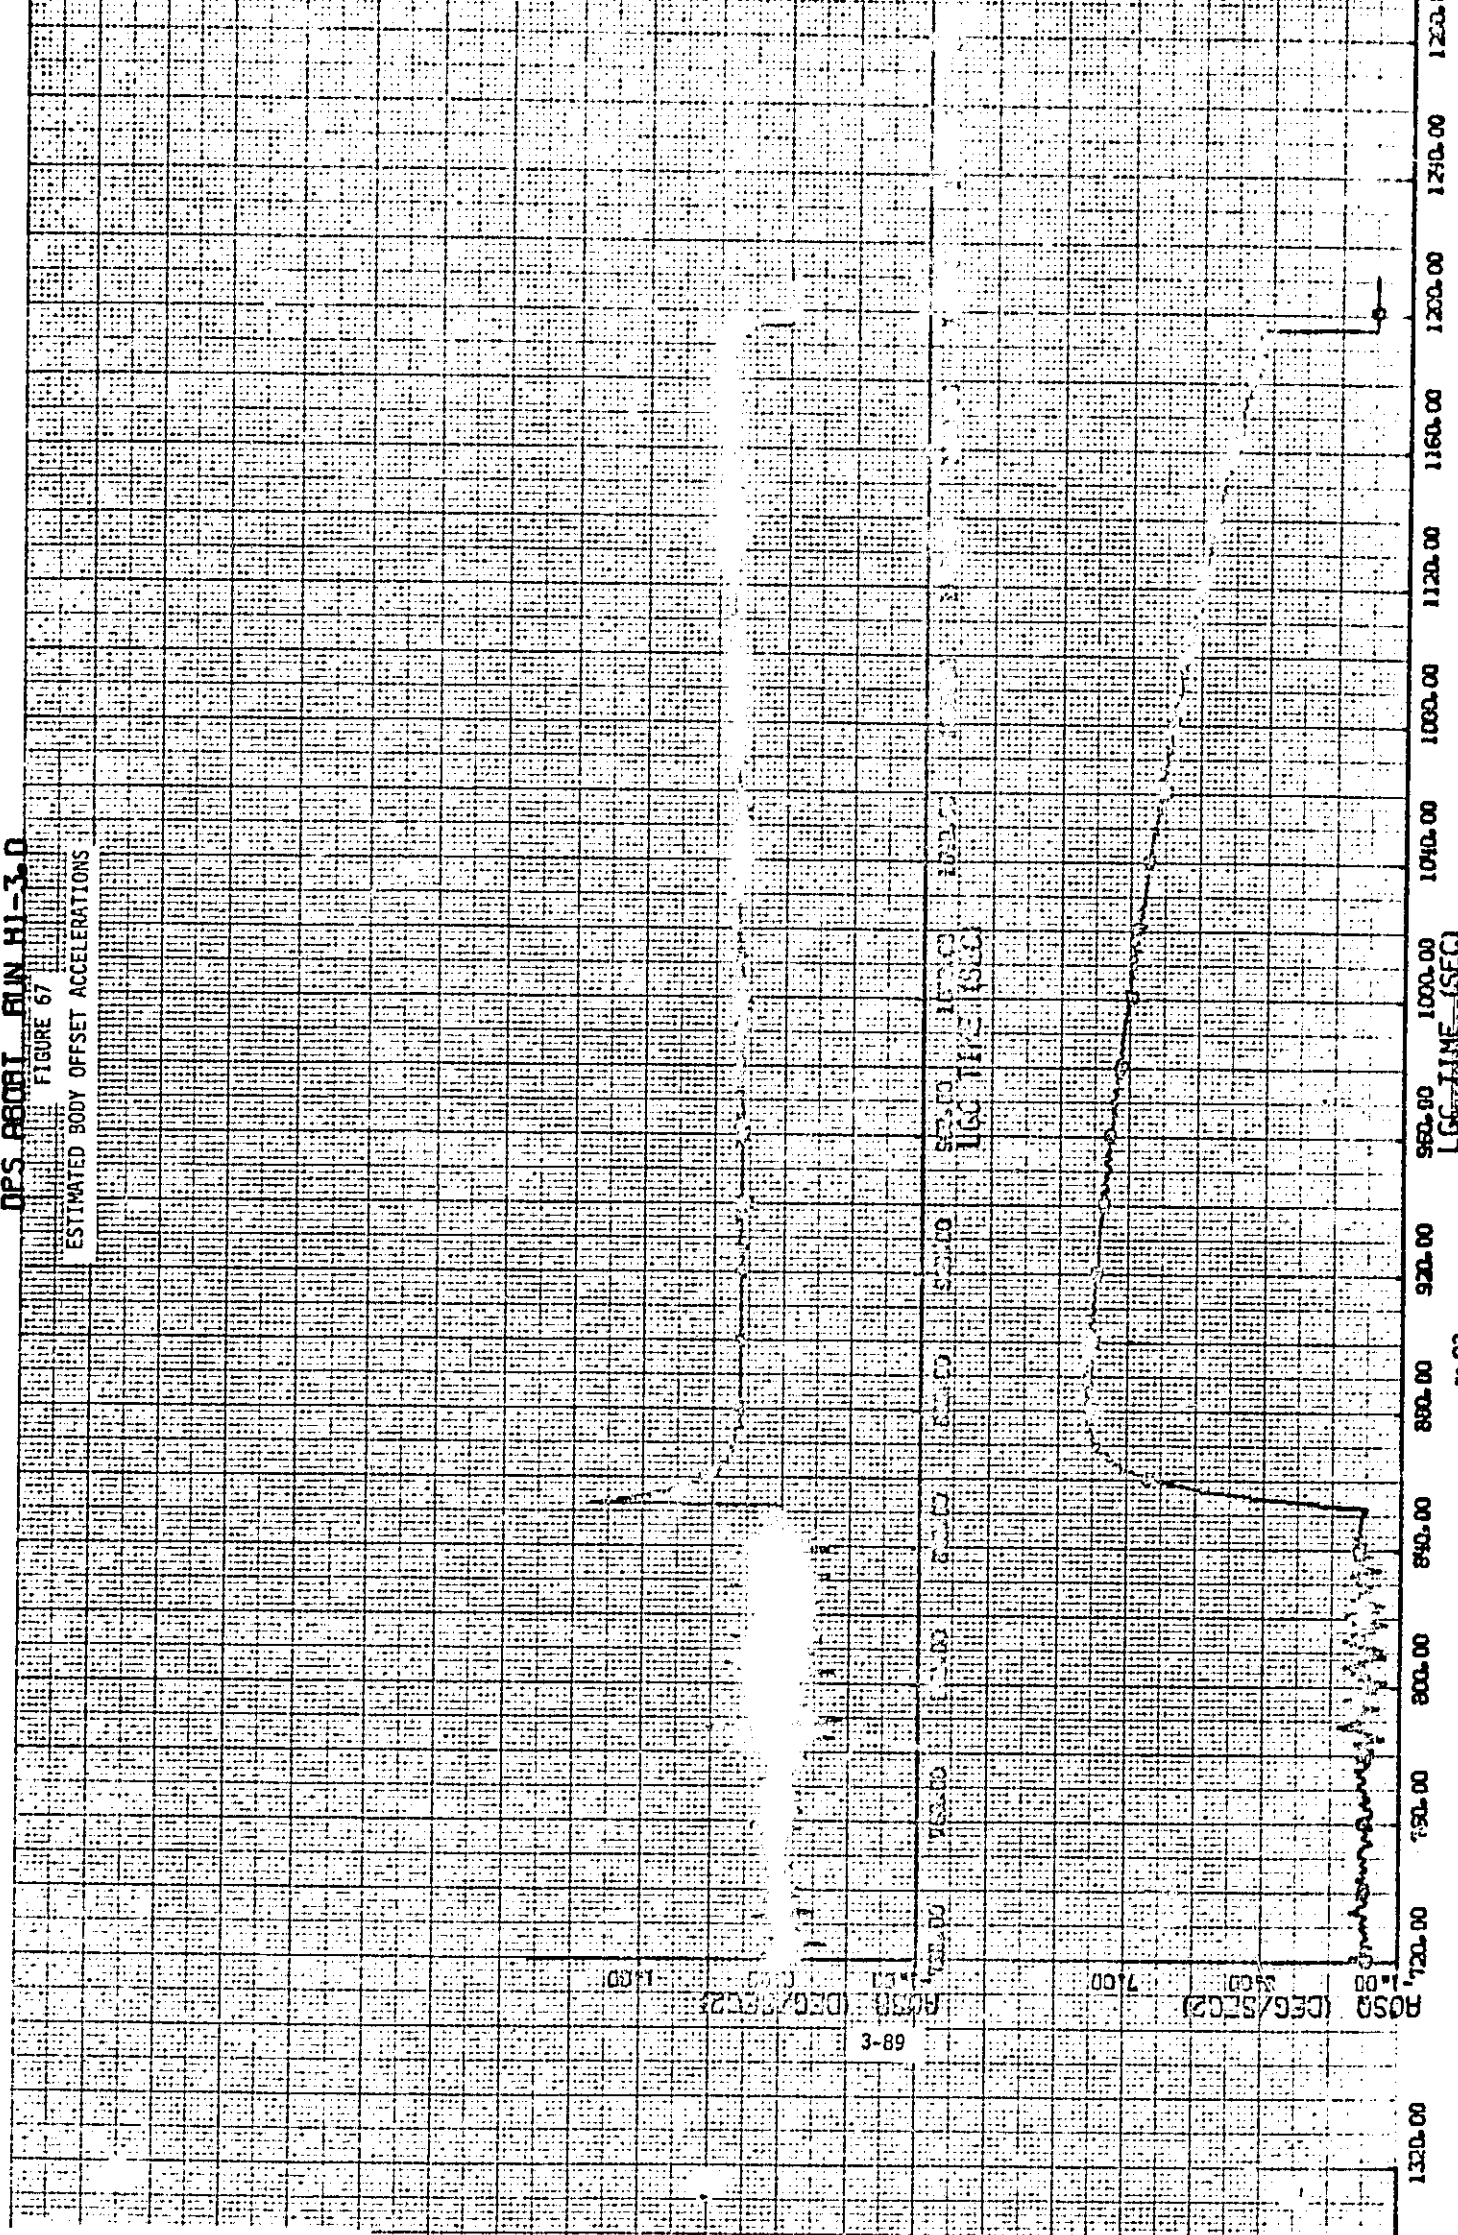
FIGURE 67

ESTIMATED BODY OFFSET ACCELERATIONS
