PROJECT TECHNICAL REPORT
TASK E-72B

LUMINARY 1B DAP PREFLIGHT PERFORMANCE
EVALUATION

NAS 9-8166

13 November 1969

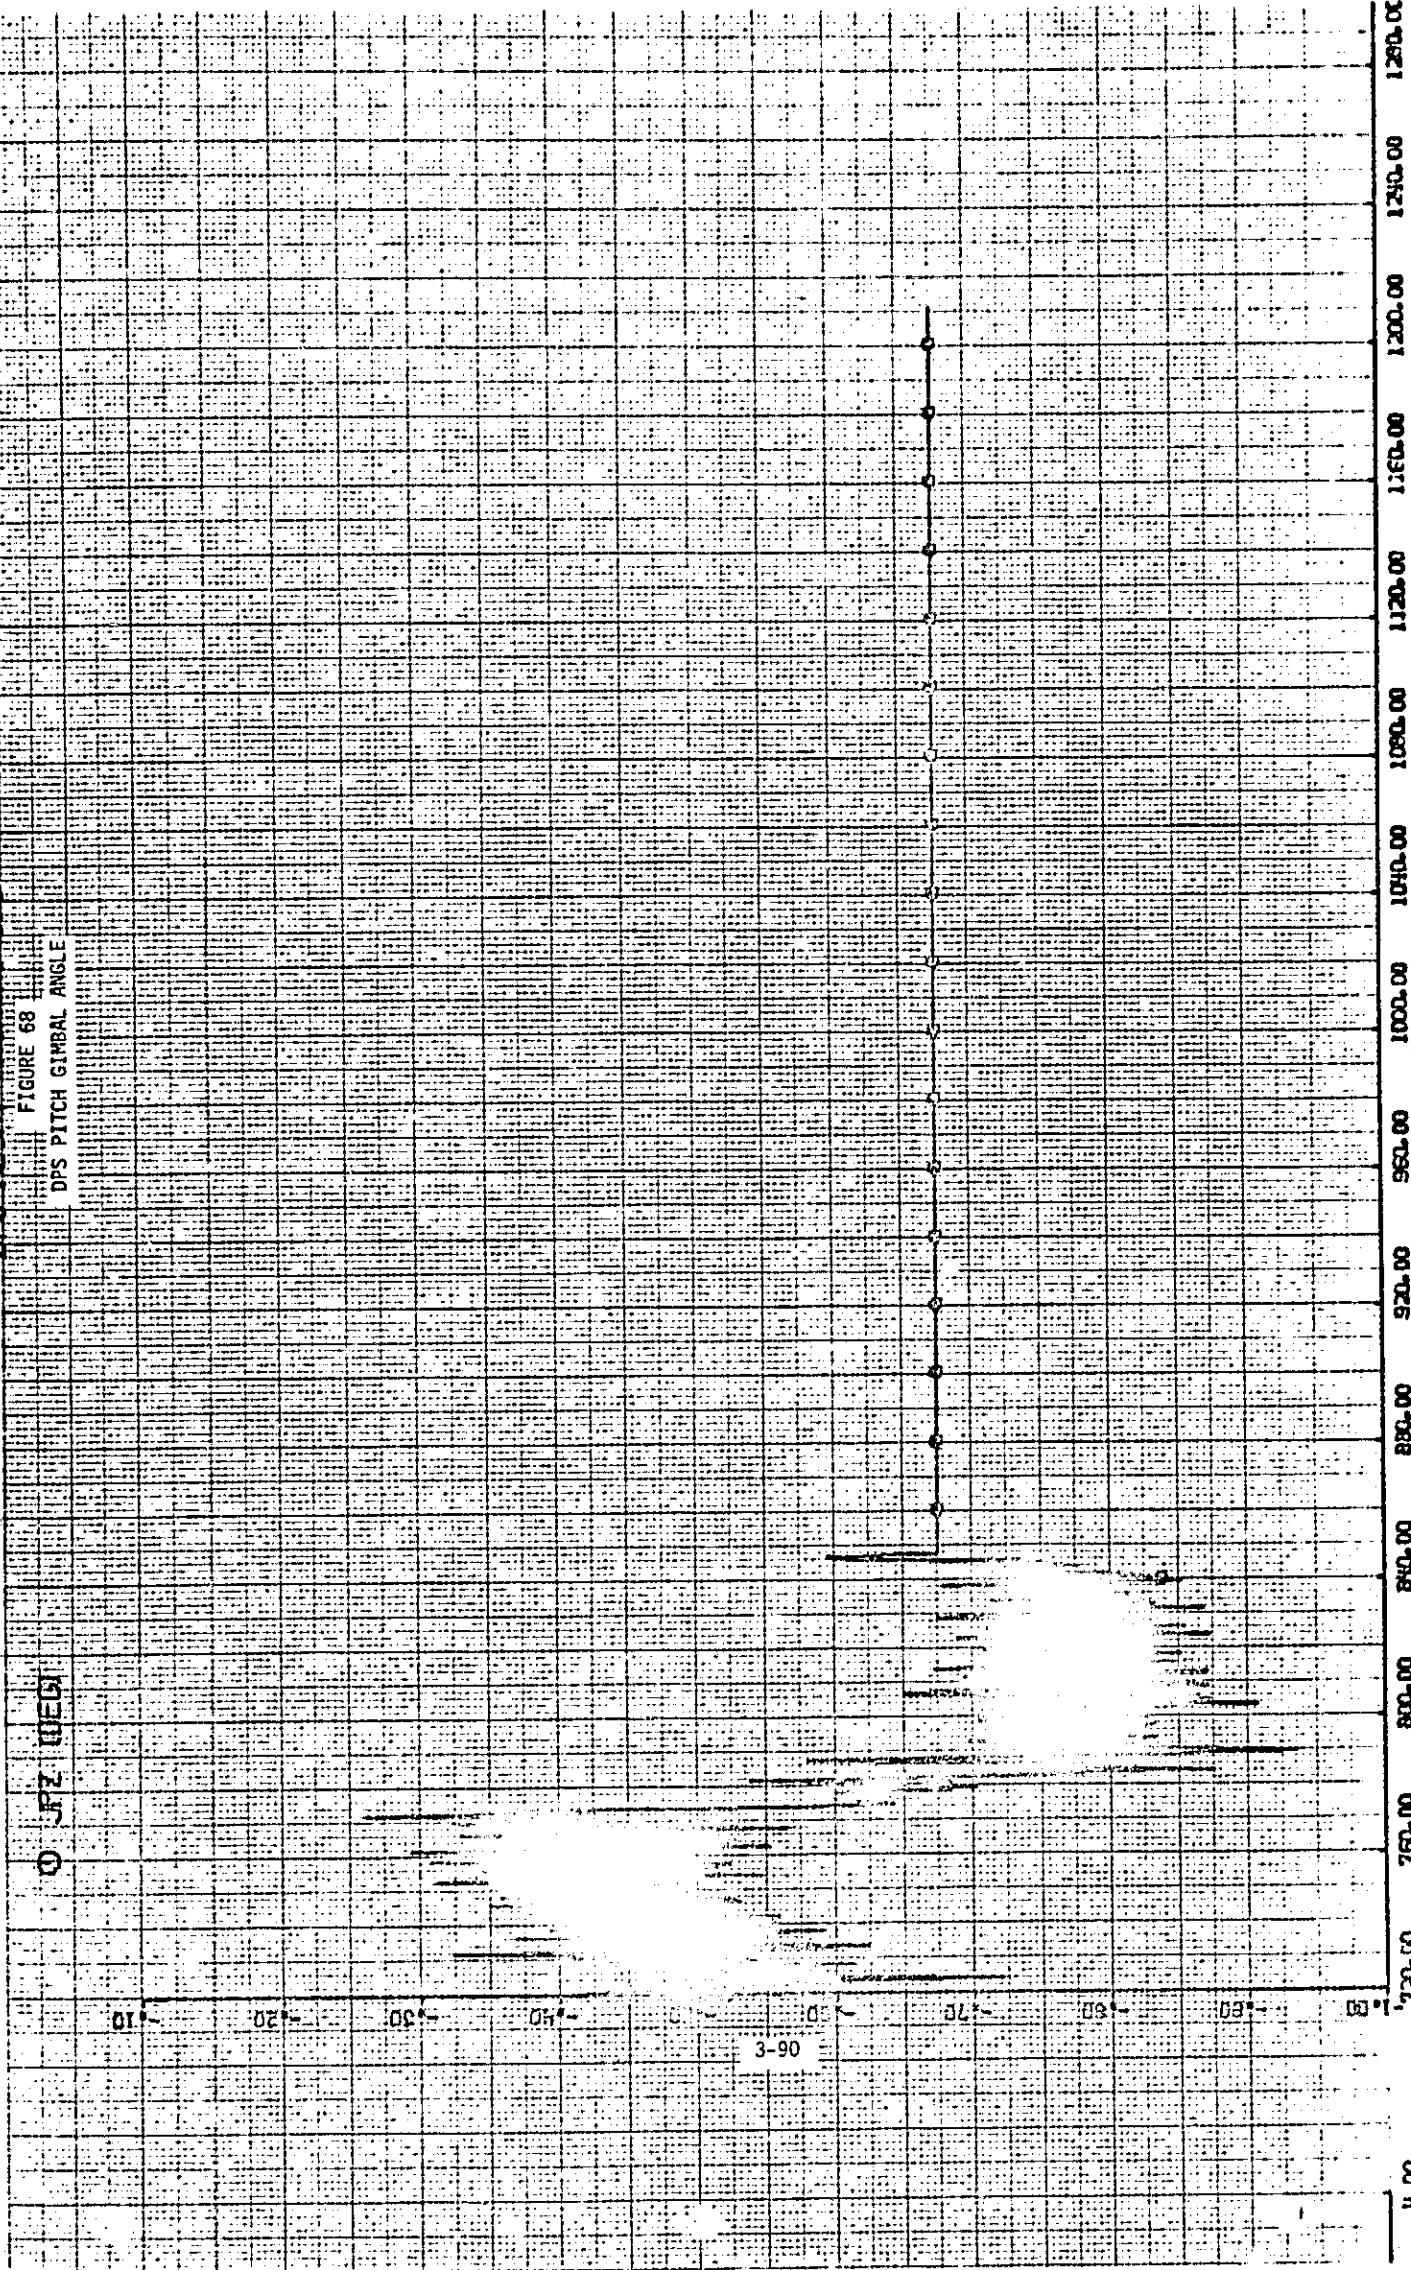
FIGURE 68
DPS PITCH GIMBAL ANGLE

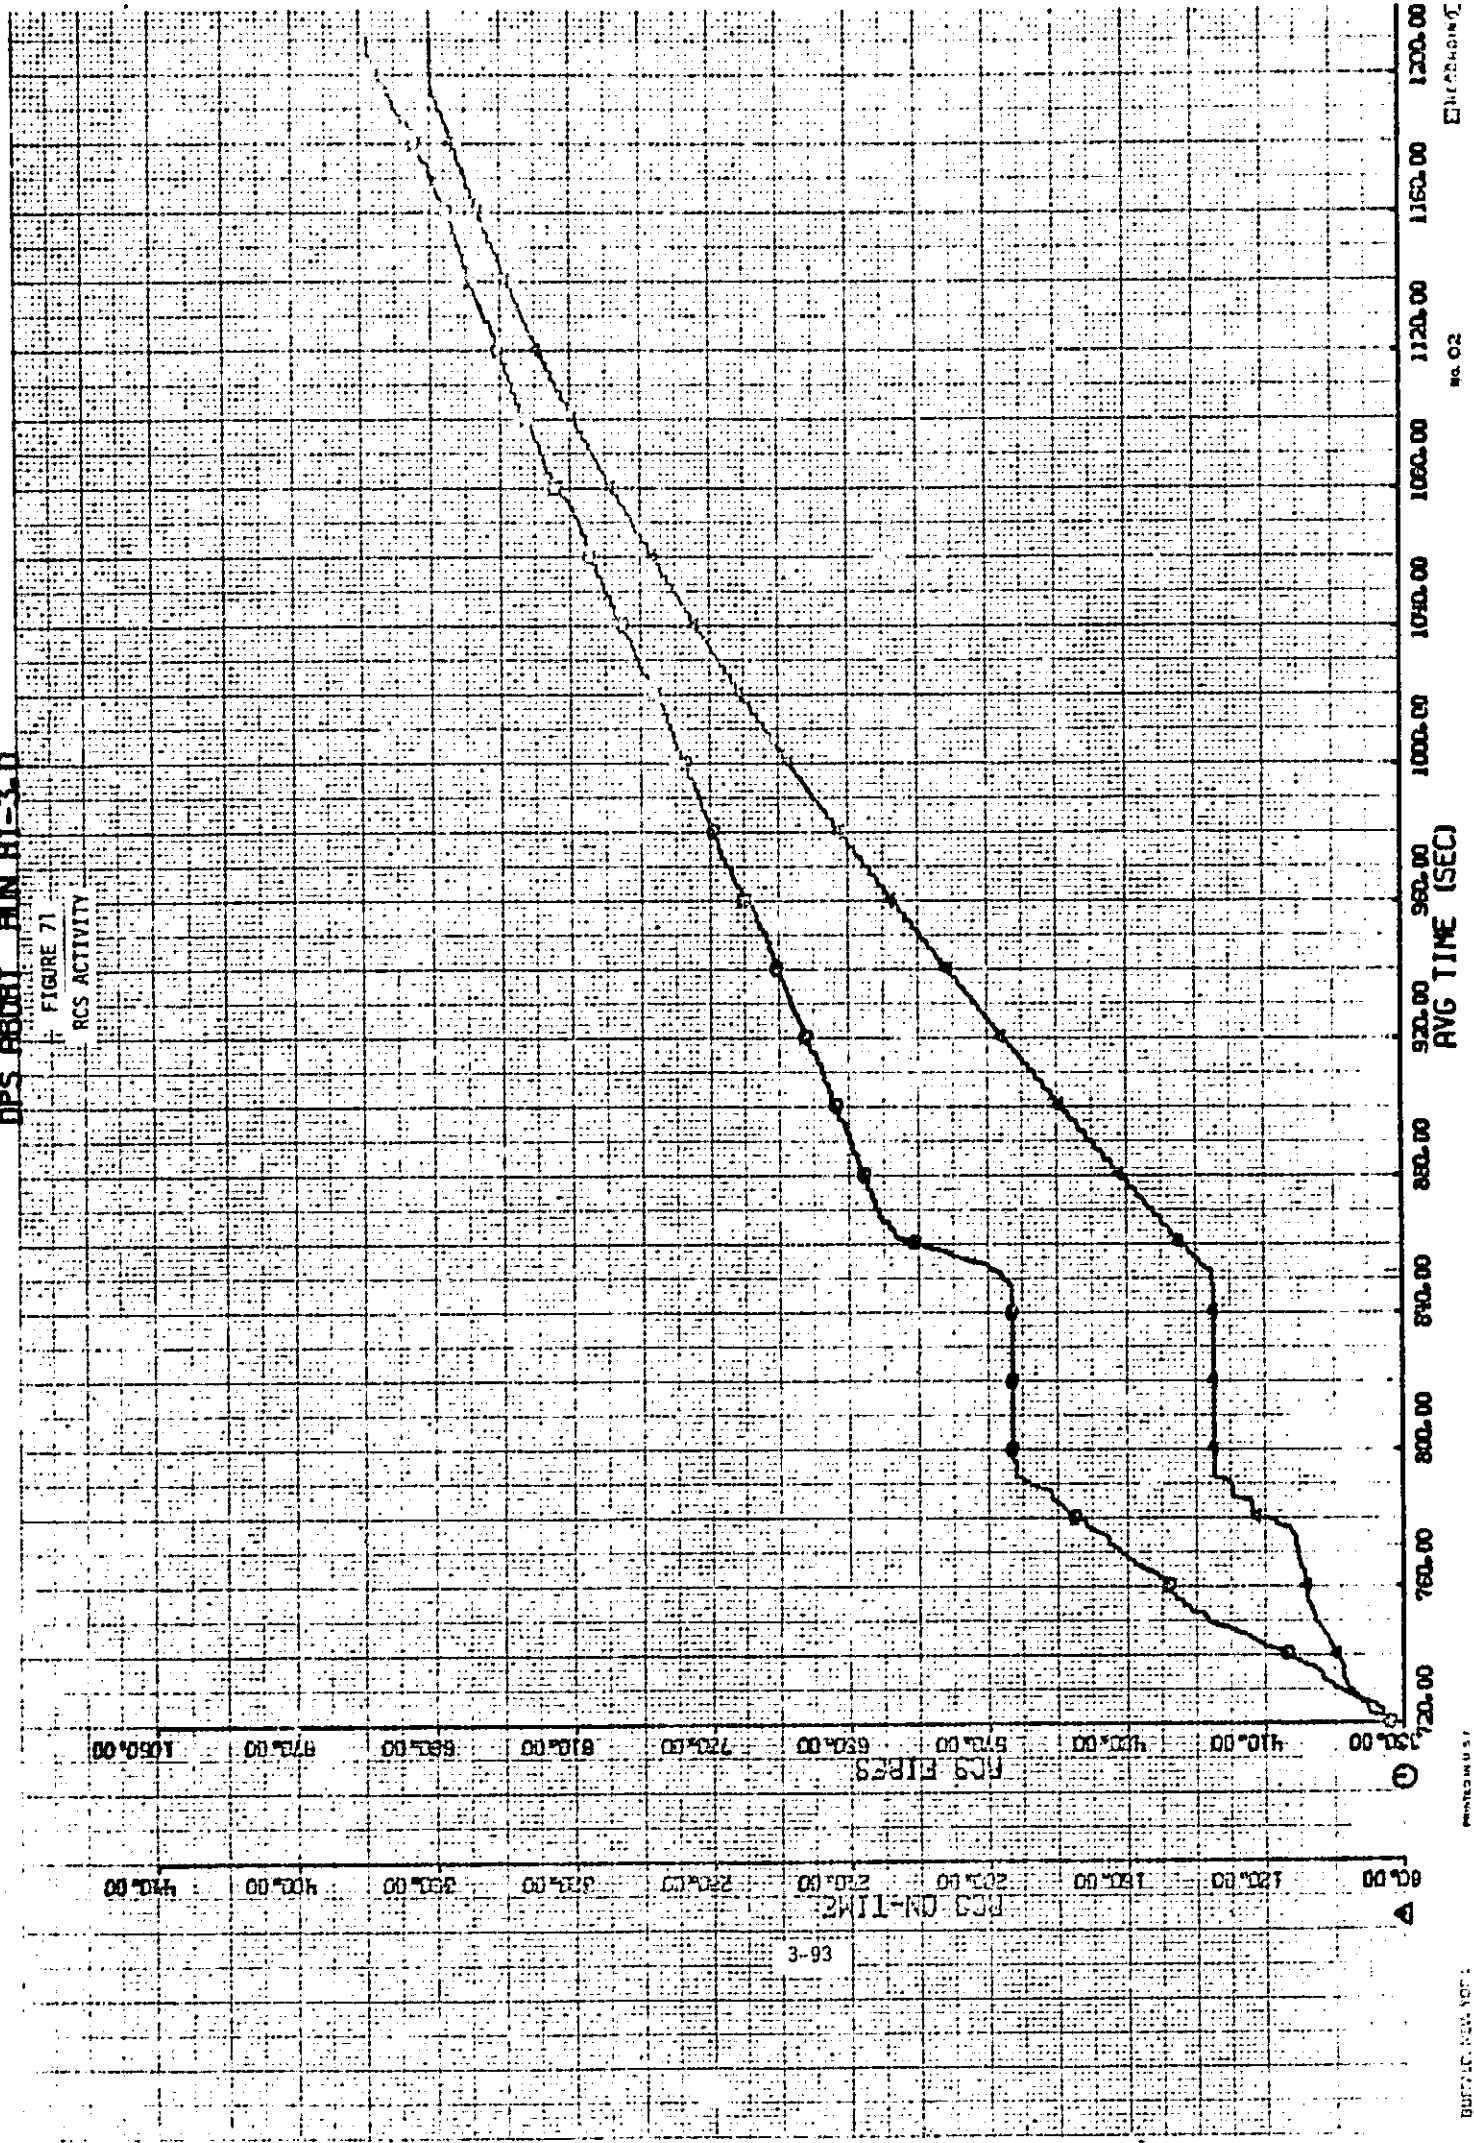
FIGURE 71

RCS ACTIVITY

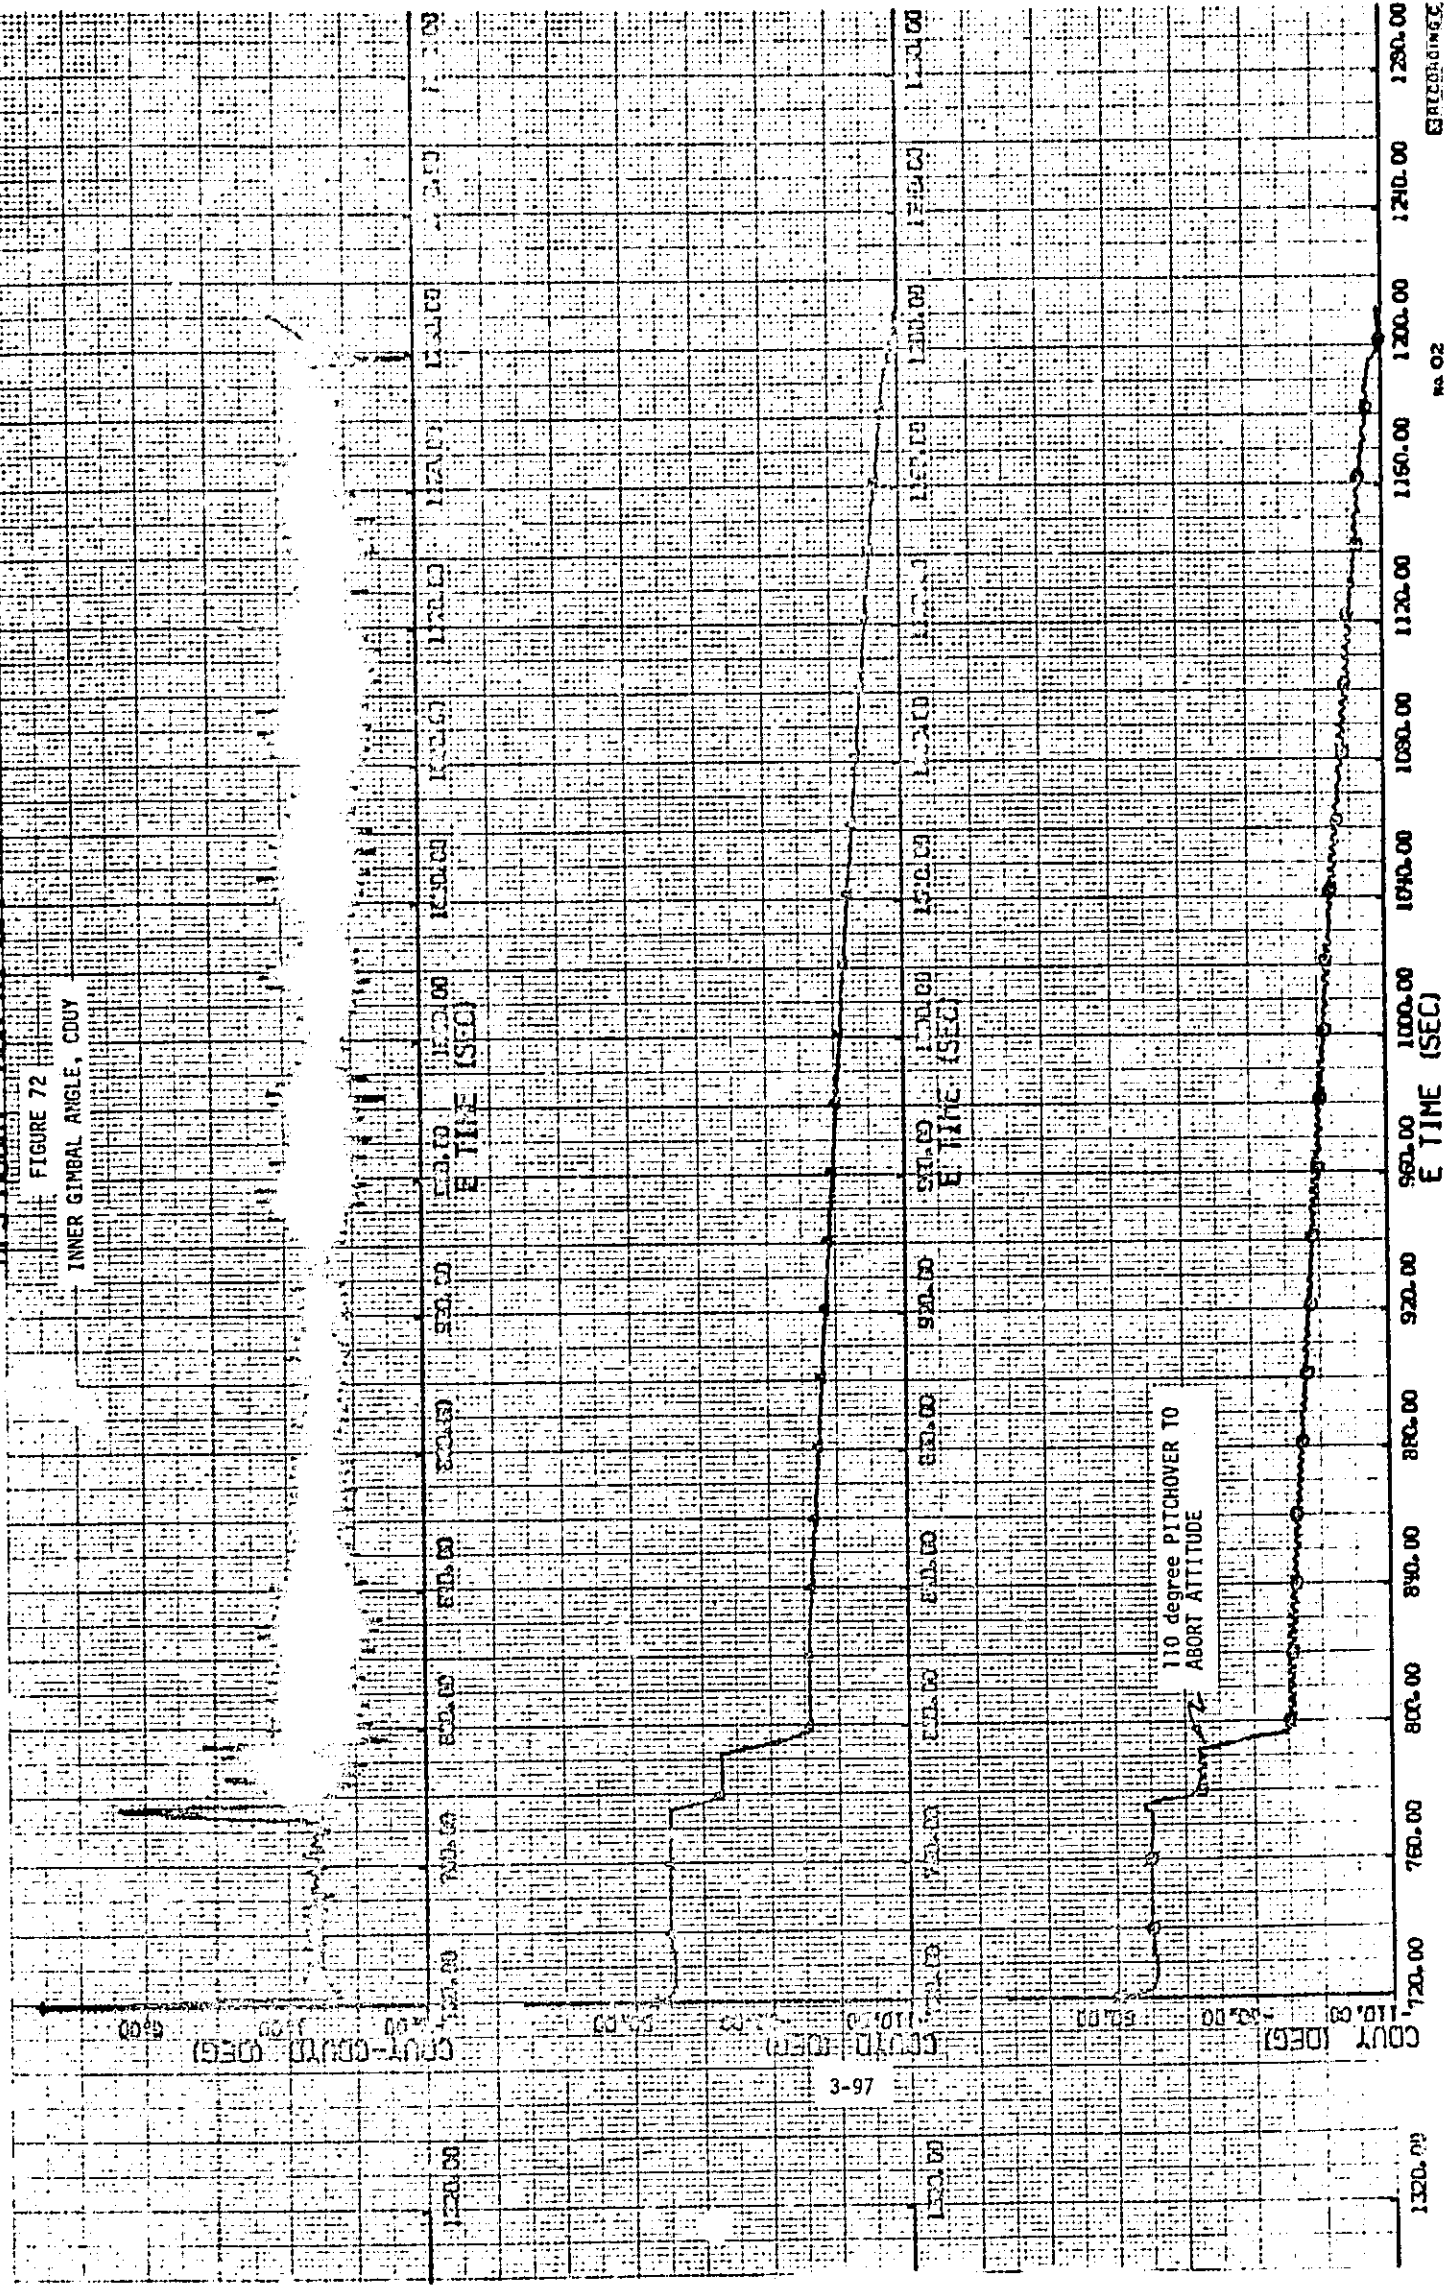
FIGURE 72

INNER GIMBAL ANGLE, COUY

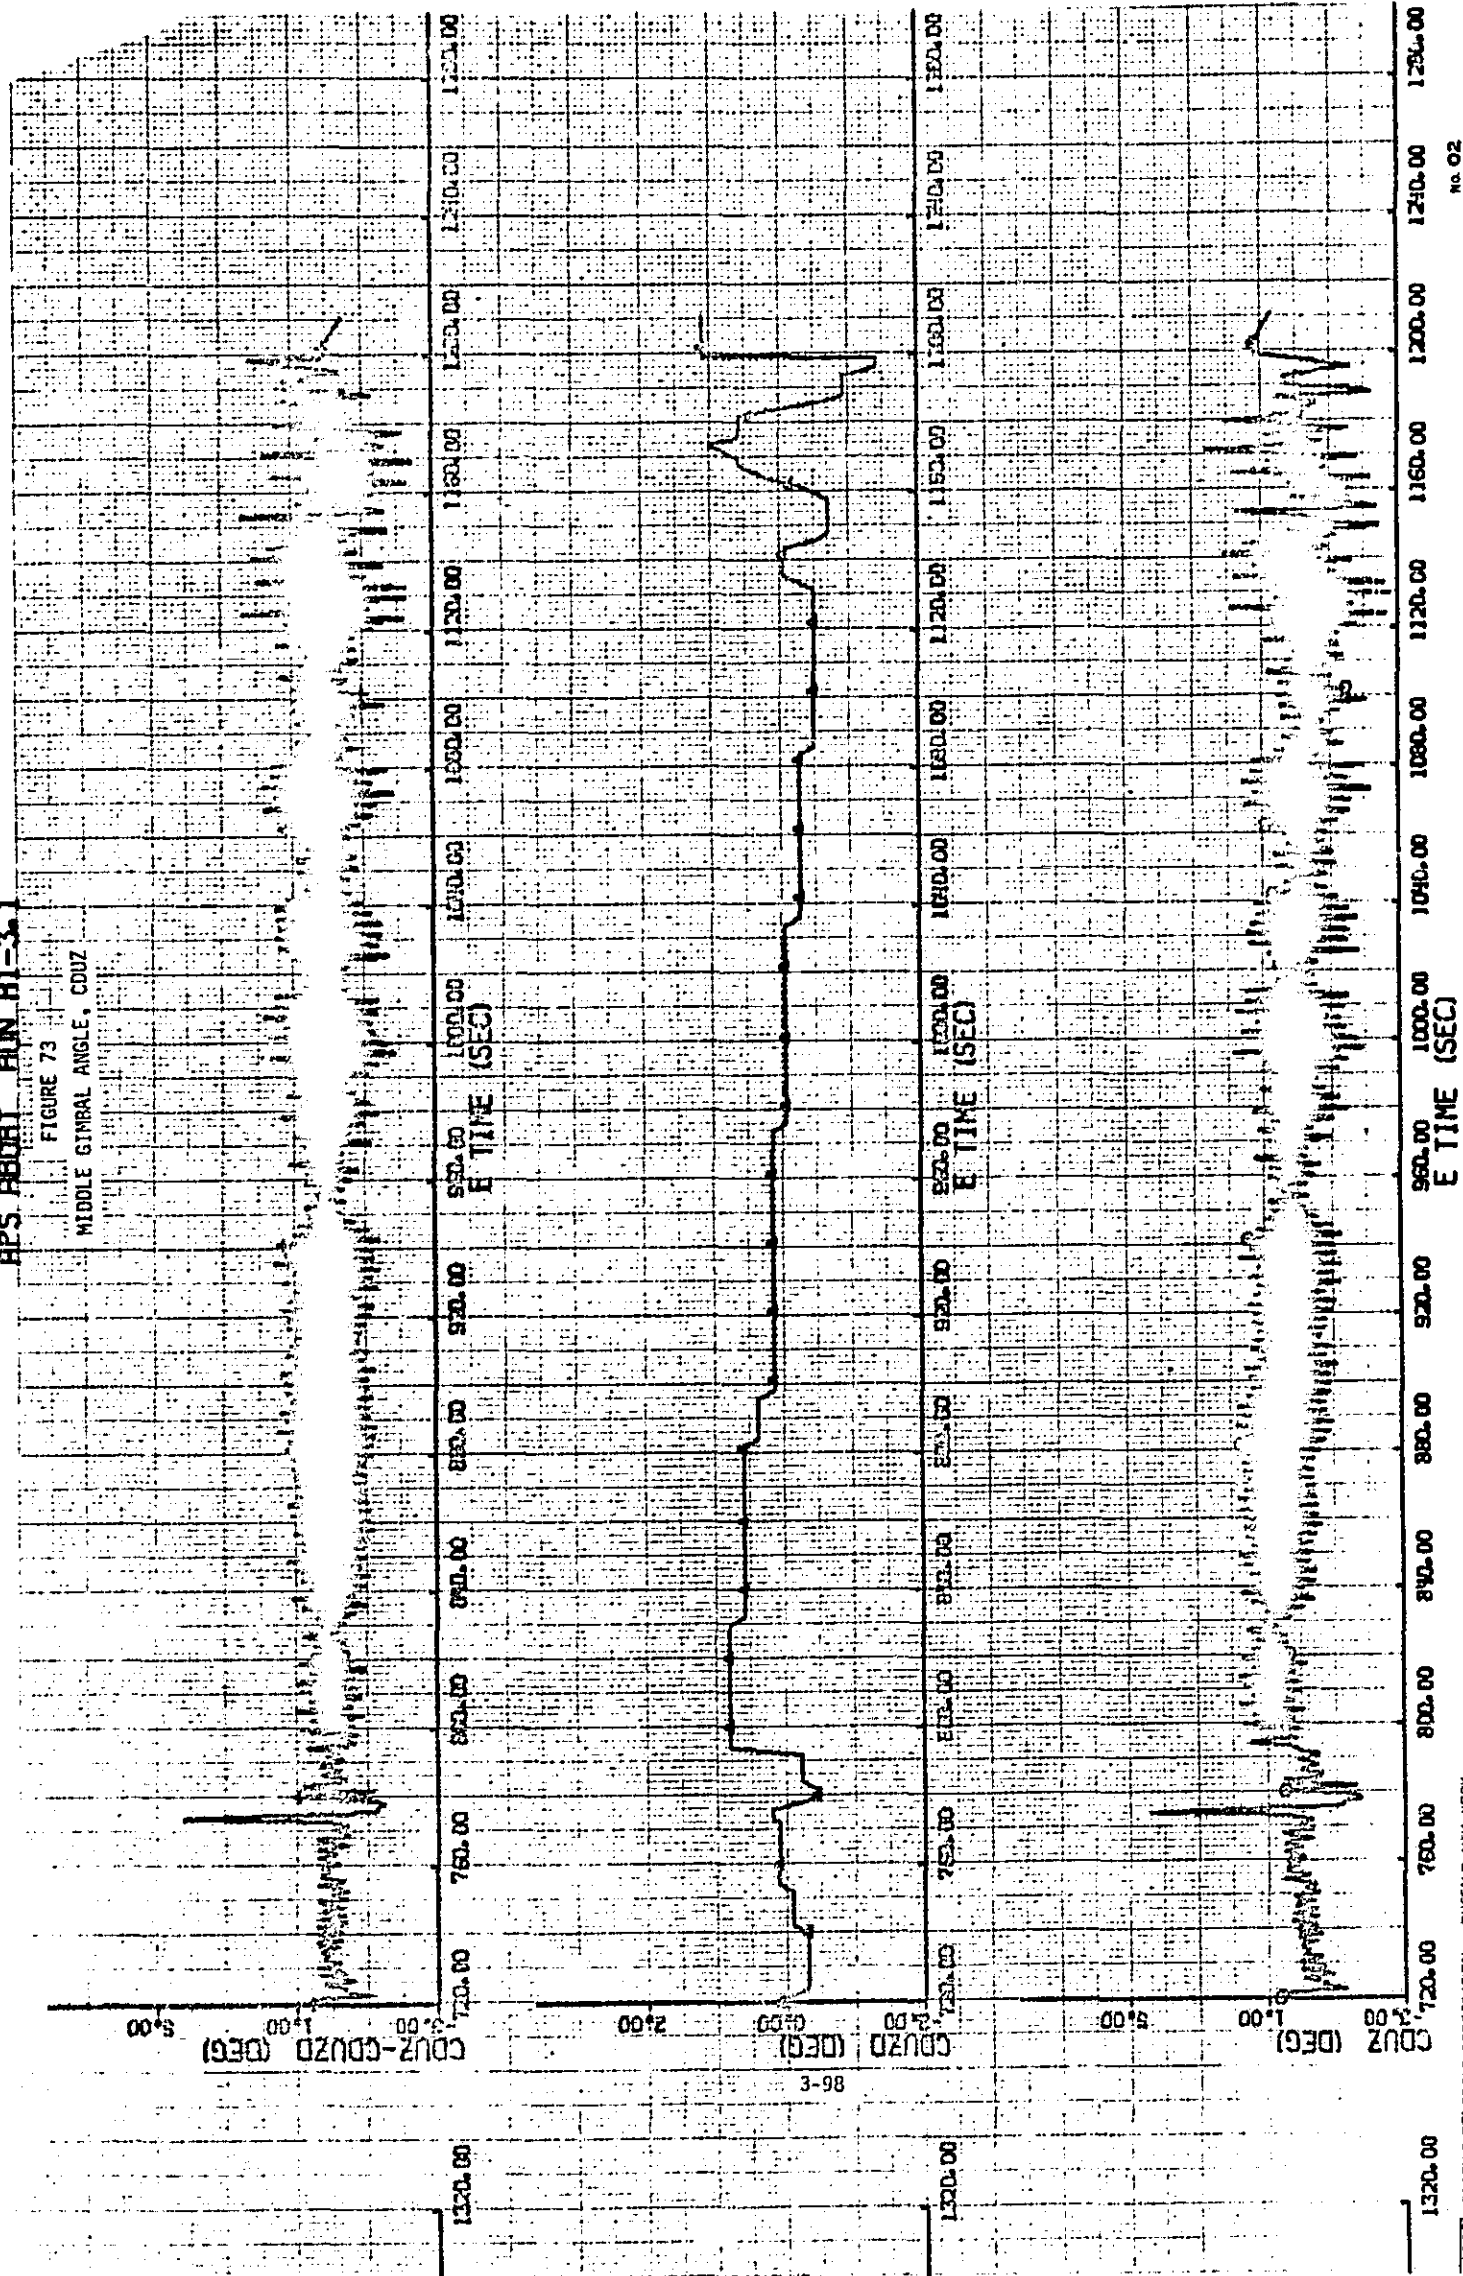
FIGURE 73

MIDDLE GIRRAL ANGLE, COUZ

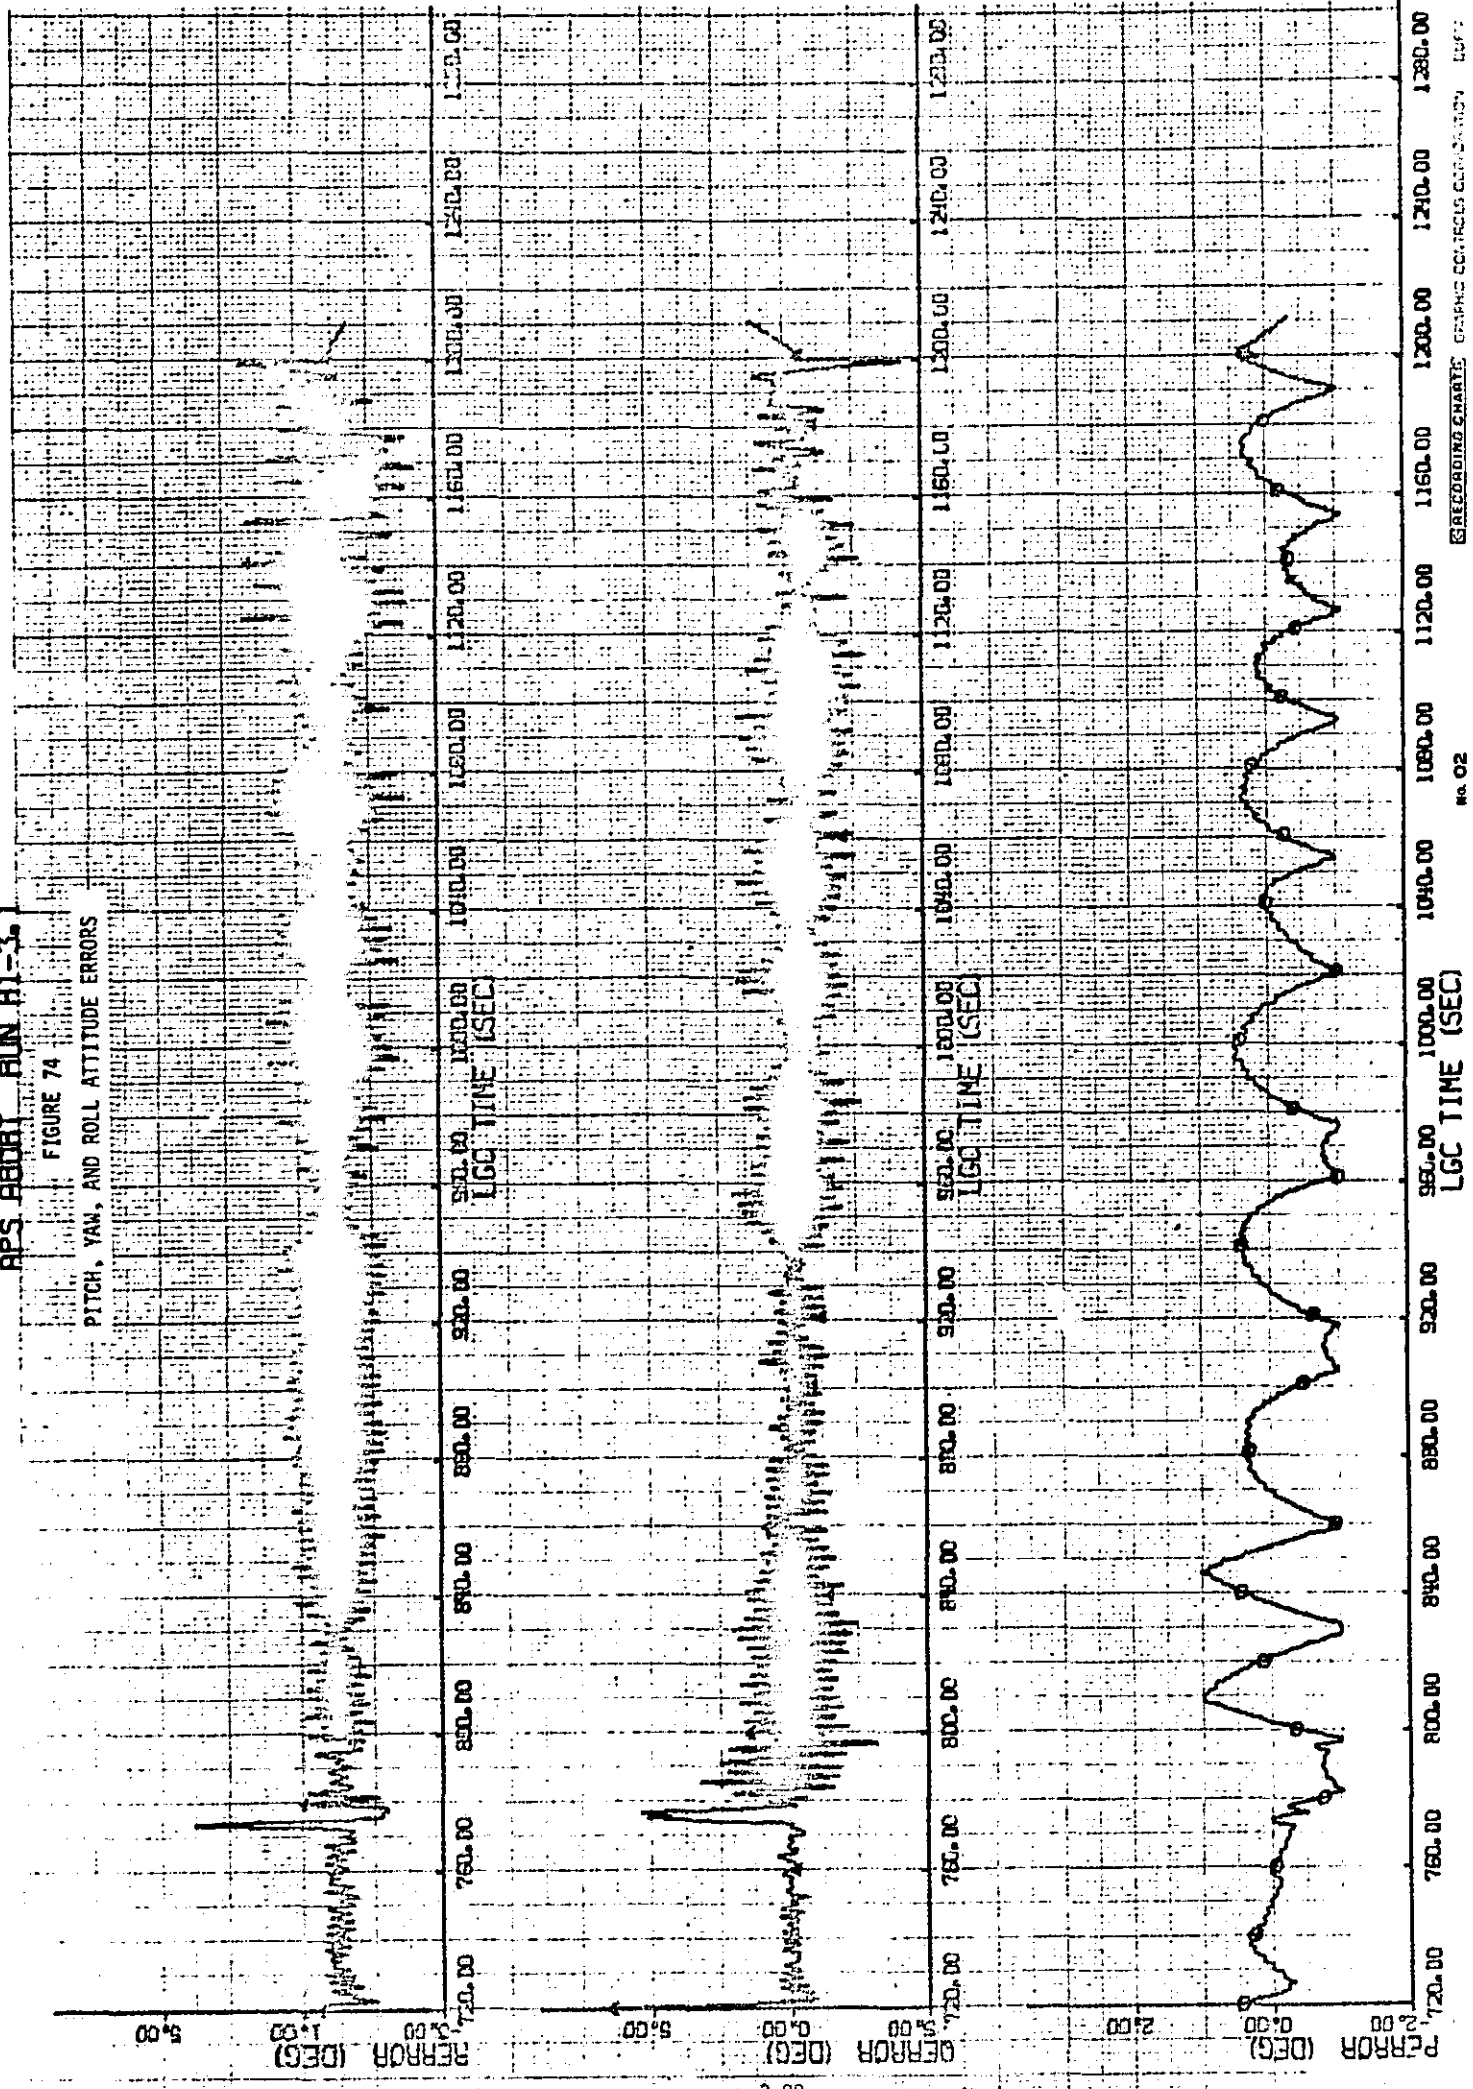
FIGURE 74

PITCH, YAW, AND ROLL ATTITUDE ERRORS

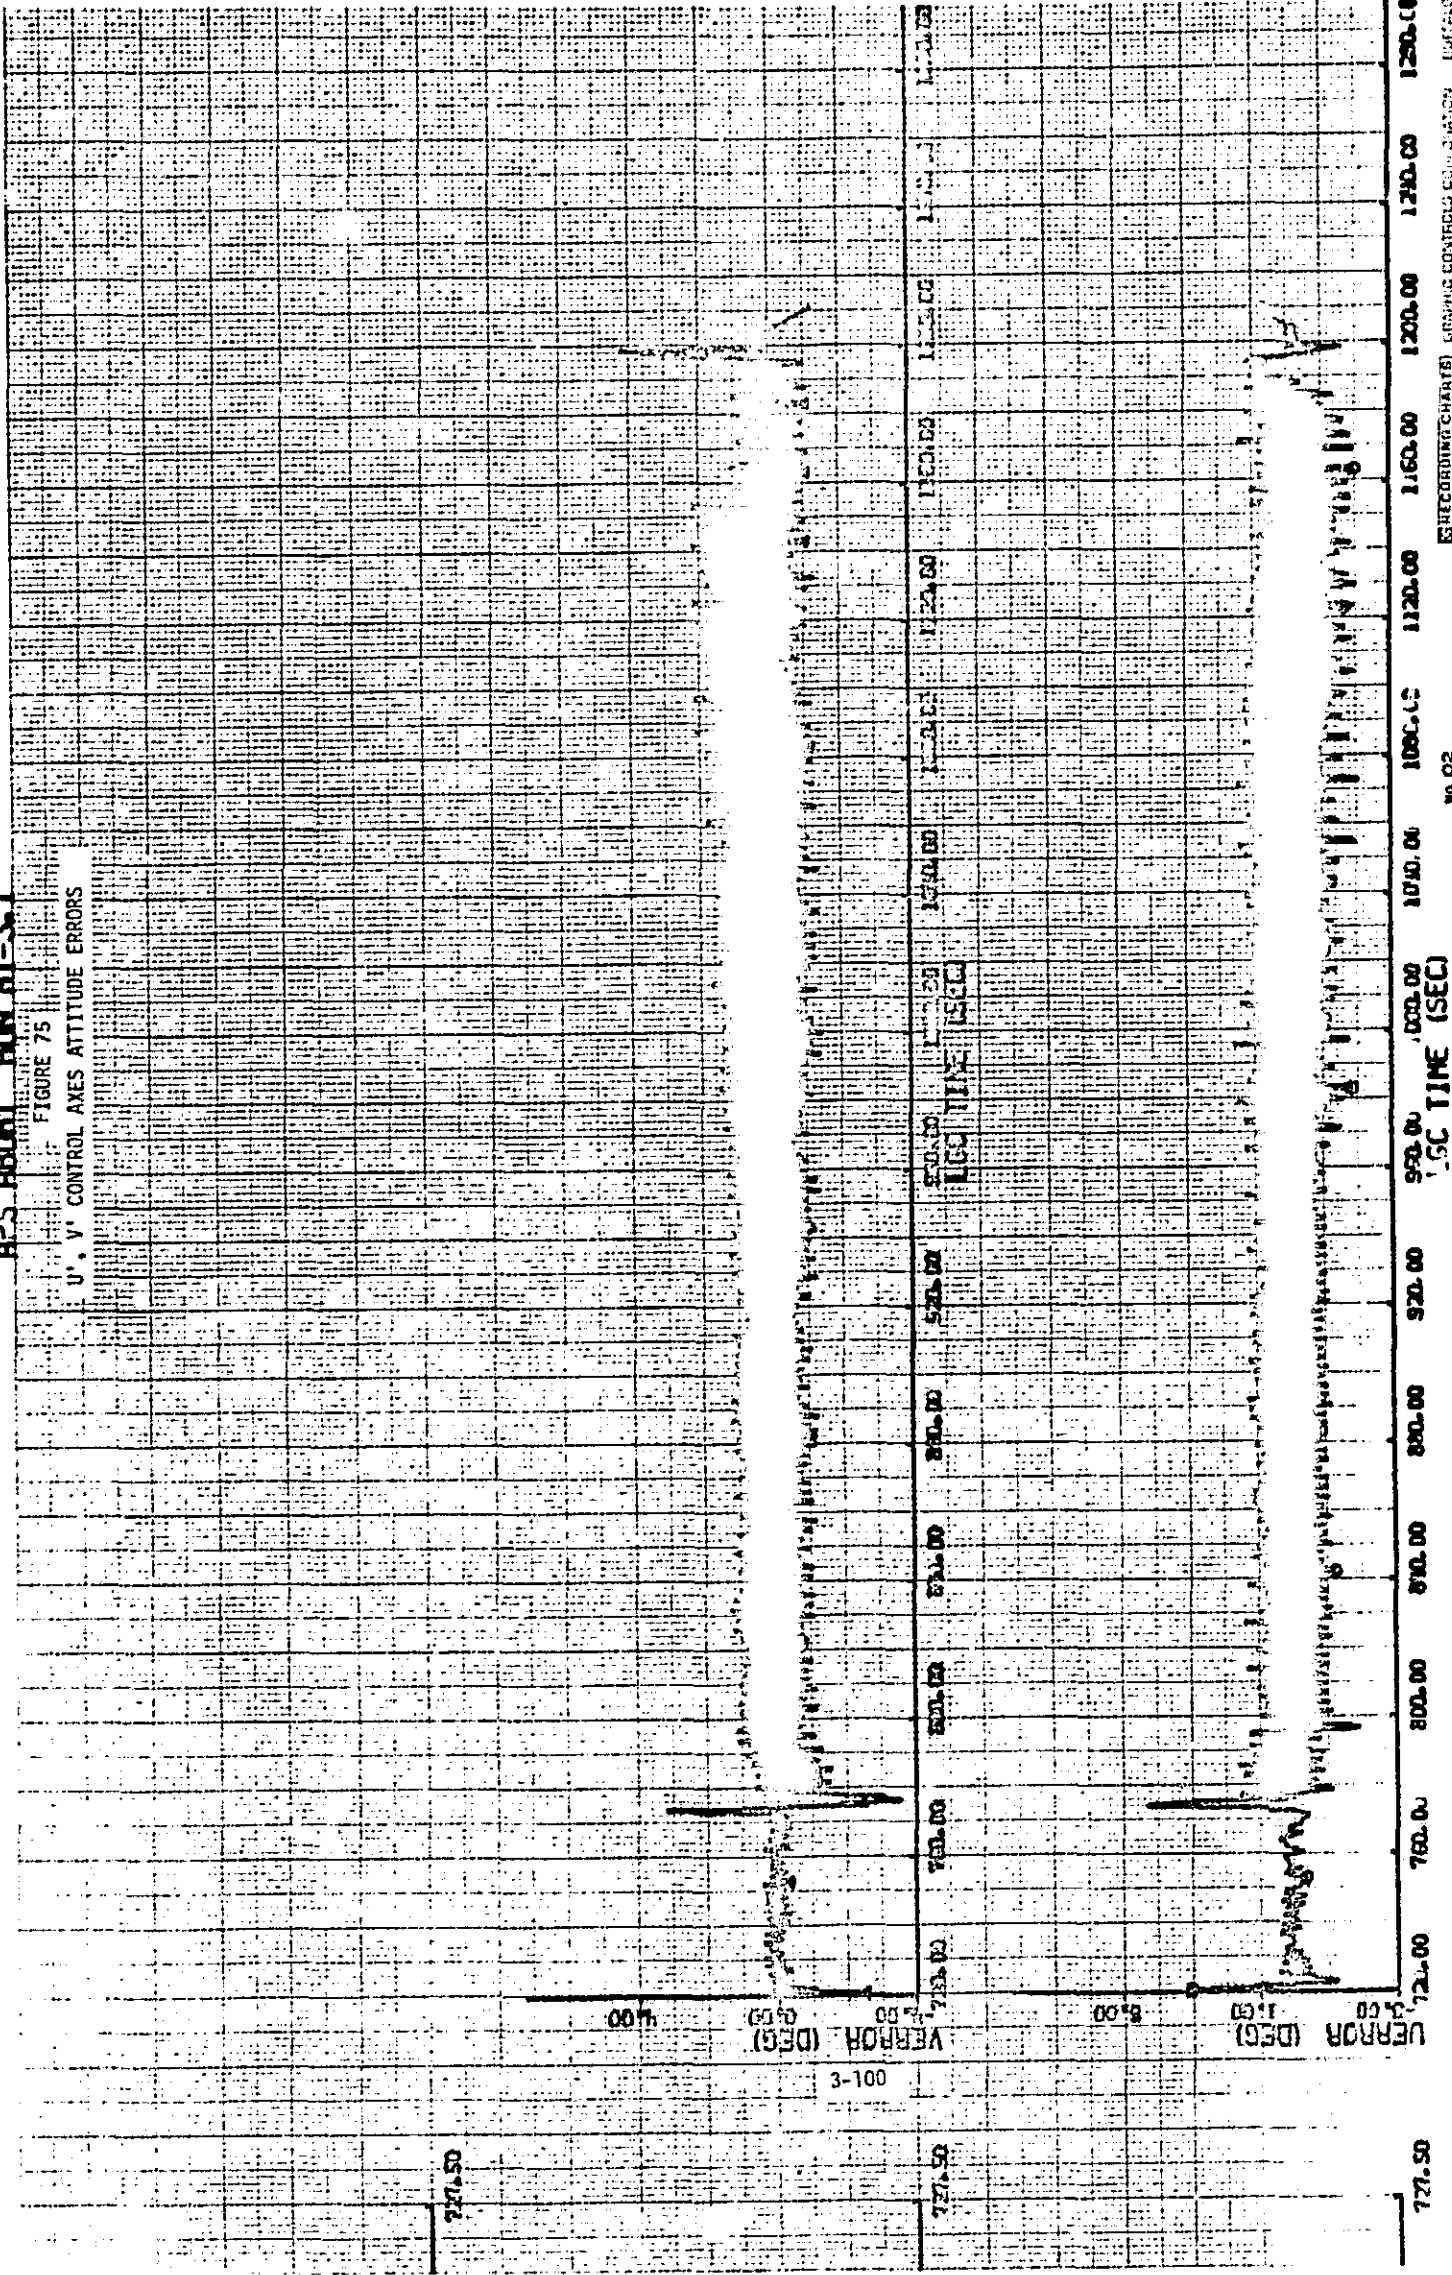
FIGURE 75
U, V CONTROL AXES ATTITUDE ERRORS

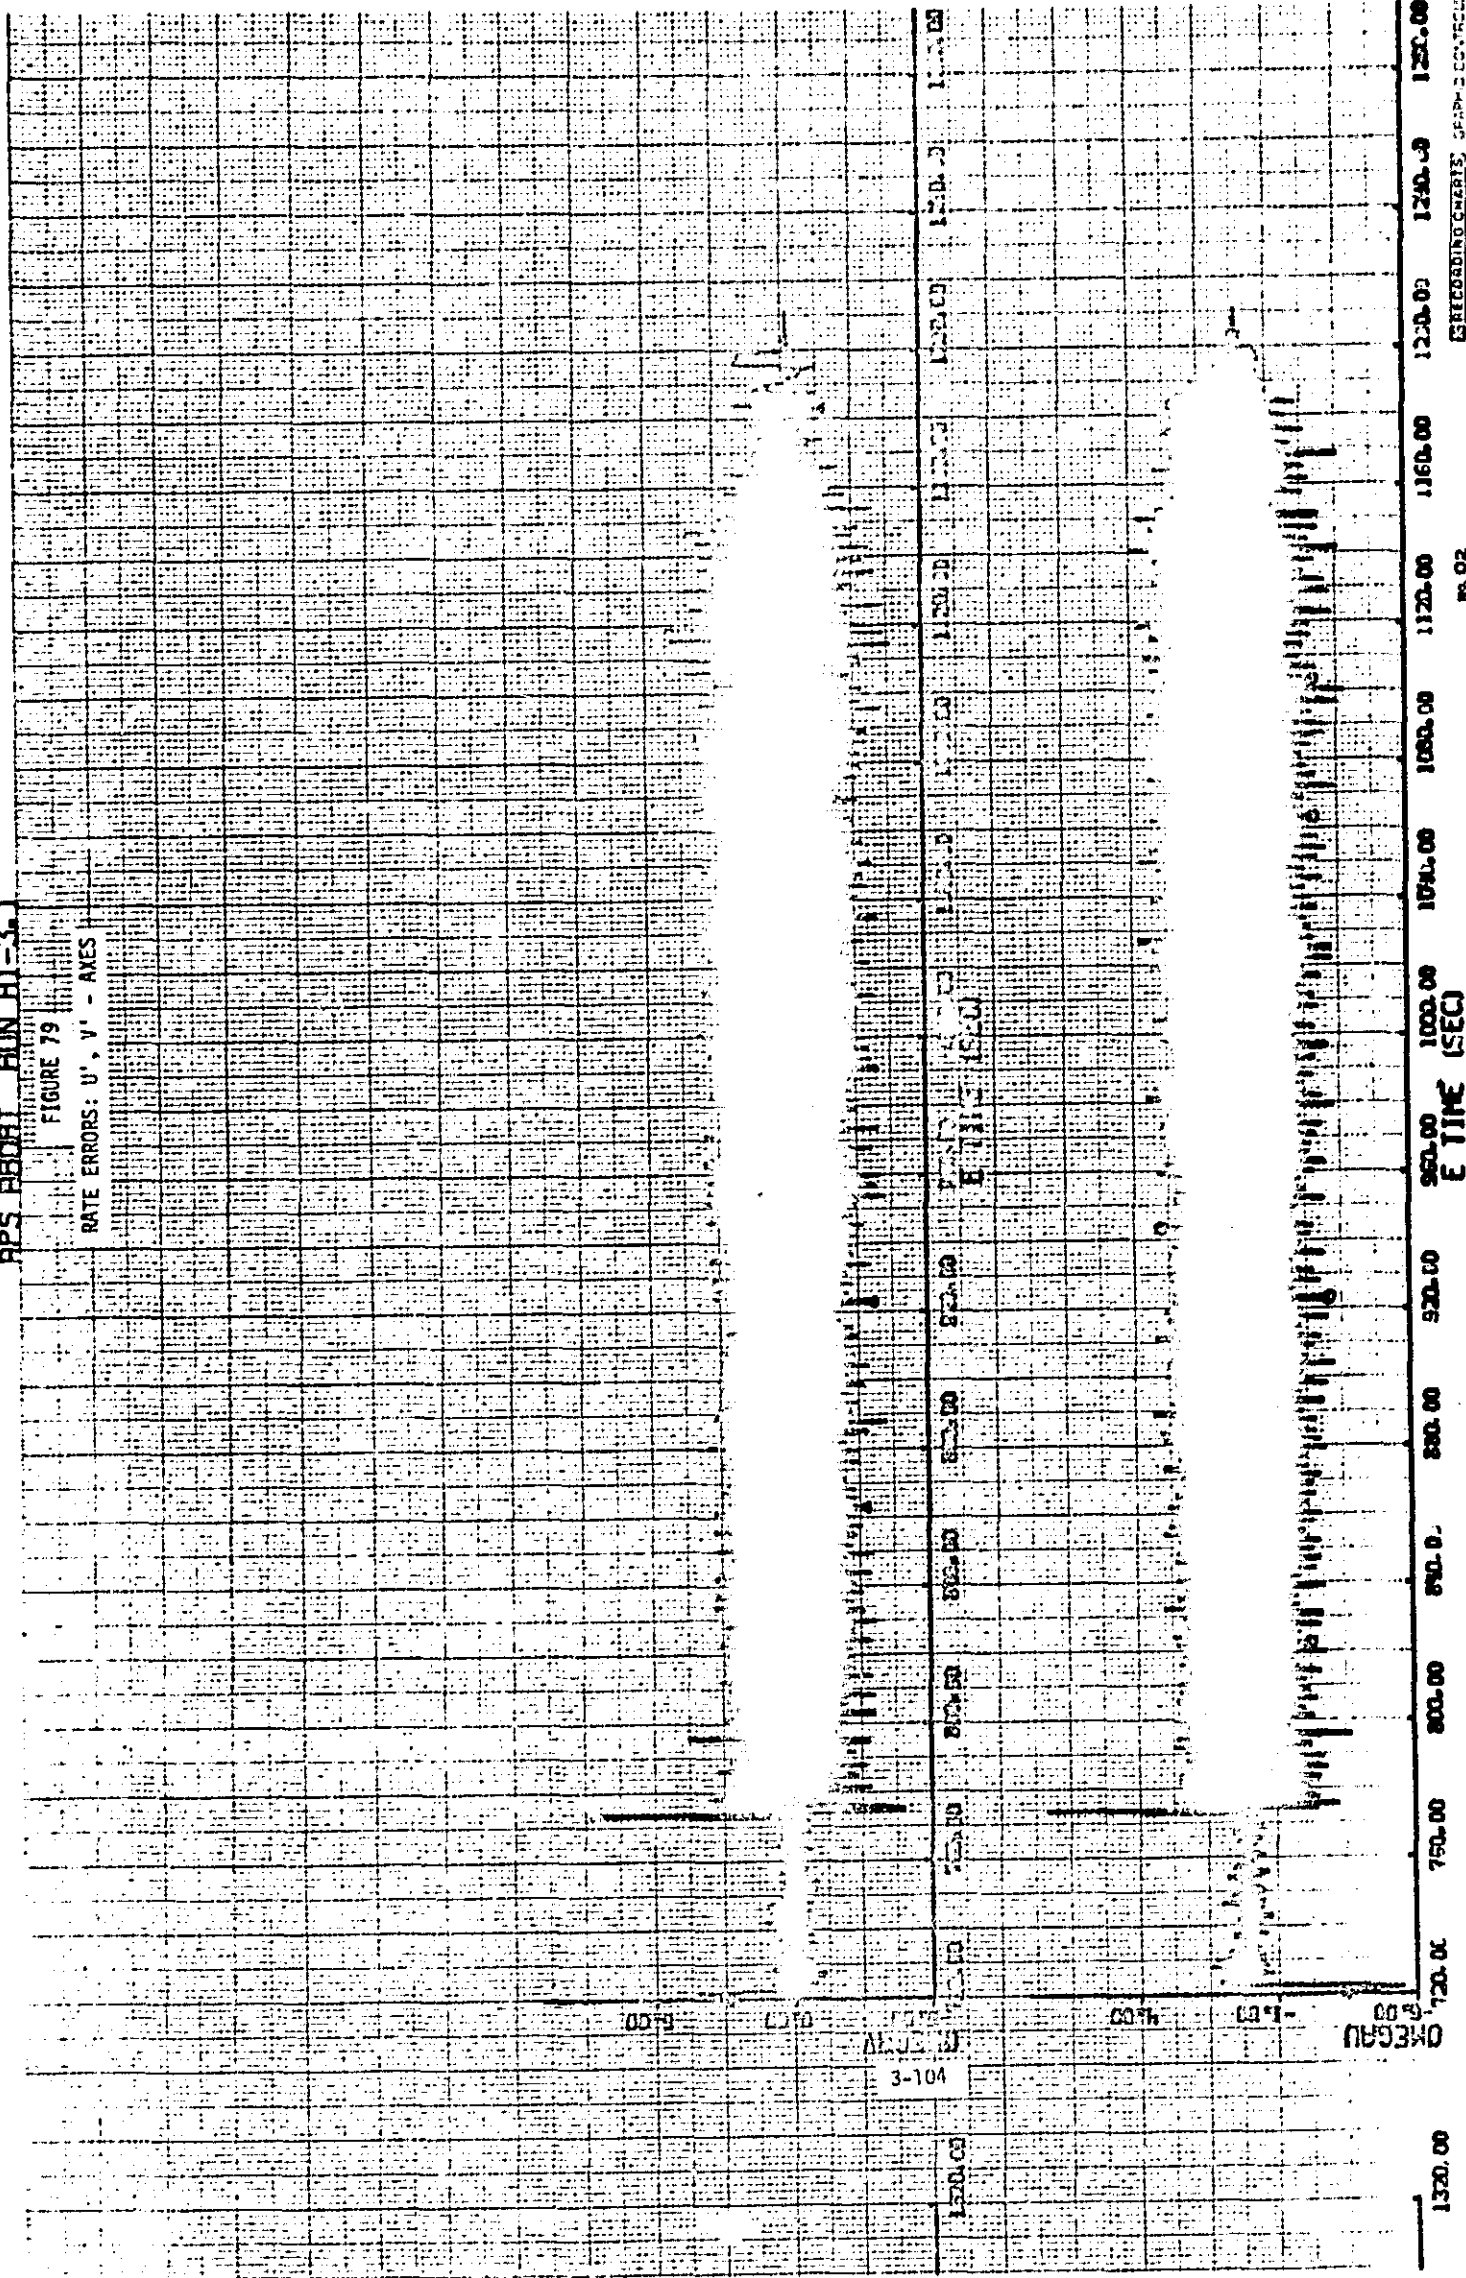
FIGURE 79

RATE ERRORS: U, V' - AXES
