PROJECT TECHNICAL REPORT
TASK E-72B

LUMINARY 1B DAP PREFLIGHT PERFORMANCE
EVALUATION

NAS 9-8166

13 November 1969

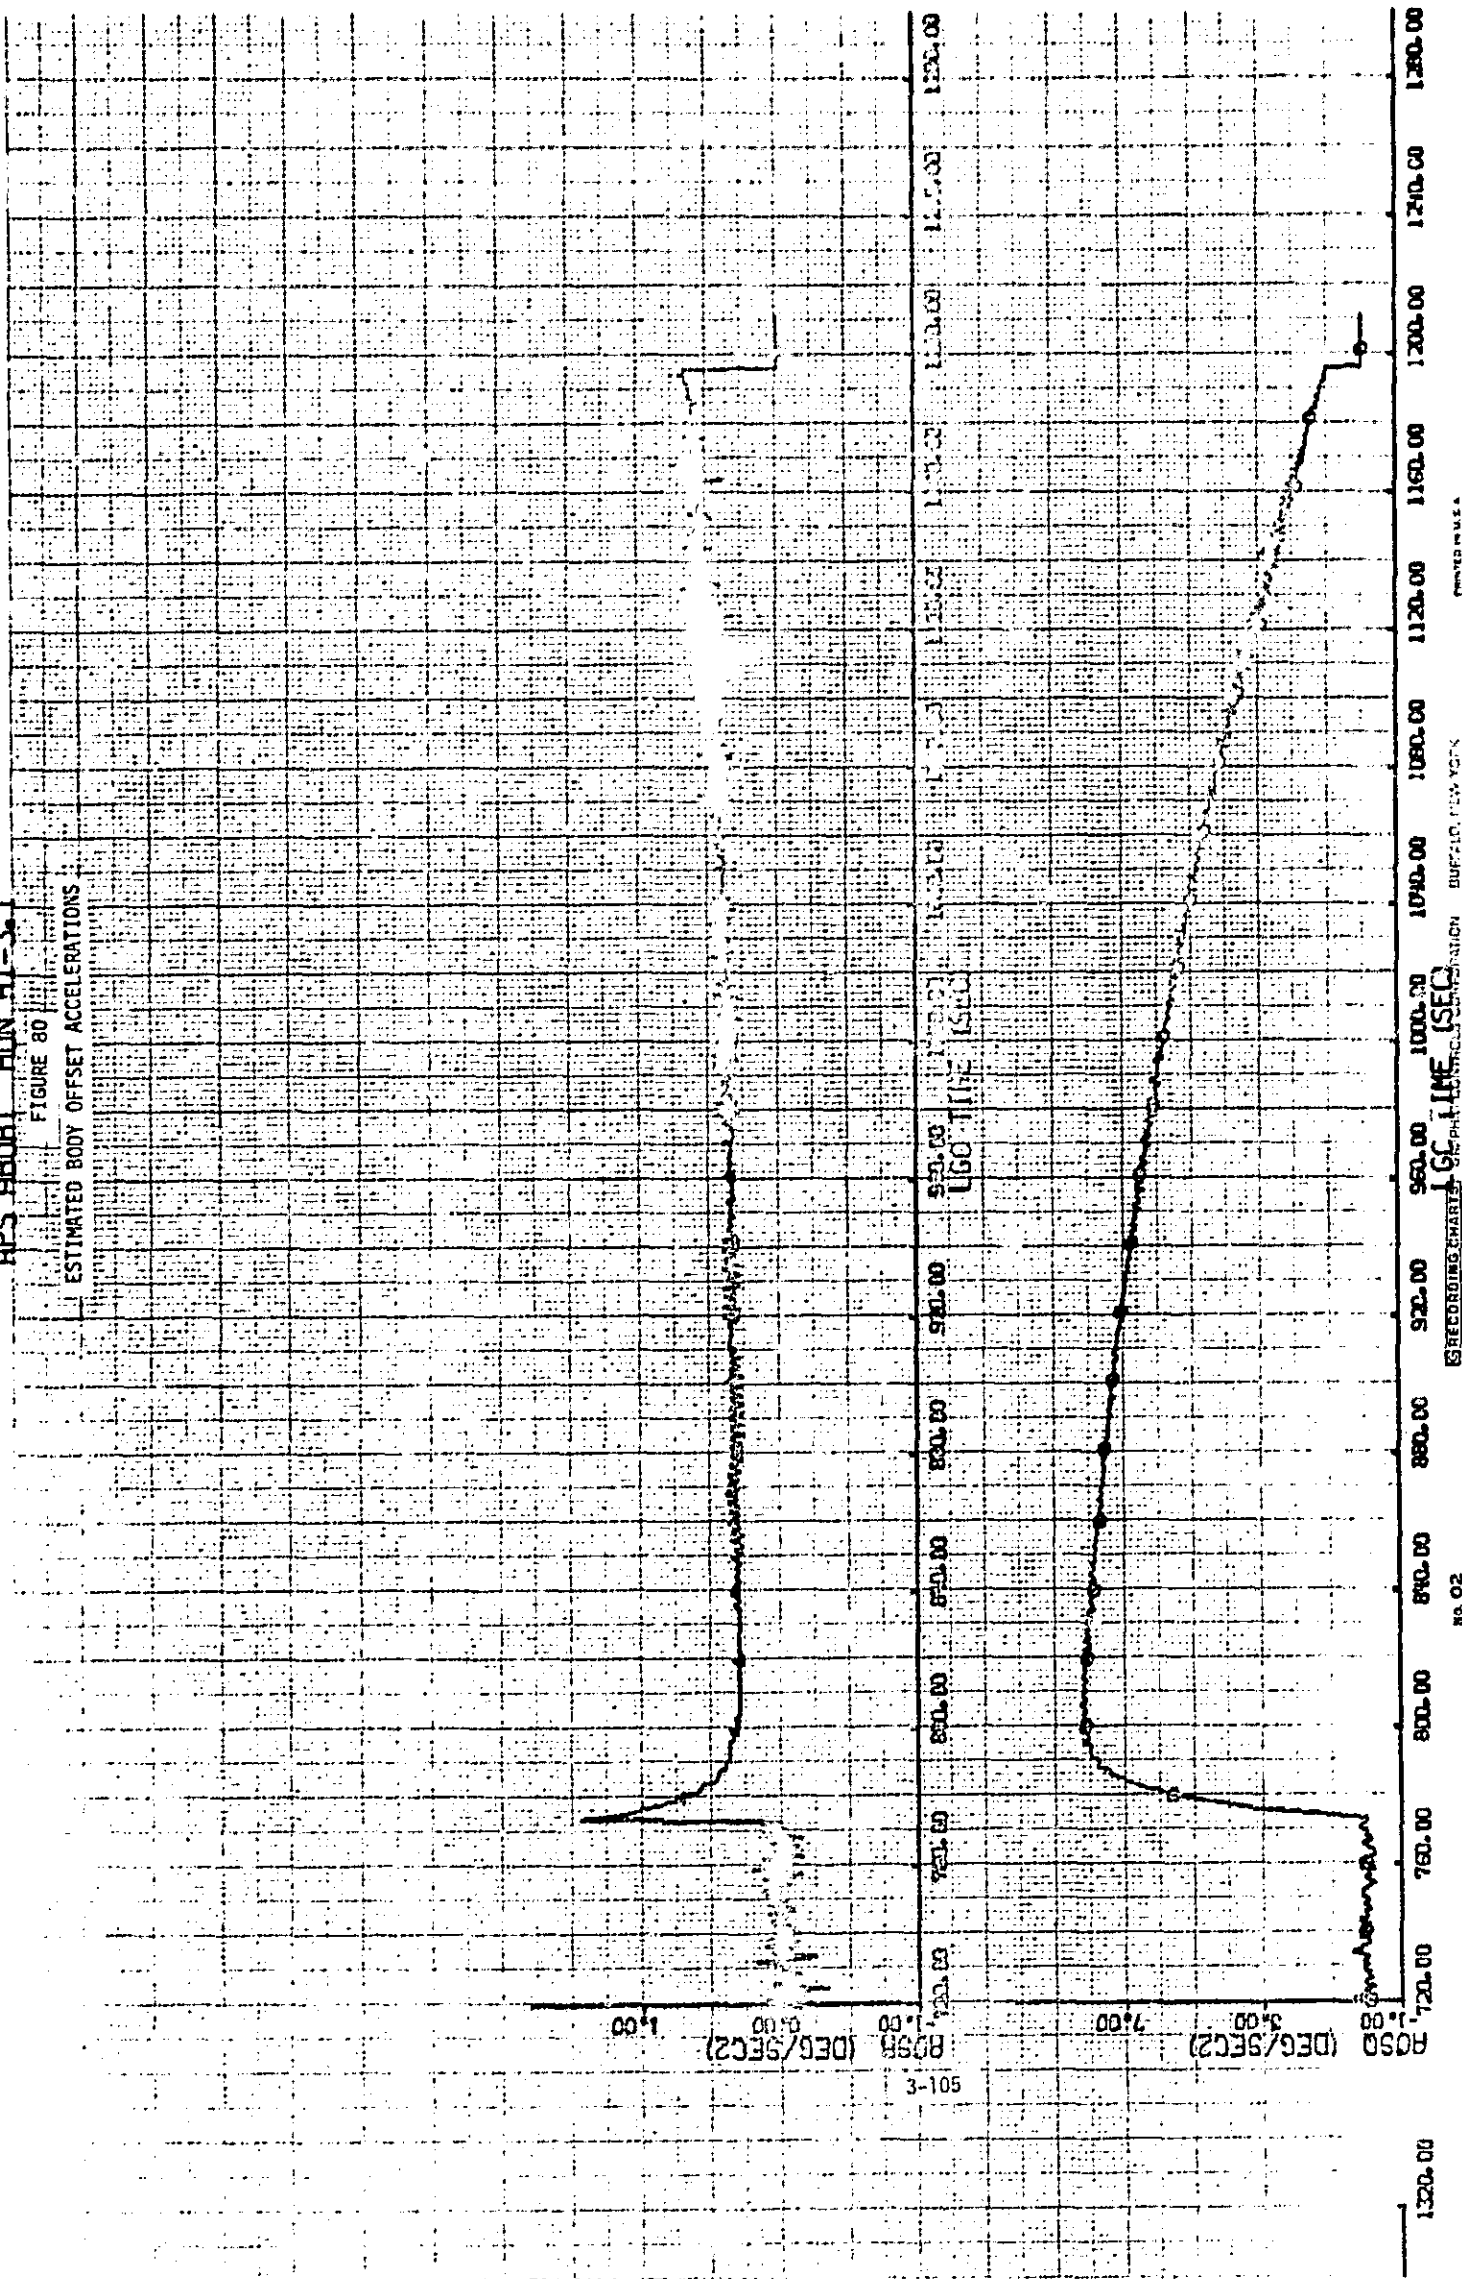
FIGURE 80

ESTIMATED BODY OFFSET ACCELERATIONS

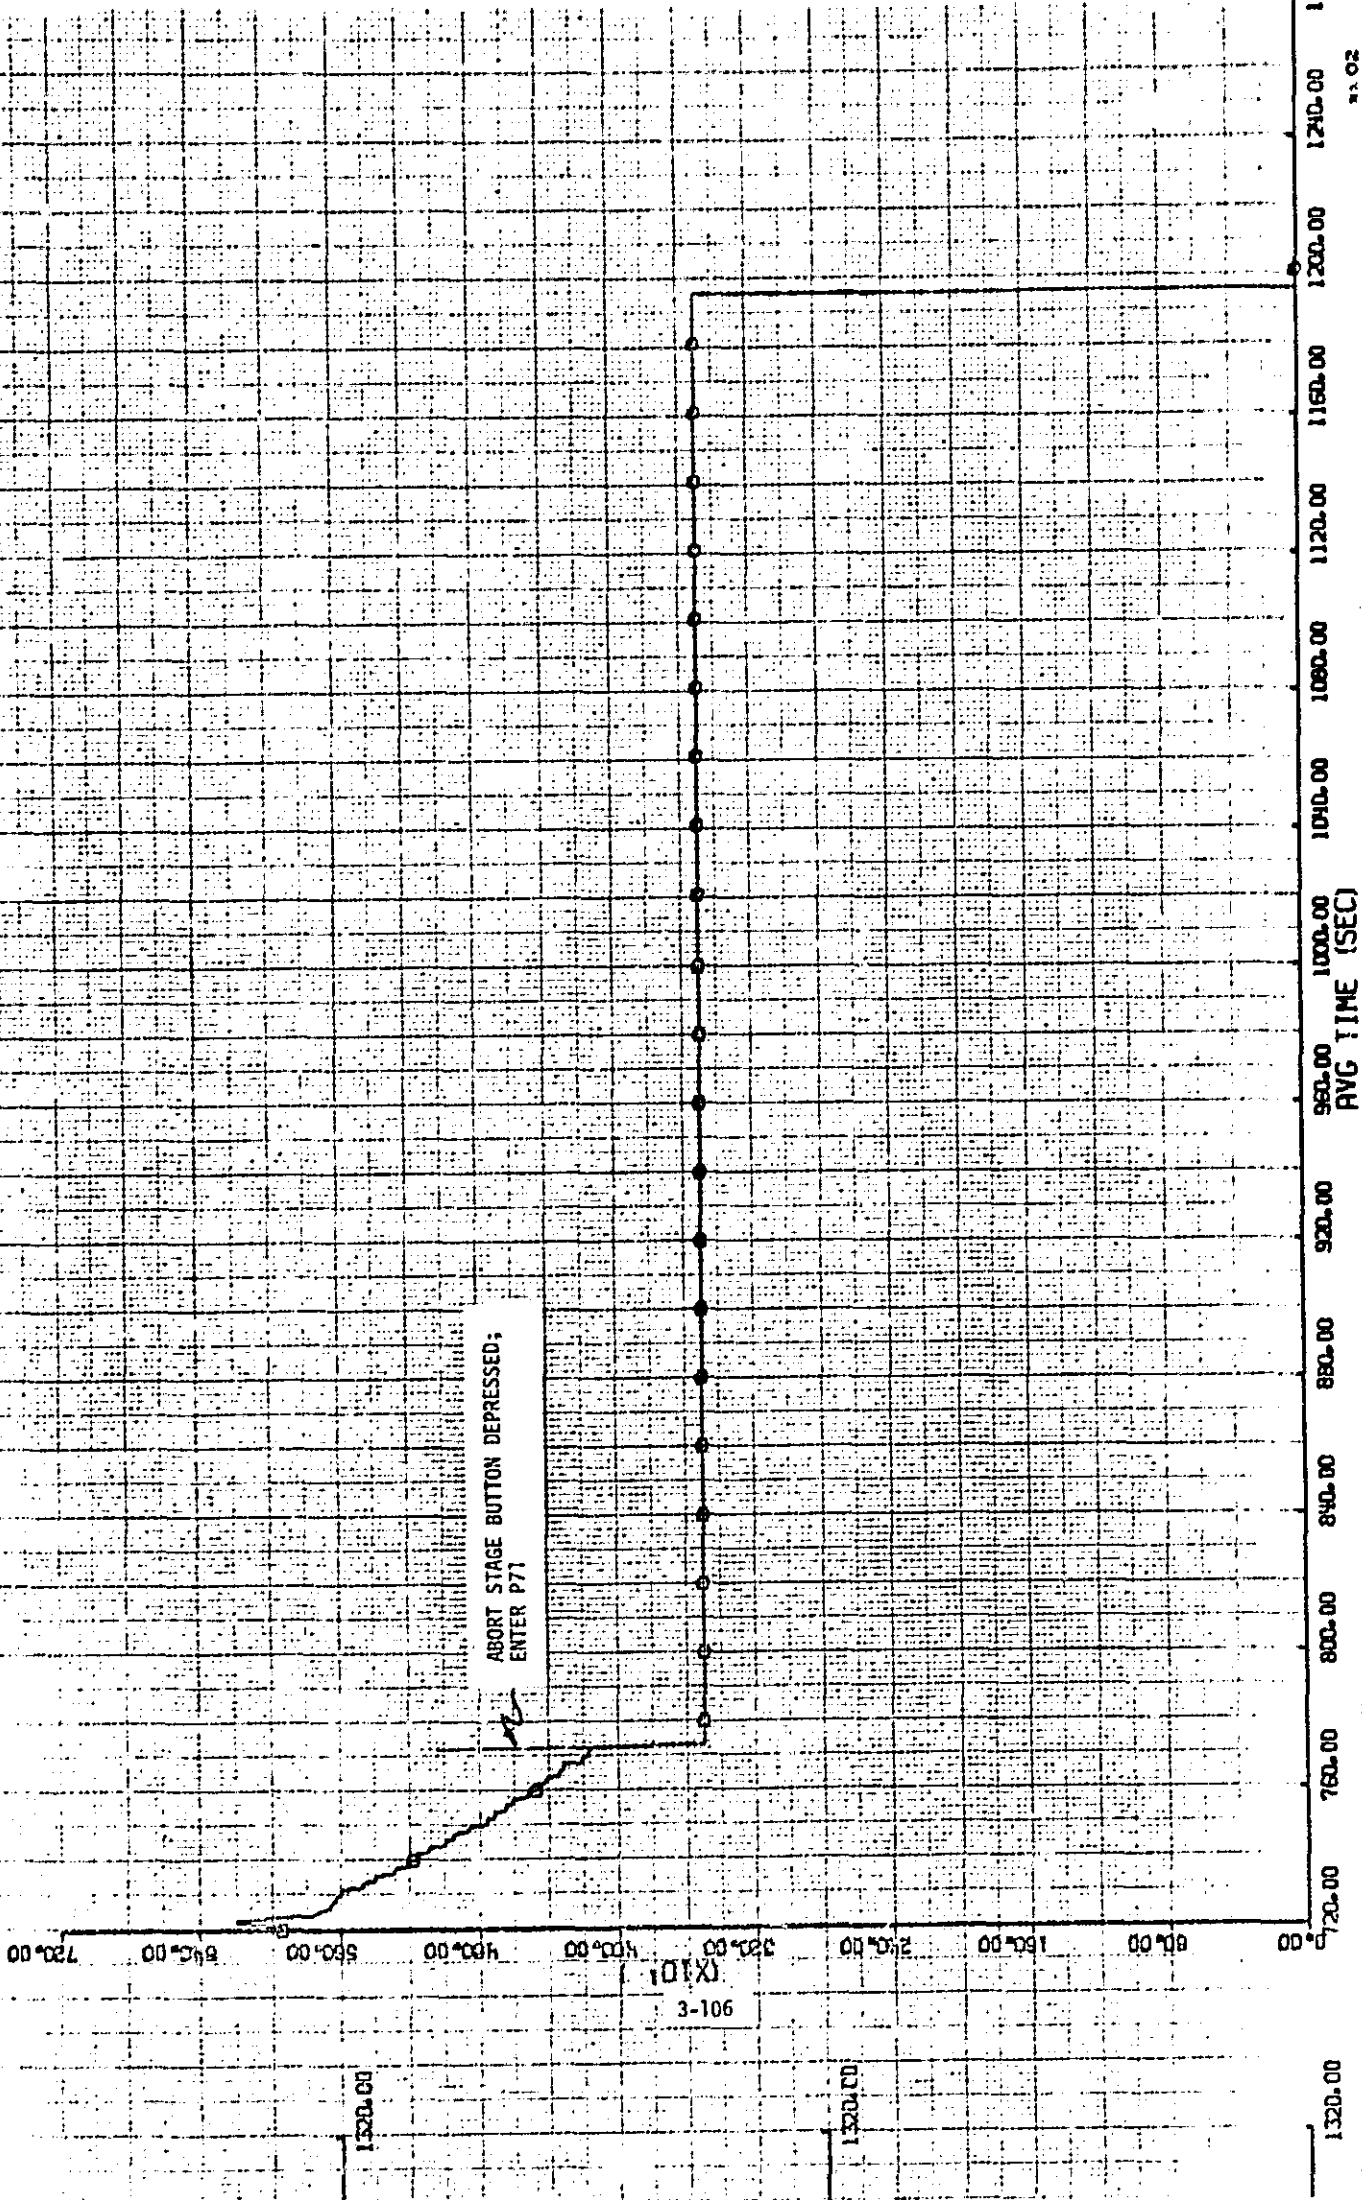
THRUST PROFILE

ABORT STAGE BUTTON DEPRESSED;
ENTER P71

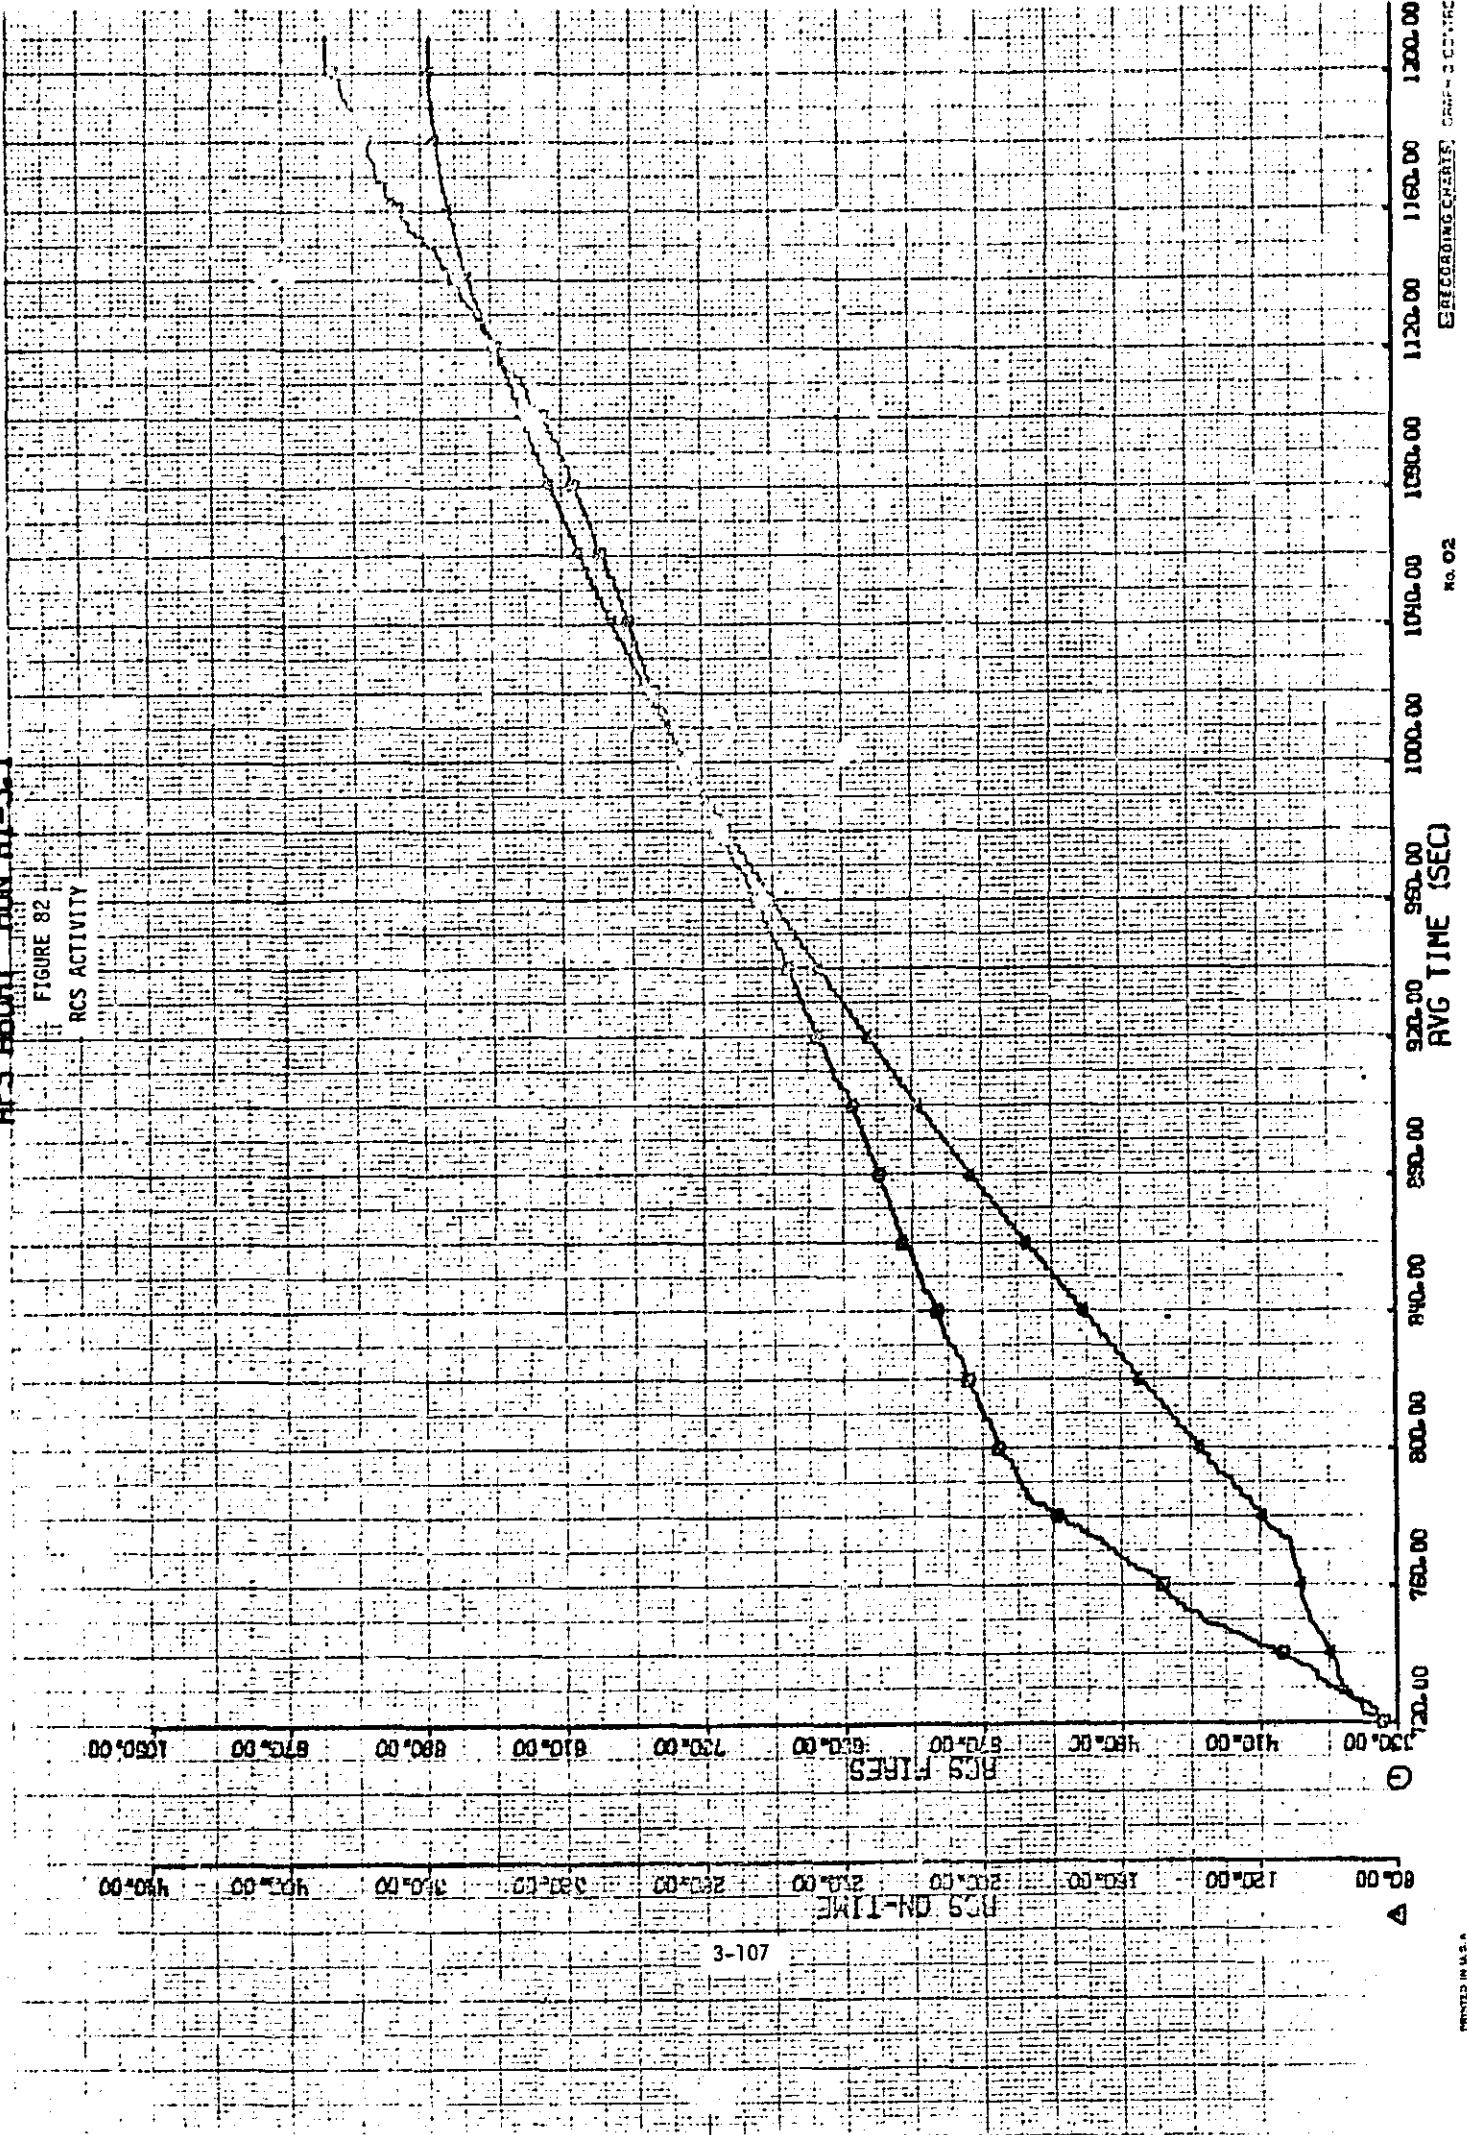
FIGURE 82

RCS ACTIVITY

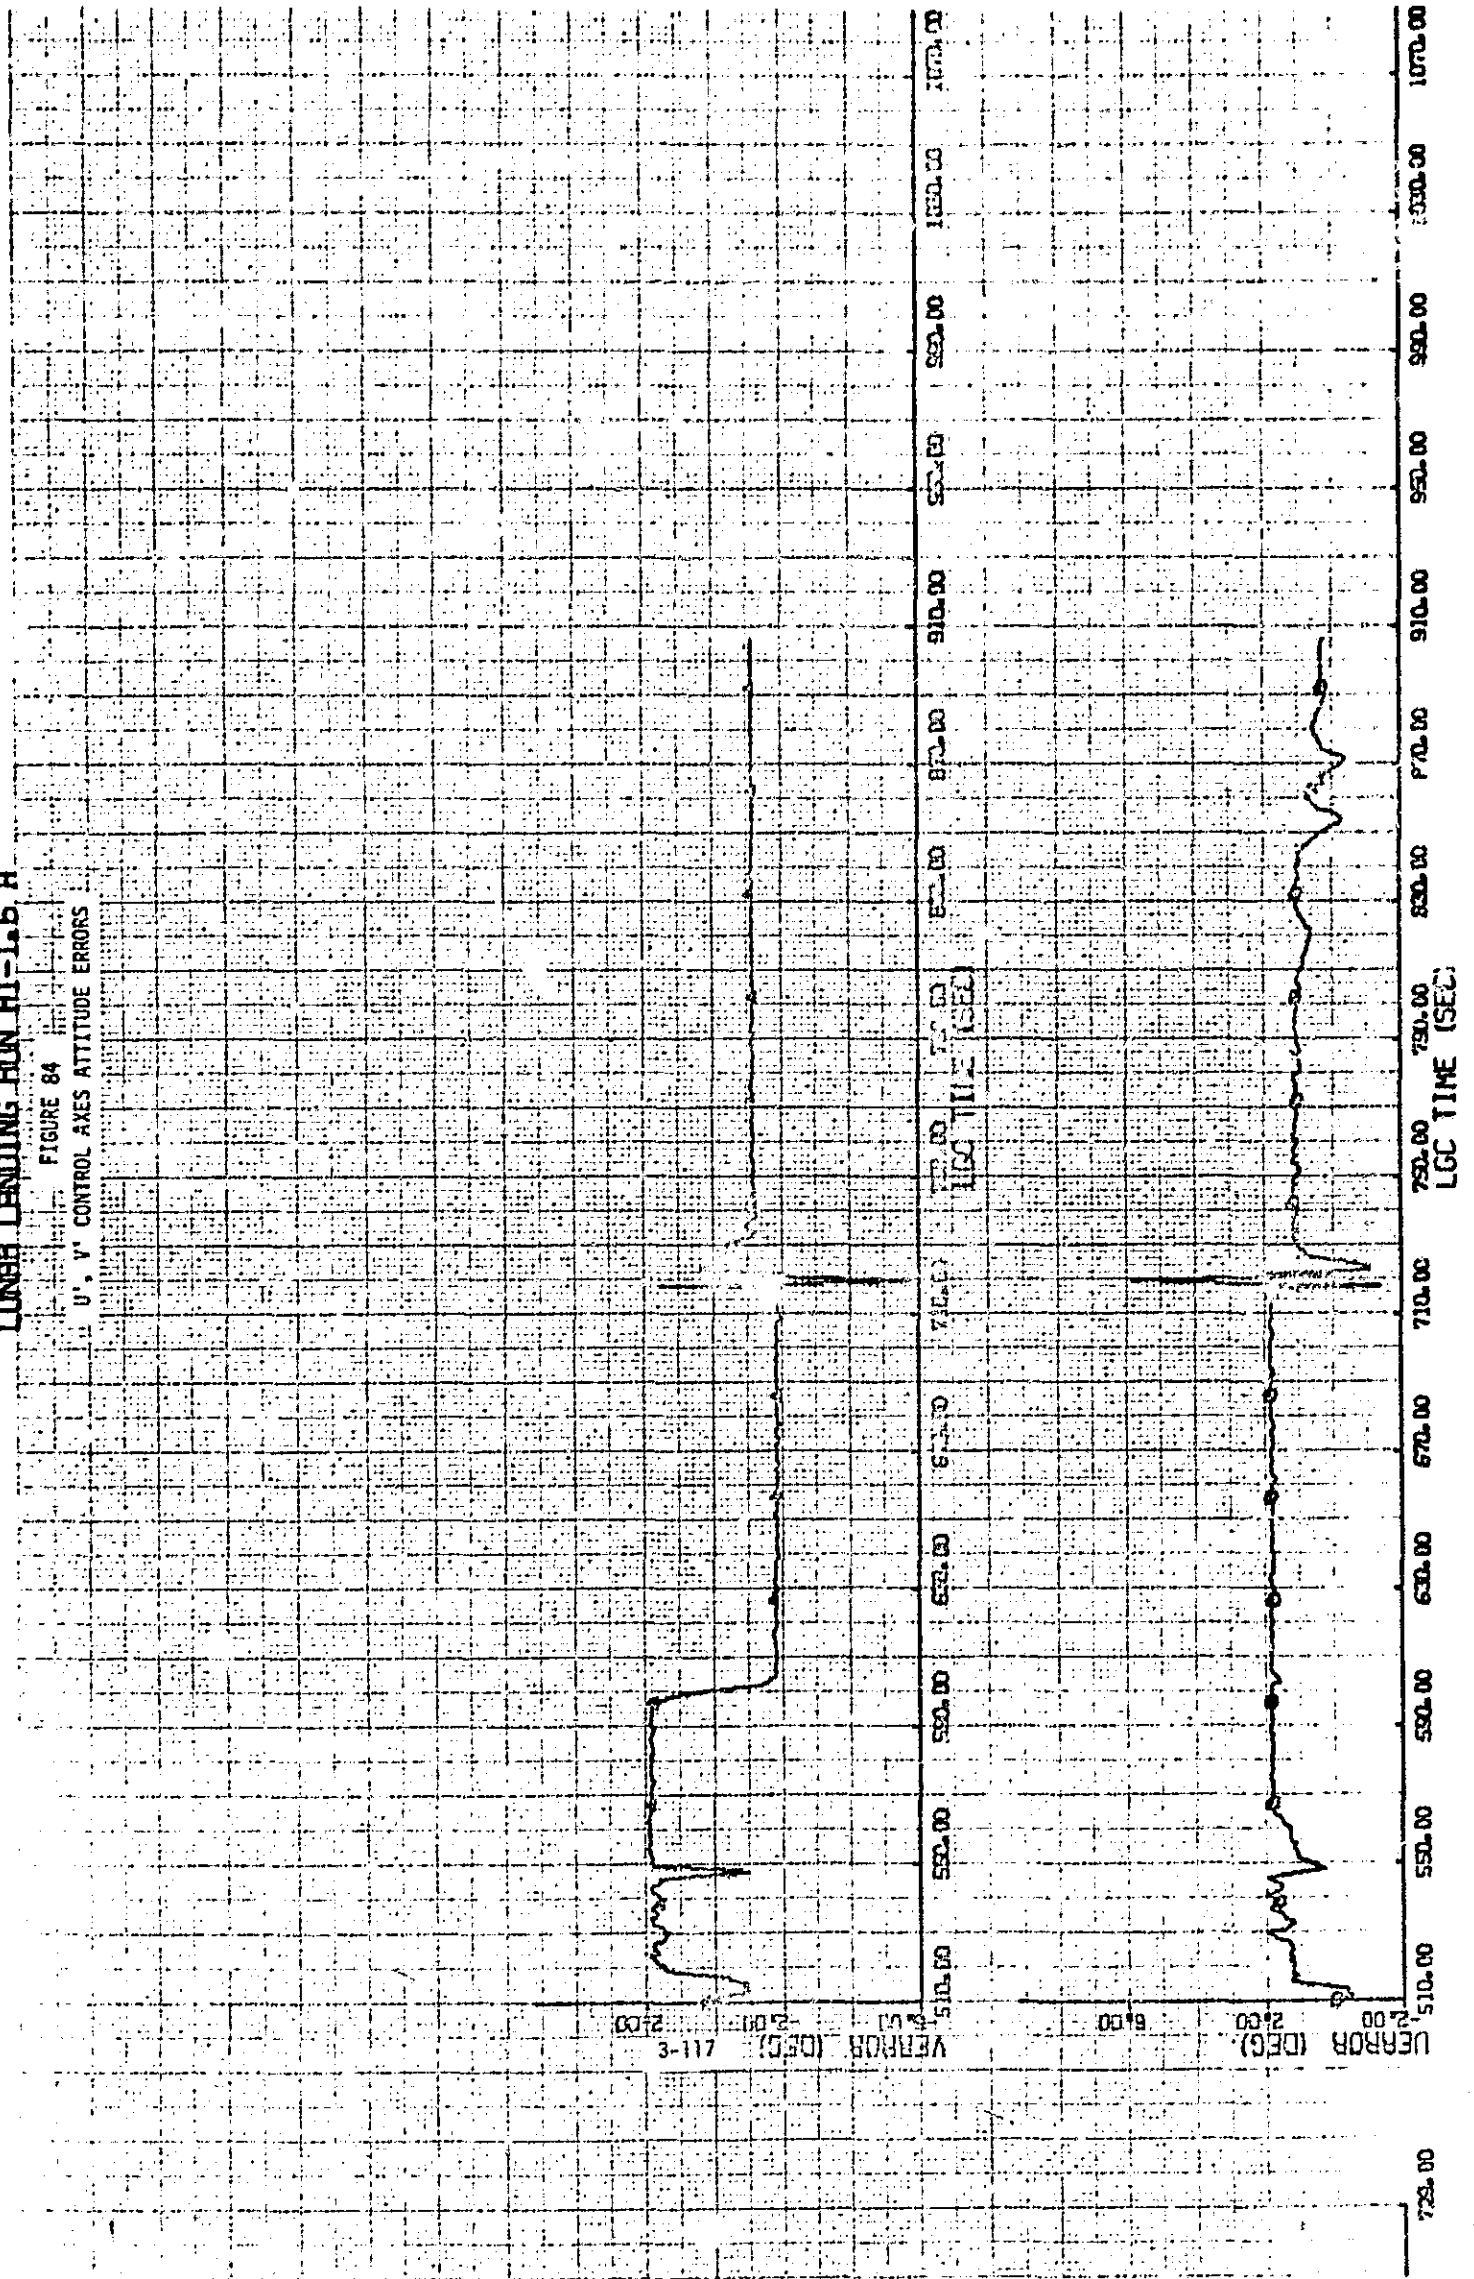
FIGURE 84
U, V CONTROL AXES ATTITUDE ERRORS

The spacecraft response for all three simulations was essentially of the same character. The three runs are discussed in a composite fashion here. Attitude errors as shown in Figures 84, 93, and 105 are biased around the deadbands. Phase planes presented in Figures 98 and 99 show the nature of the observed RCS limit cycle. The vehicle response seen here is essentially the same behavior seen in long ascent burns. At the end of long ascent burns discussed in References 2 and 5 the offset acceleration becomes small as the c.g. approaches and crosses the body axes. Under these conditions of small offset accelerations, the phase plane trajectories hang-up on the deadbands. This results in a small amplitude and unsymmetrical limit cycle. These same conditions are observed from the results obtained for the gimbal failure conditions. Even with 1 degree mistrims at the time of gimbal failure, offset accelerations are sufficiently small to produce the small amplitude and attitude-error-biased limit cycle. The spacecraft response from an overall view was extremely smooth, and fuel slosh dynamics, while present (Refer to Figures 94, 95, and 96), are significantly reduced in amplitude in comparison with results obtained in the nominal descent case. (See Section 3.1). Estimated body rates, for example as shown in Figures 86, 95, and 107, include a small steady-state error. This steady-state rate error results from the state estimators prediction of the effect of DPS gimbal activity which never occurs. (The GTS control law continues to function after the gimbal failures). The effect of the steady state rate error should be small in that it simply displaces the limit cycle above or below the attitude error axis on the phase plane. As the powered descent continues, the small RCS limit cycle centers around +1.8 degrees (deadband + FLAT). After P64 is reached, the limit cycle settles around +1.1 degrees (0.3 degree deadband + FLAT).

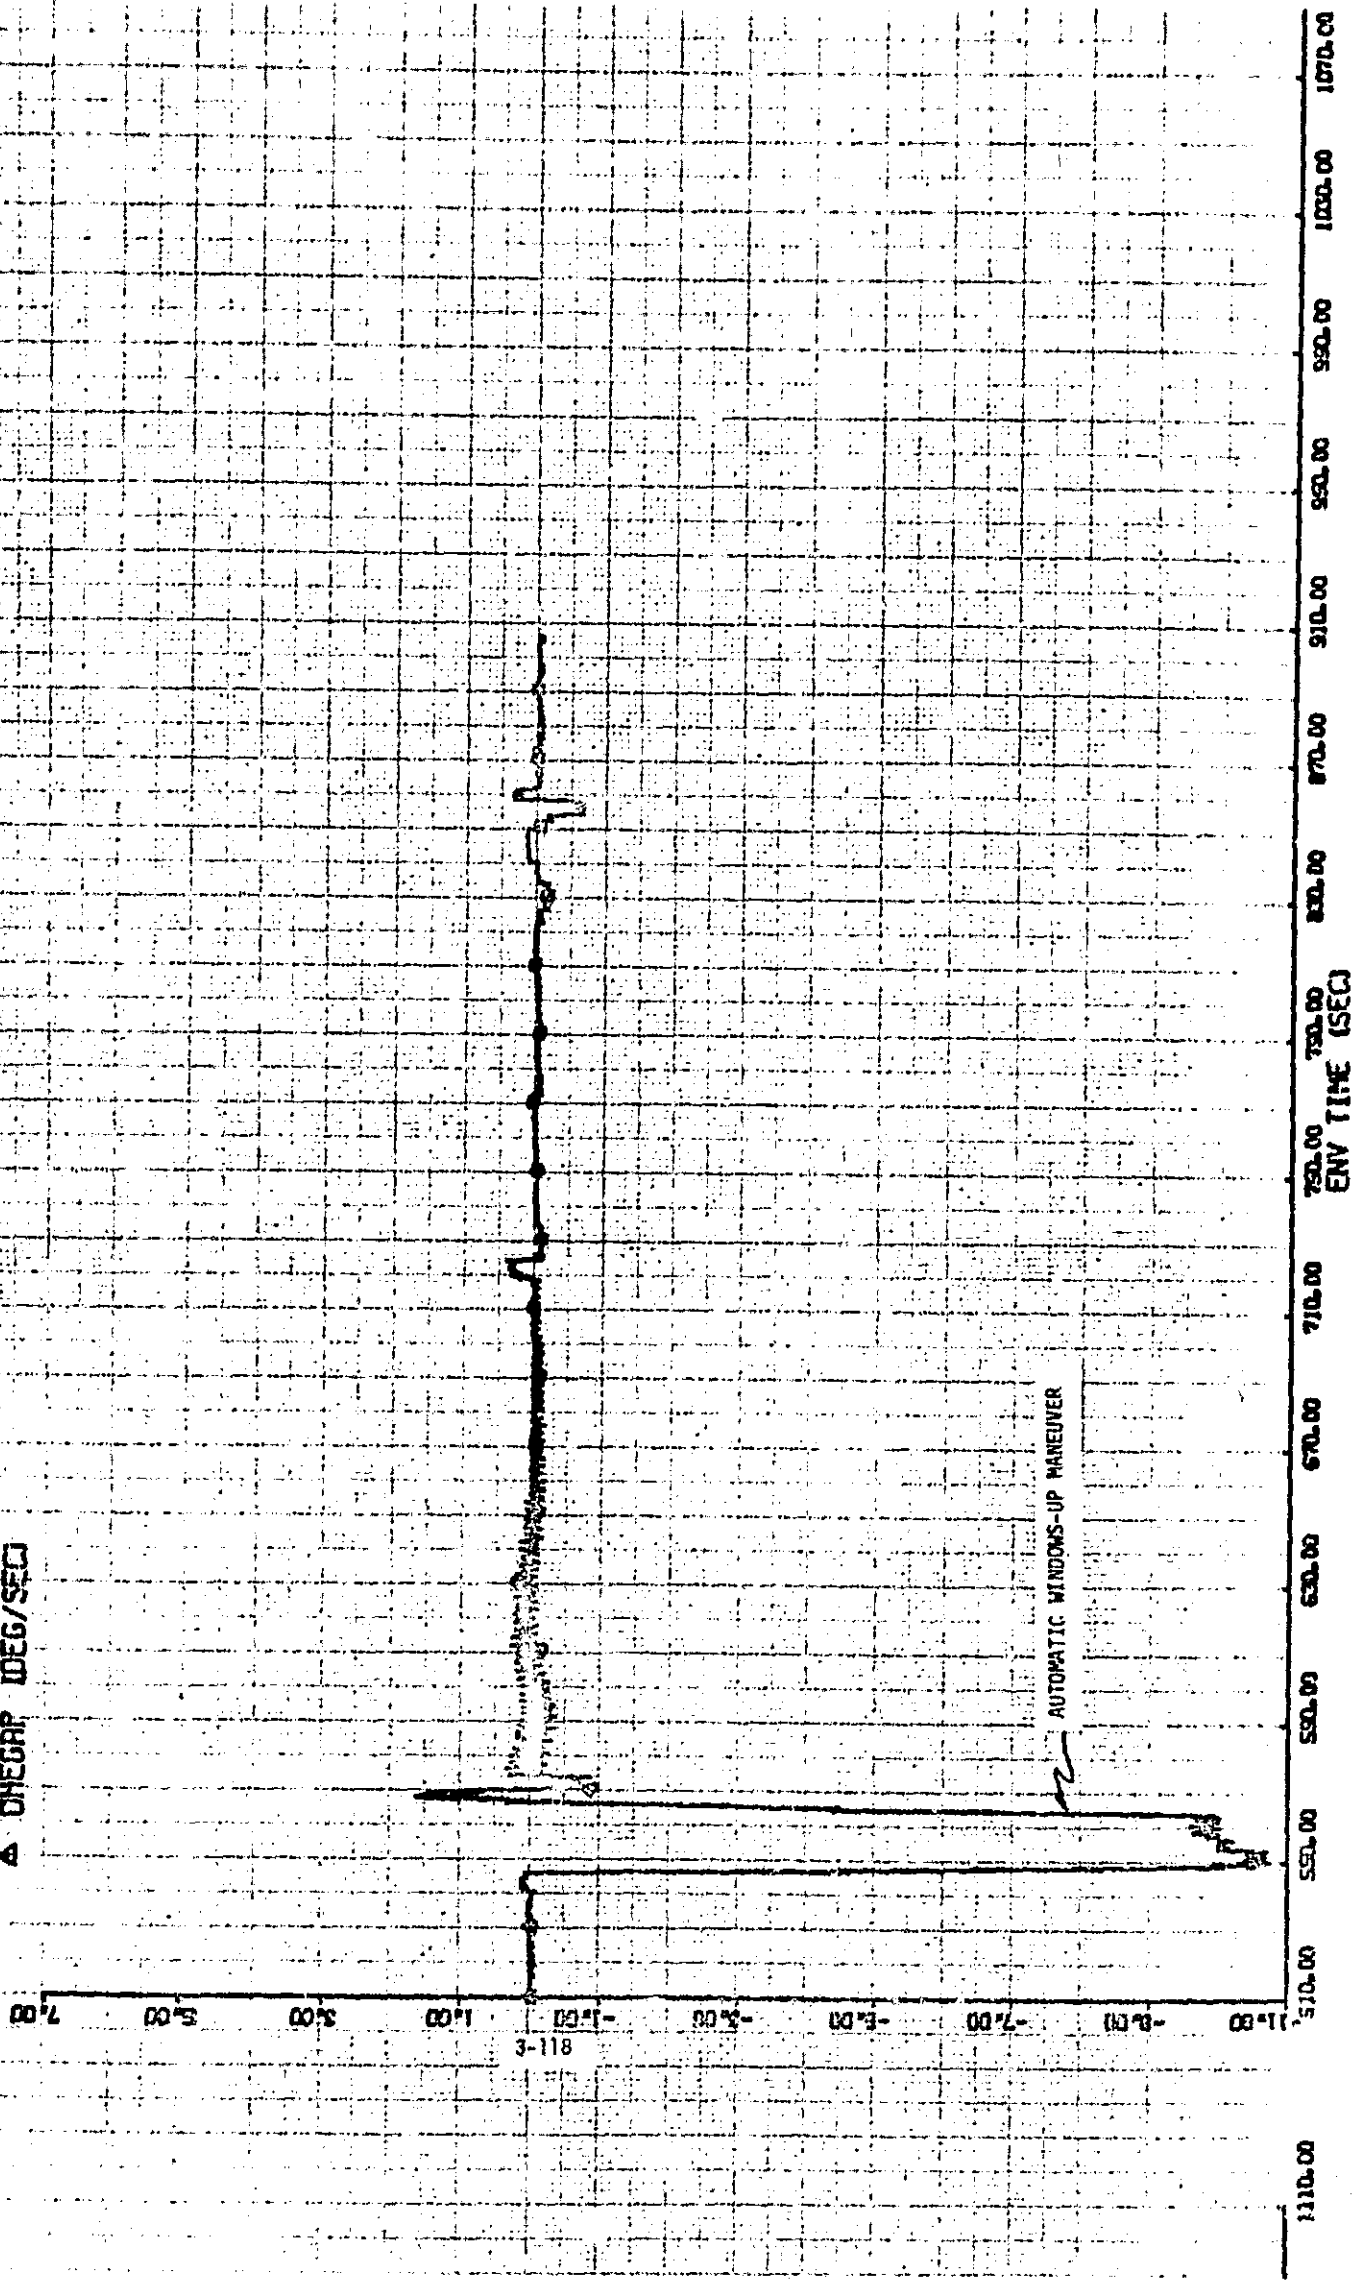
FIGURE 85
YAW BODY RATES: ACTUAL AND ESTIMATED

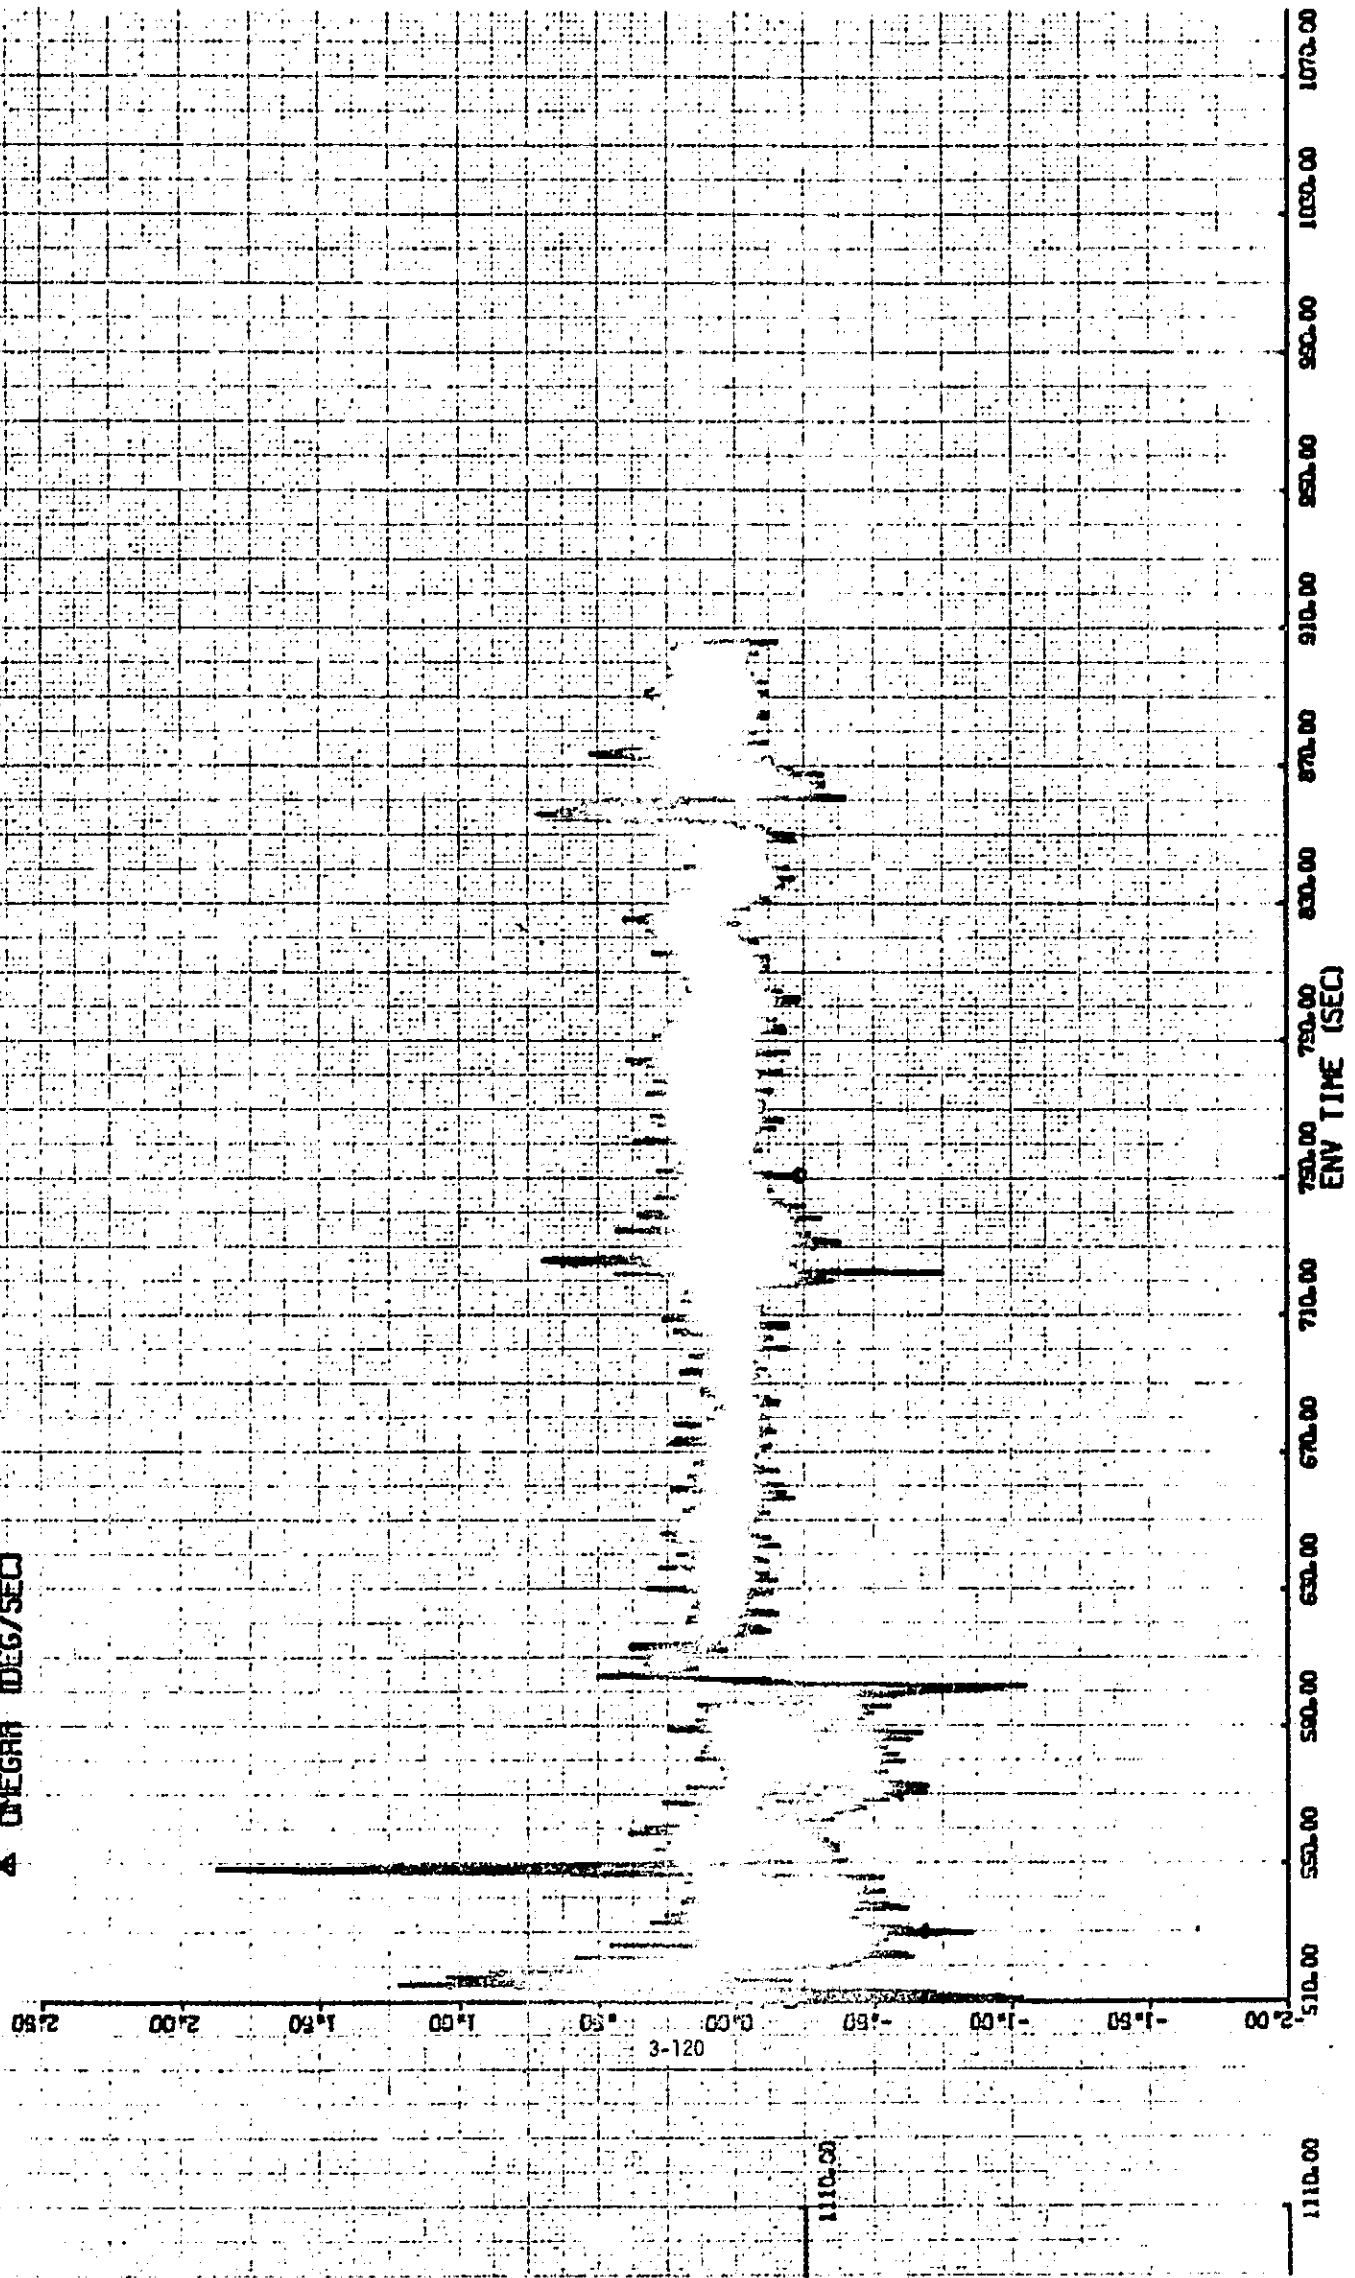
FIGURE 87
ROLL BODY RATES: ACTUAL AND ESTIMATED

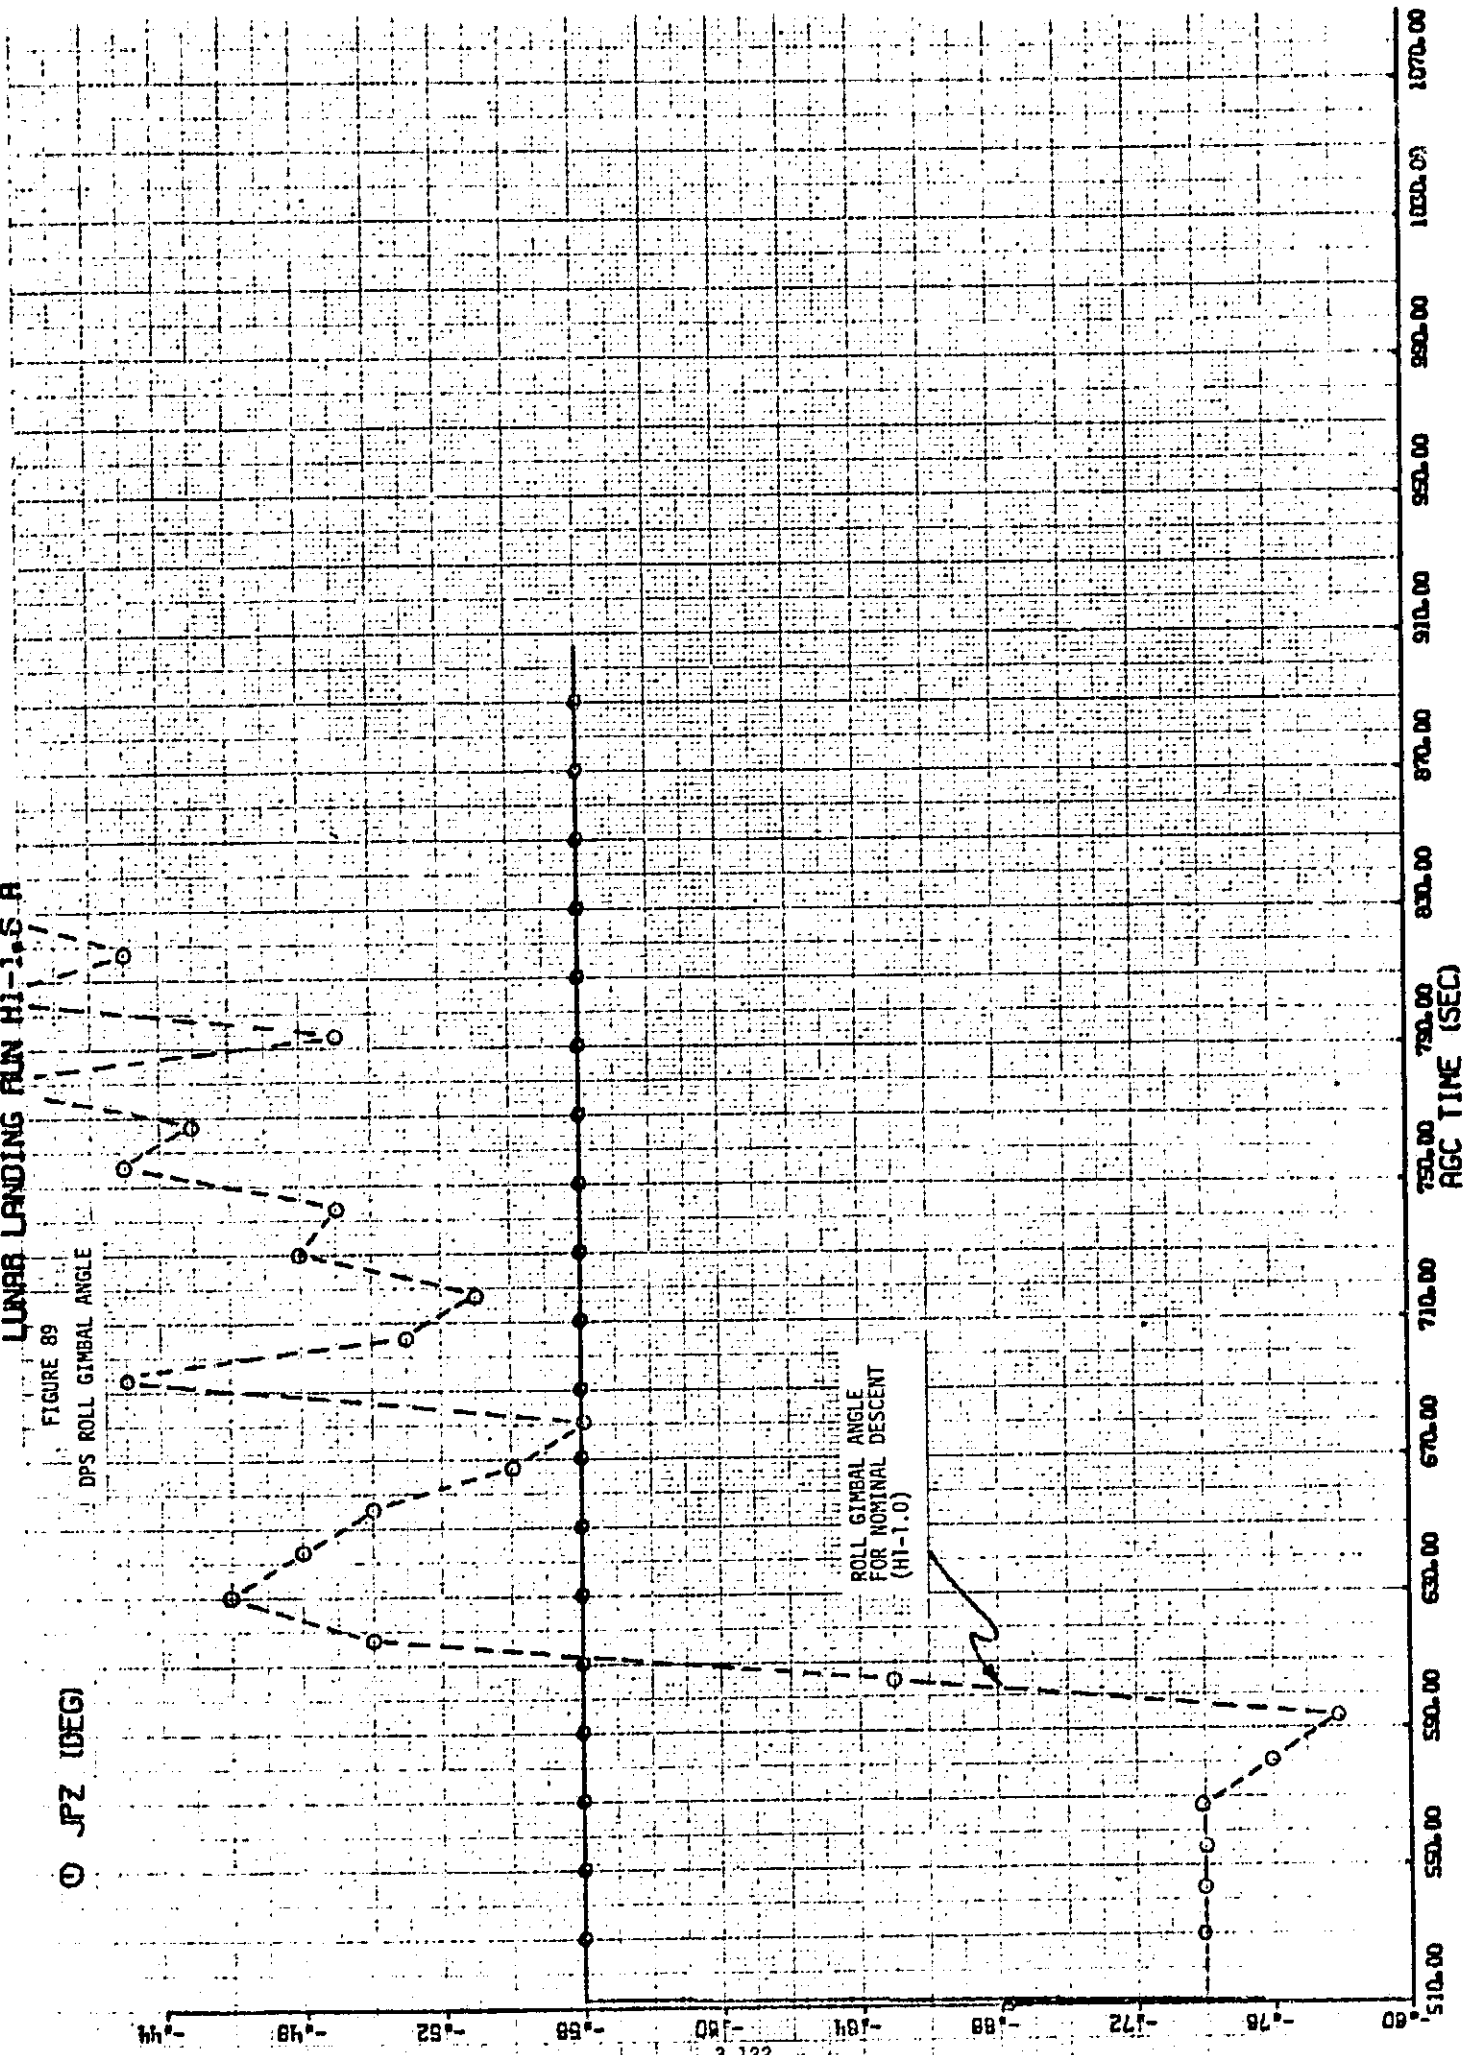
DPS ROLL GIMBAL ANGLE

ROLL GIMBAL ANGLE FOR NOMINAL DESCENT (HI-1.0)
