PROJECT TECHNICAL REPORT
TASK E-72B

LUMINARY 1B DAP PREFLIGHT PERFORMANCE
EVALUATION

NAS 9-8166

13 November 1969

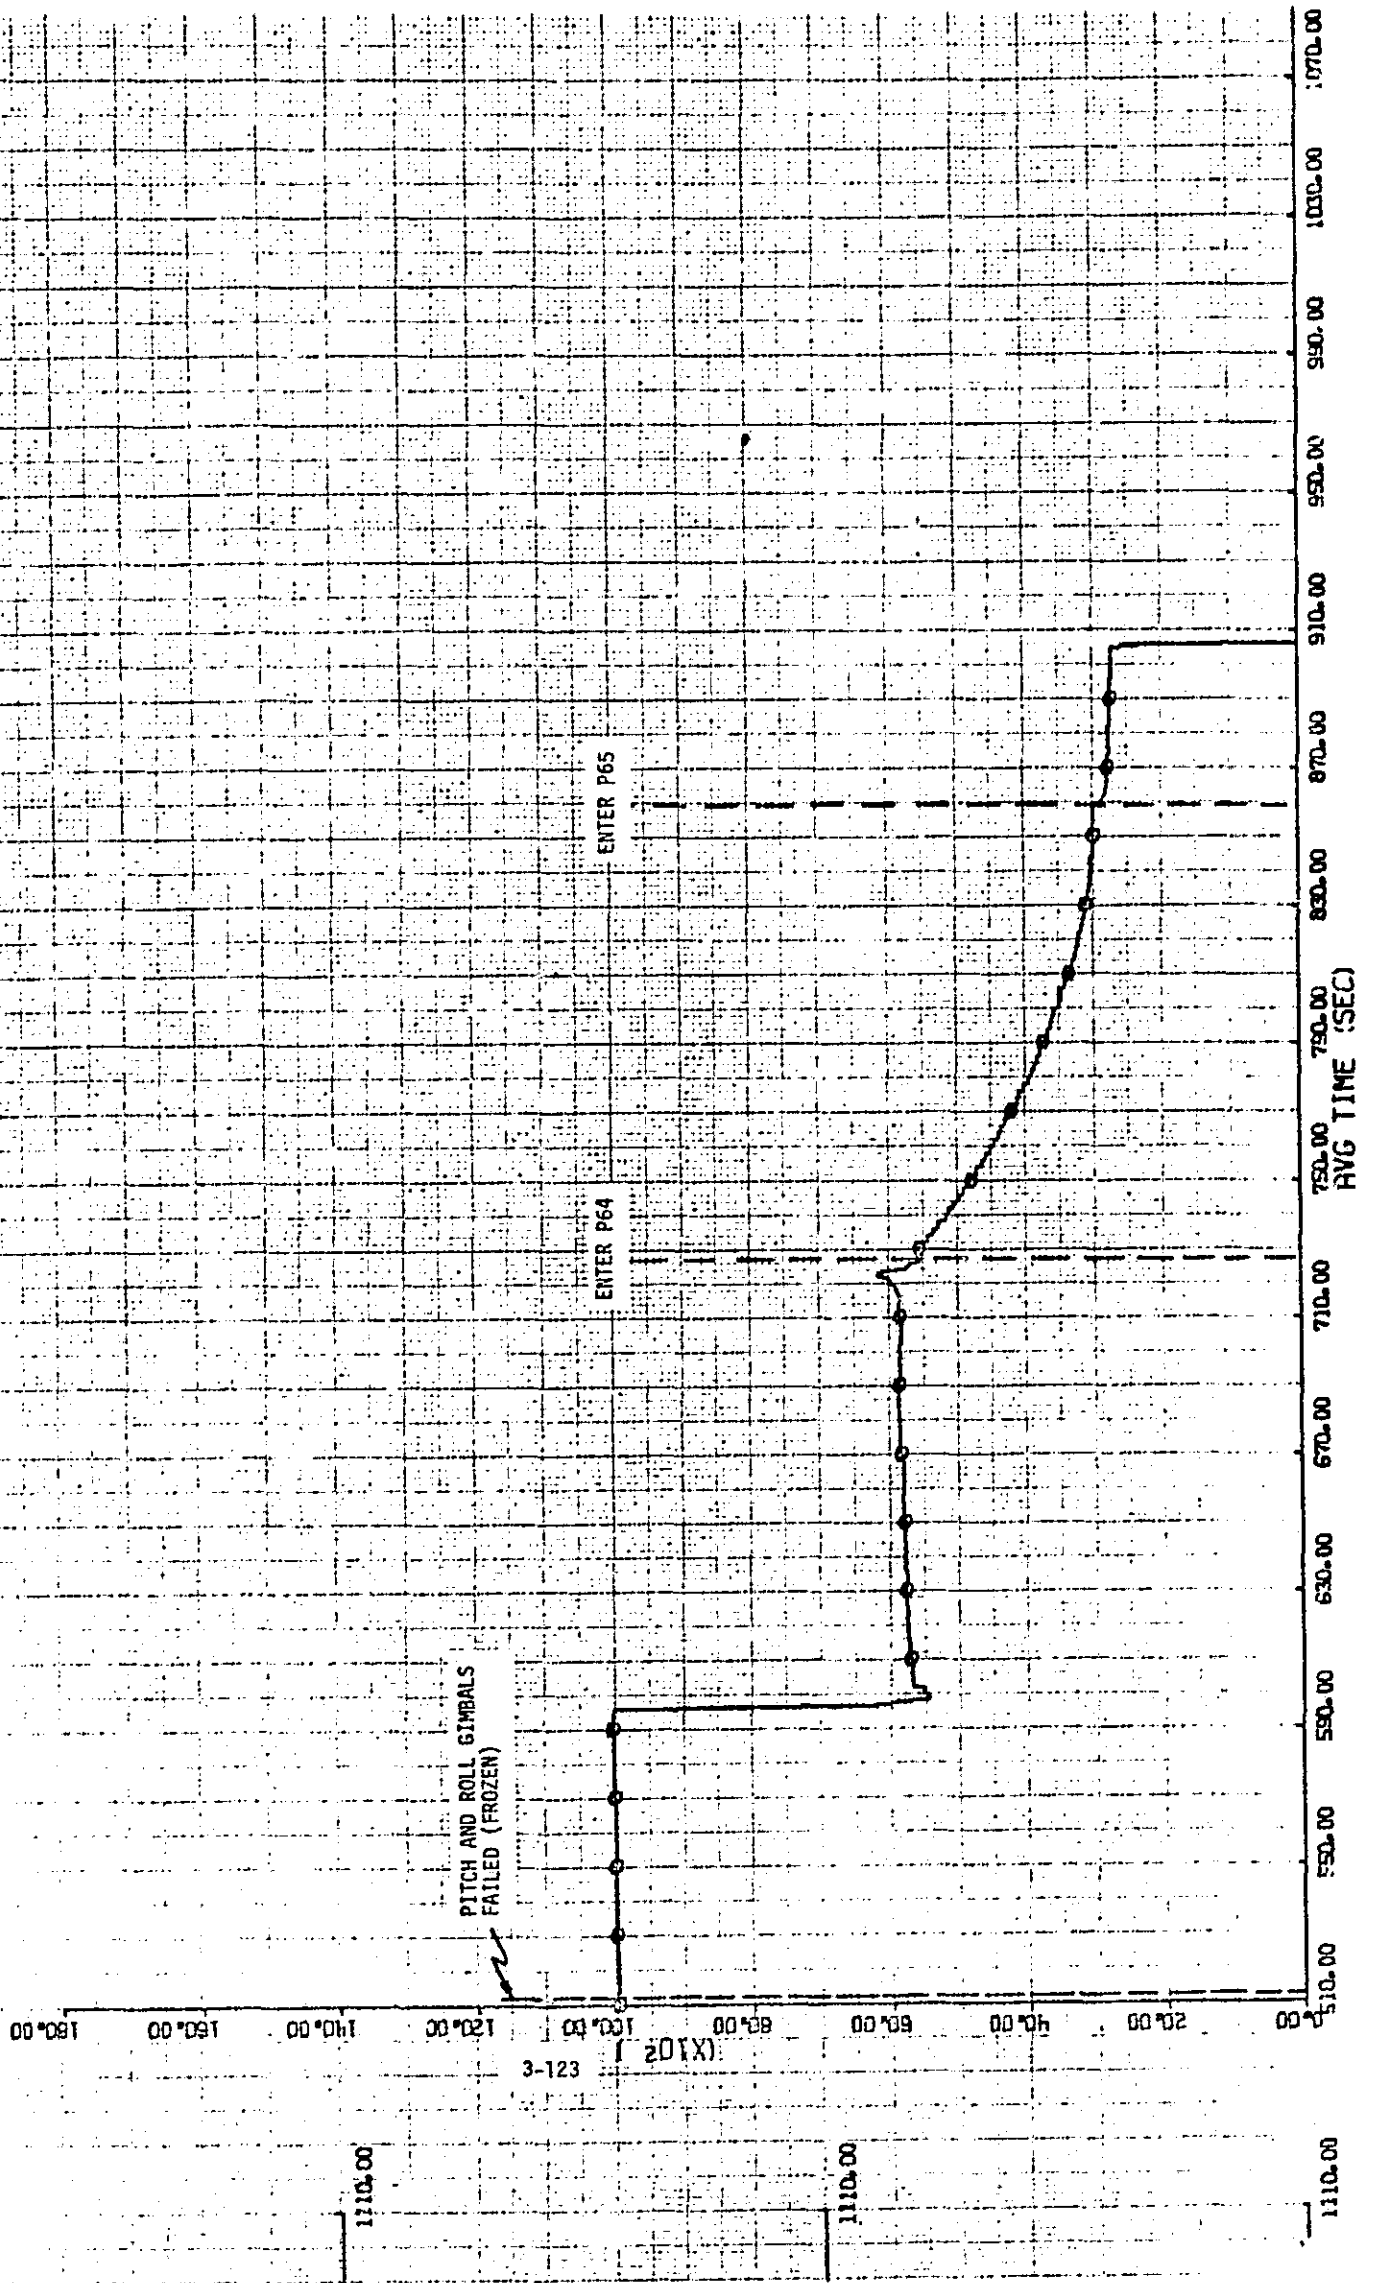
FIGURE 90
THRUST PROFILE

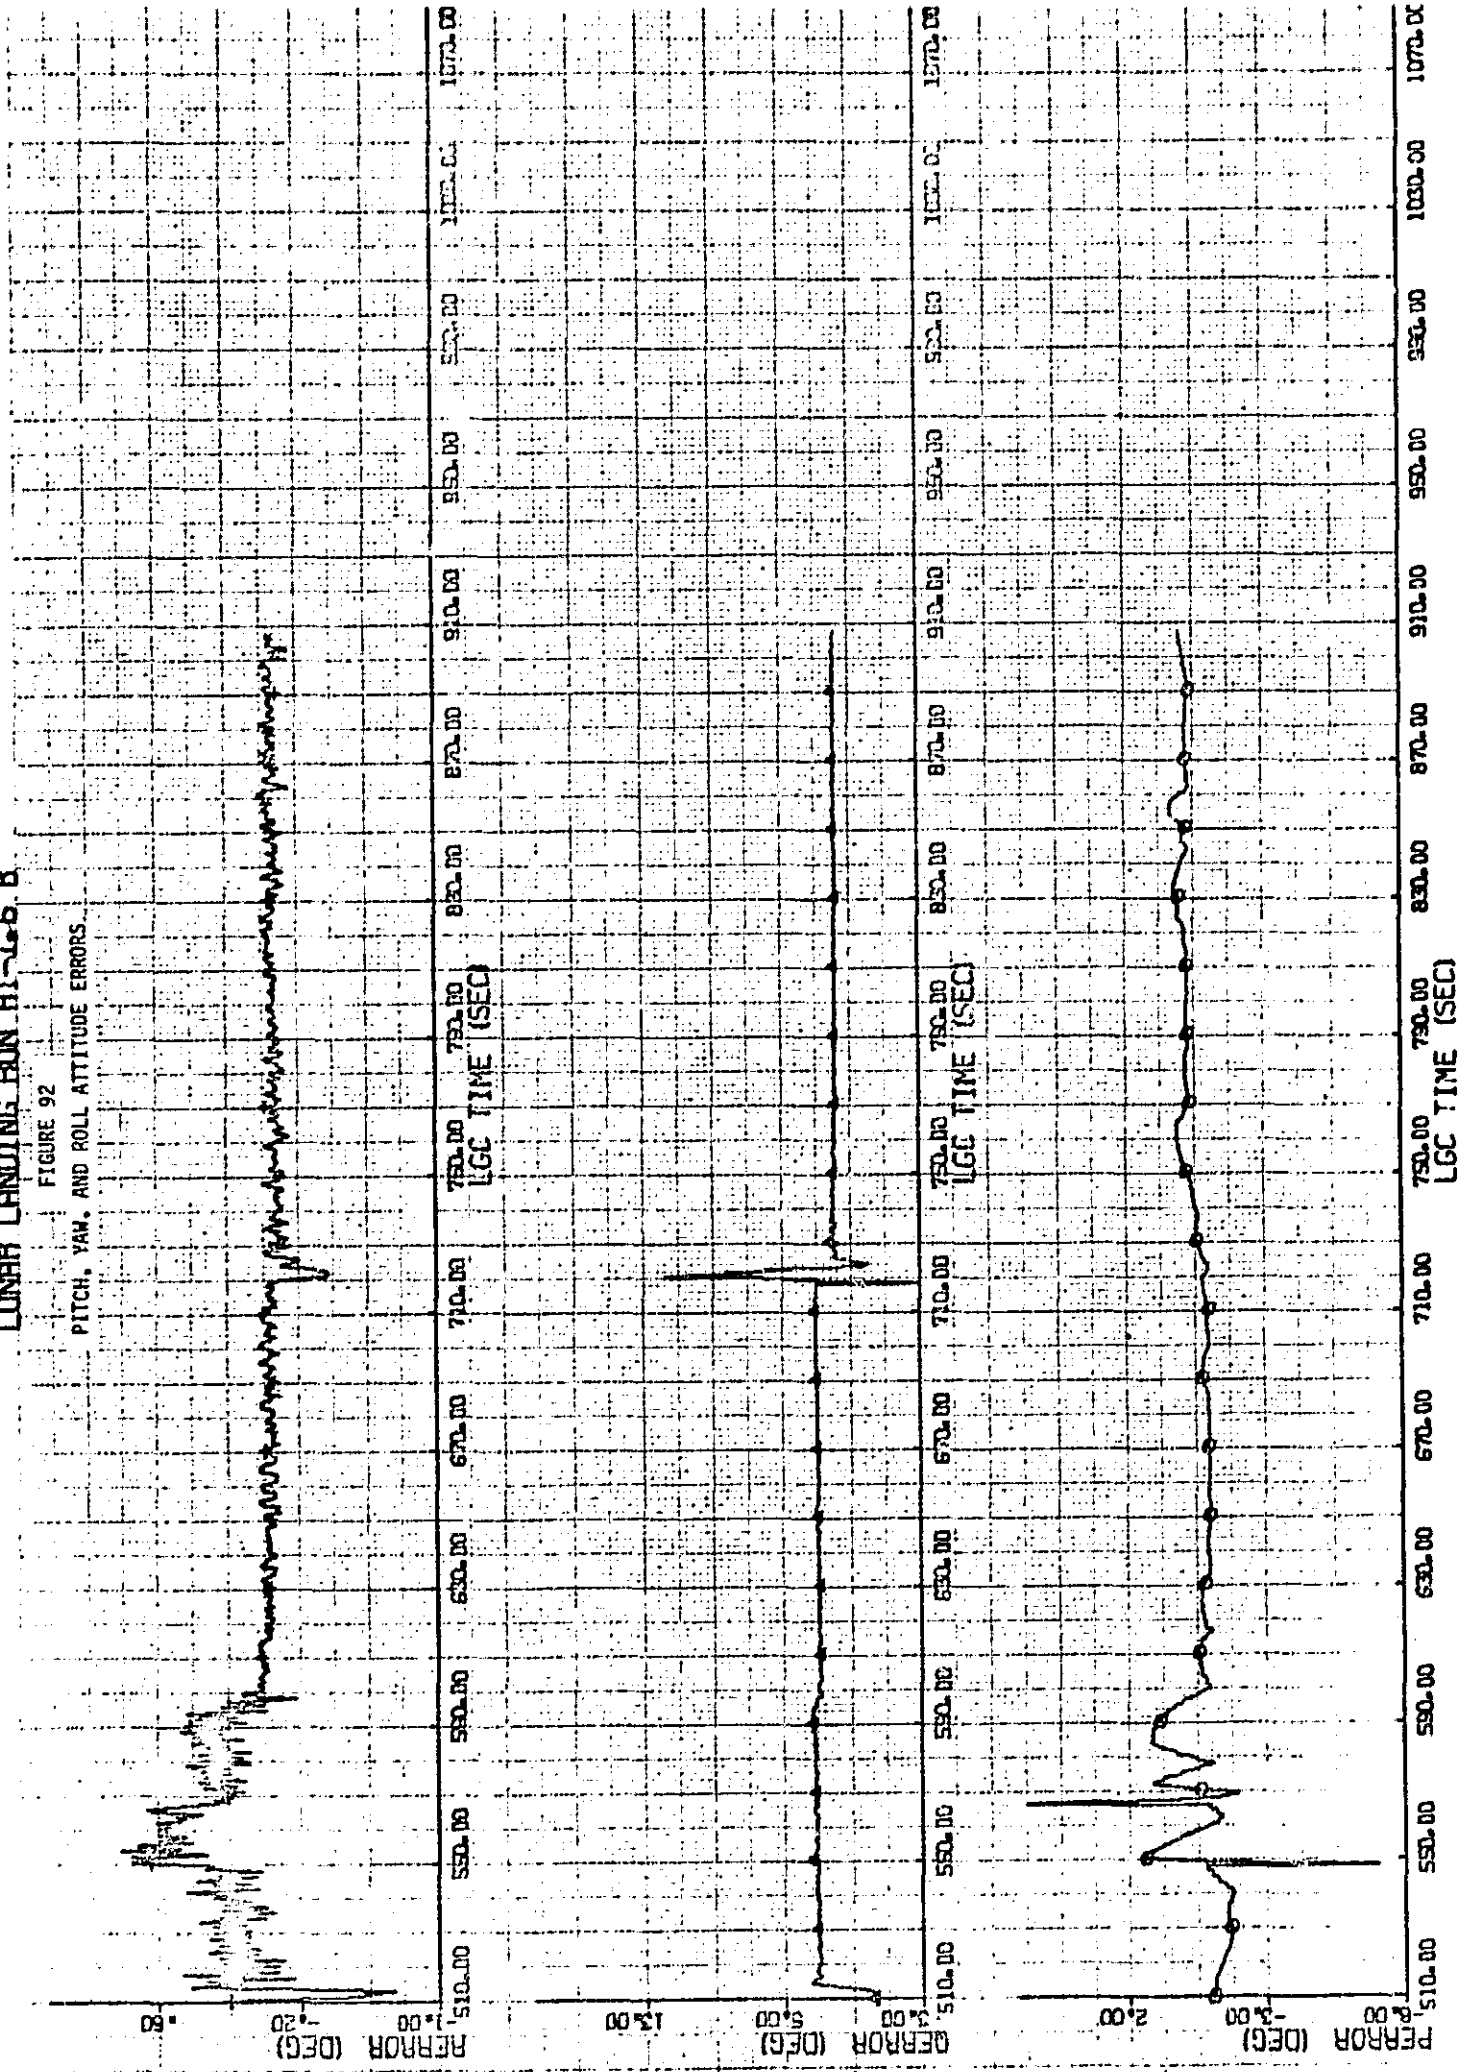
FIGURE 92
PITCH, YAW, AND ROLL ATTITUDE ERRORS

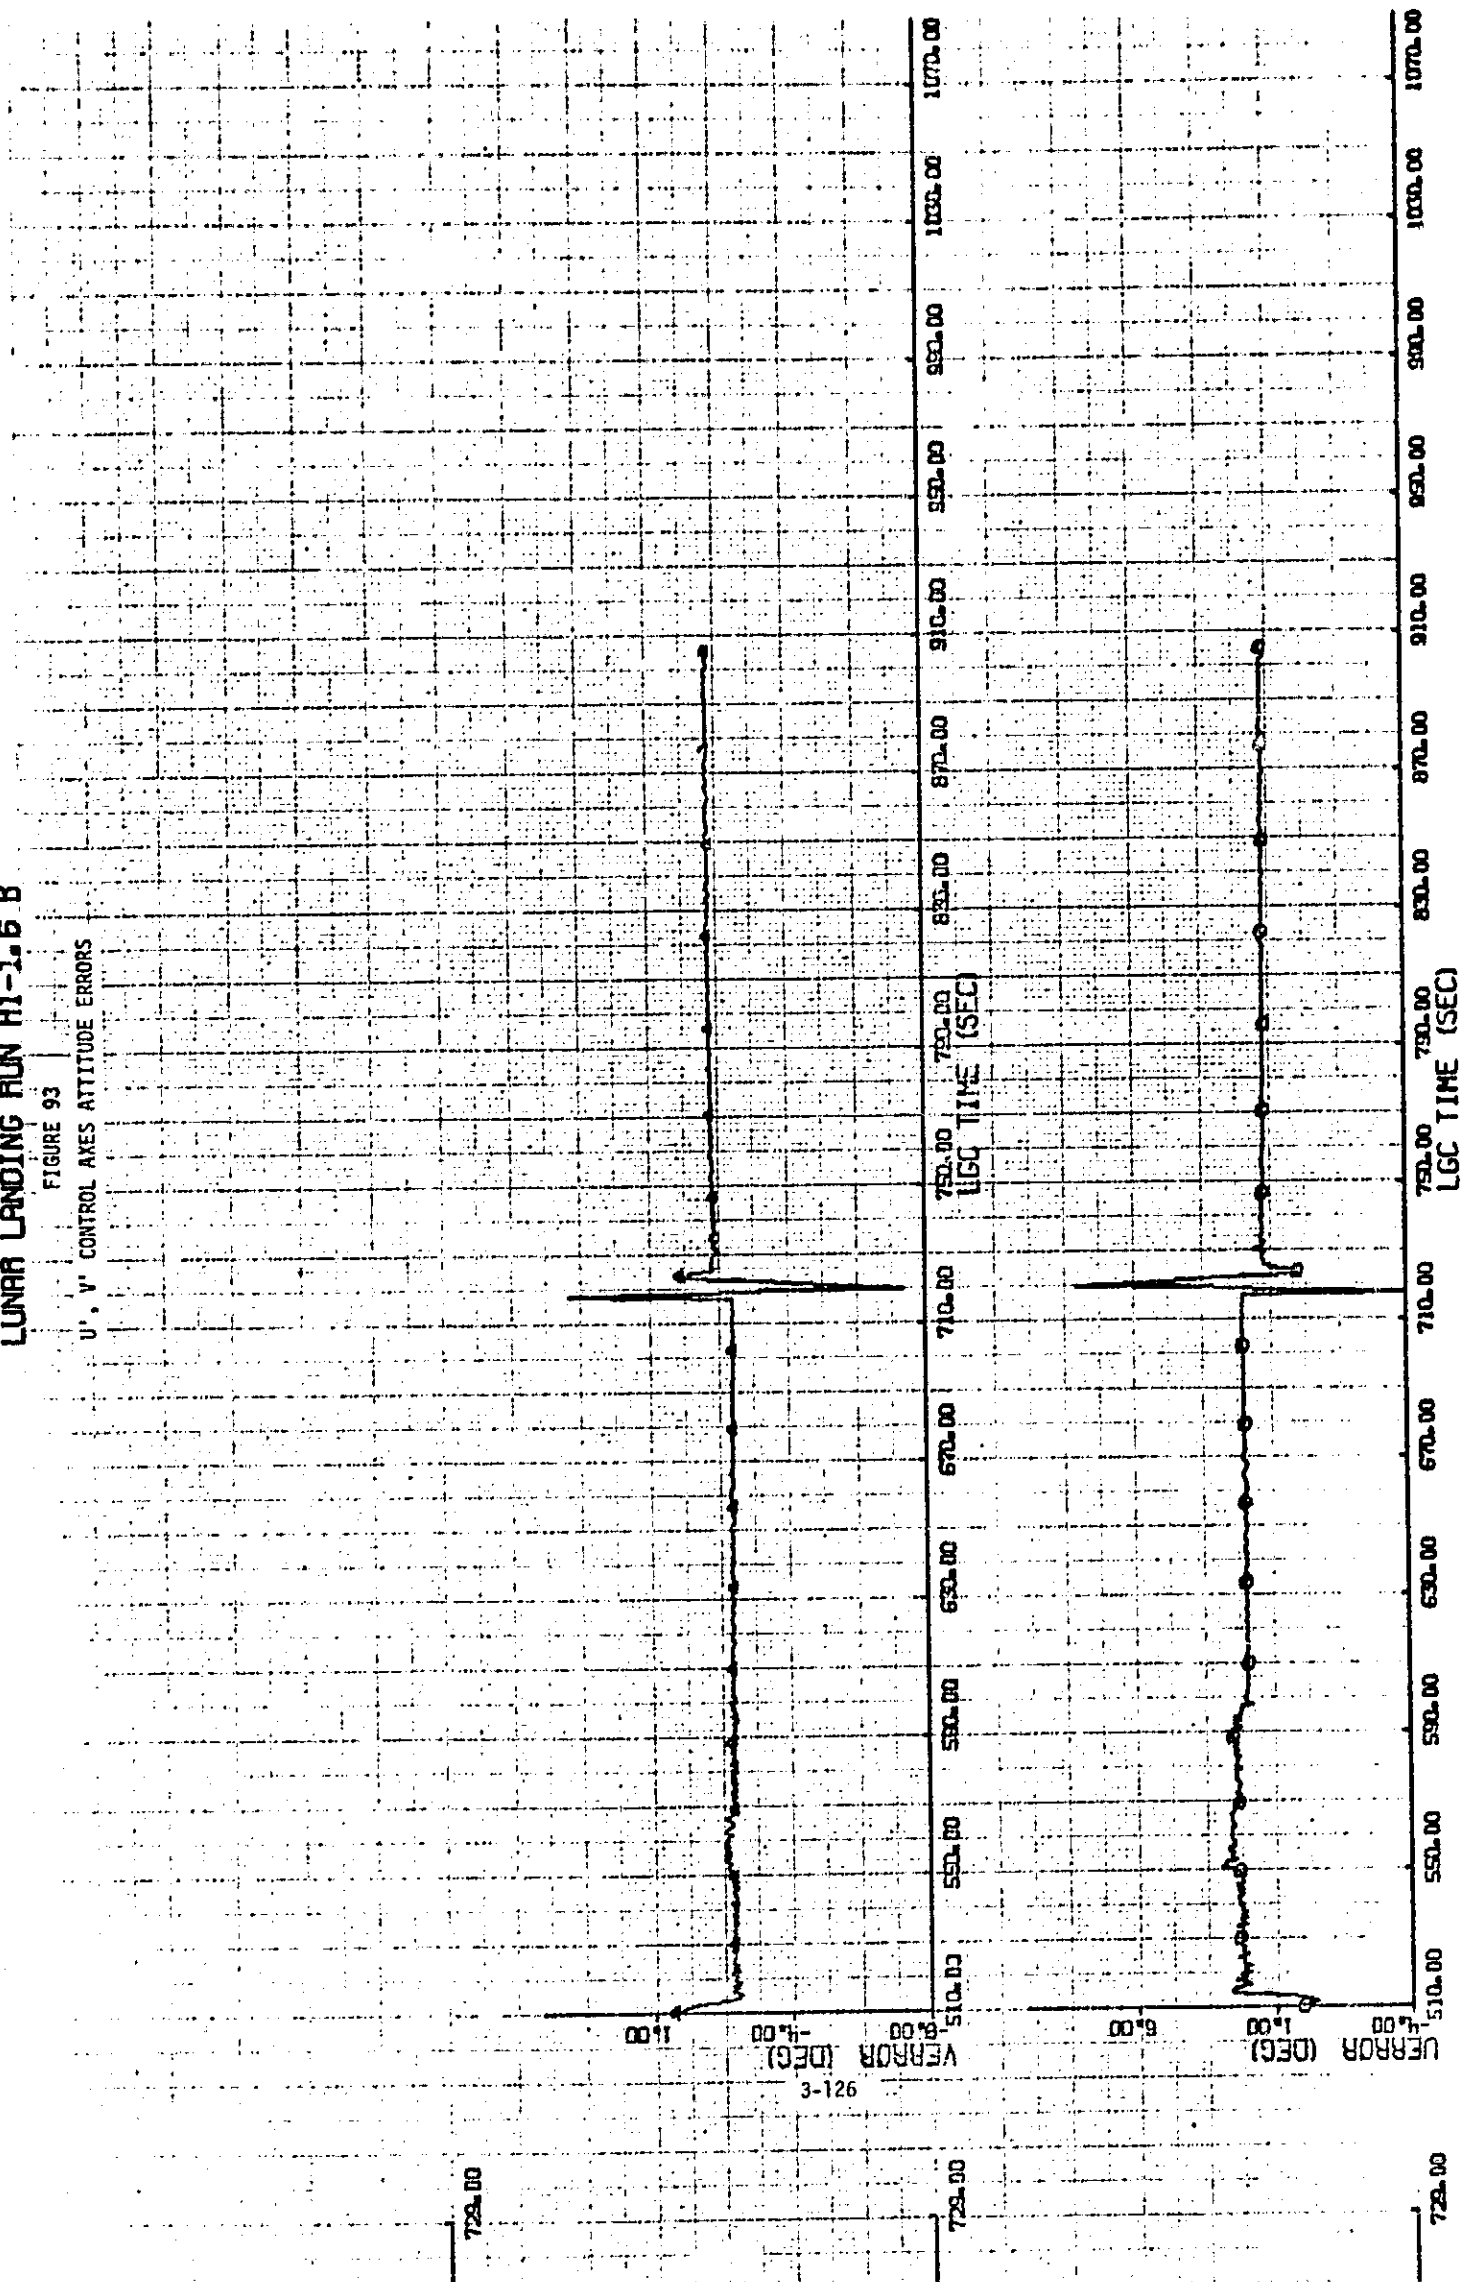
FIGURE 93

U, V CONTROL AXES ATTITUDE ERRORS

The spacecraft response for all three simulations was essentially of the same character. The three runs are discussed in a composite fashion here. Attitude errors as shown in Figures 84, 93, and 105 are biased around the deadbands. Phase planes presented in Figures 98 and 99 show the nature of the observed RCS limit cycle. The vehicle response seen here is essentially the same behavior seen in long ascent burns. At the end of long ascent burns discussed in References 2 and 5 the offset acceleration becomes small as the c.g. approaches and crosses the body axes. Under these conditions of small offset accelerations, the phase plane trajectories hang-up on the deadbands. This results in a small amplitude and unsymmetrical limit cycle. These same conditions are observed from the results obtained for the gimbal failure conditions. Even with 1 degree mistrims at the time of gimbal failure, offset accelerations are sufficiently small to produce the small amplitude and attitude-error-biased limit cycle. The spacecraft response from an overall view was extremely smooth, and fuel slosh dynamics, while present (Refer to Figures 94, 95, and 96), are significantly reduced in amplitude in comparison with results obtained in the nominal descent case. (See Section 3.1). Estimated body rates, for example as shown in Figures 86, 95, and 107, include a small steady-state error. This steady-state rate error results from the state estimators prediction of the effect of DPS gimbal activity which never occurs. (The GTS control law continues to function after the gimbal failures). The effect of the steady state rate error should be small in that it simply displaces the limit cycle above or below the attitude error axis on the phase plane. As the powered descent continues, the small RCS limit cycle centers around +1.8 degrees (deadband + FLAT). After P64 is reached, the limit cycle settles around +1.1 degrees (0.3 degree deadband + FLAT).

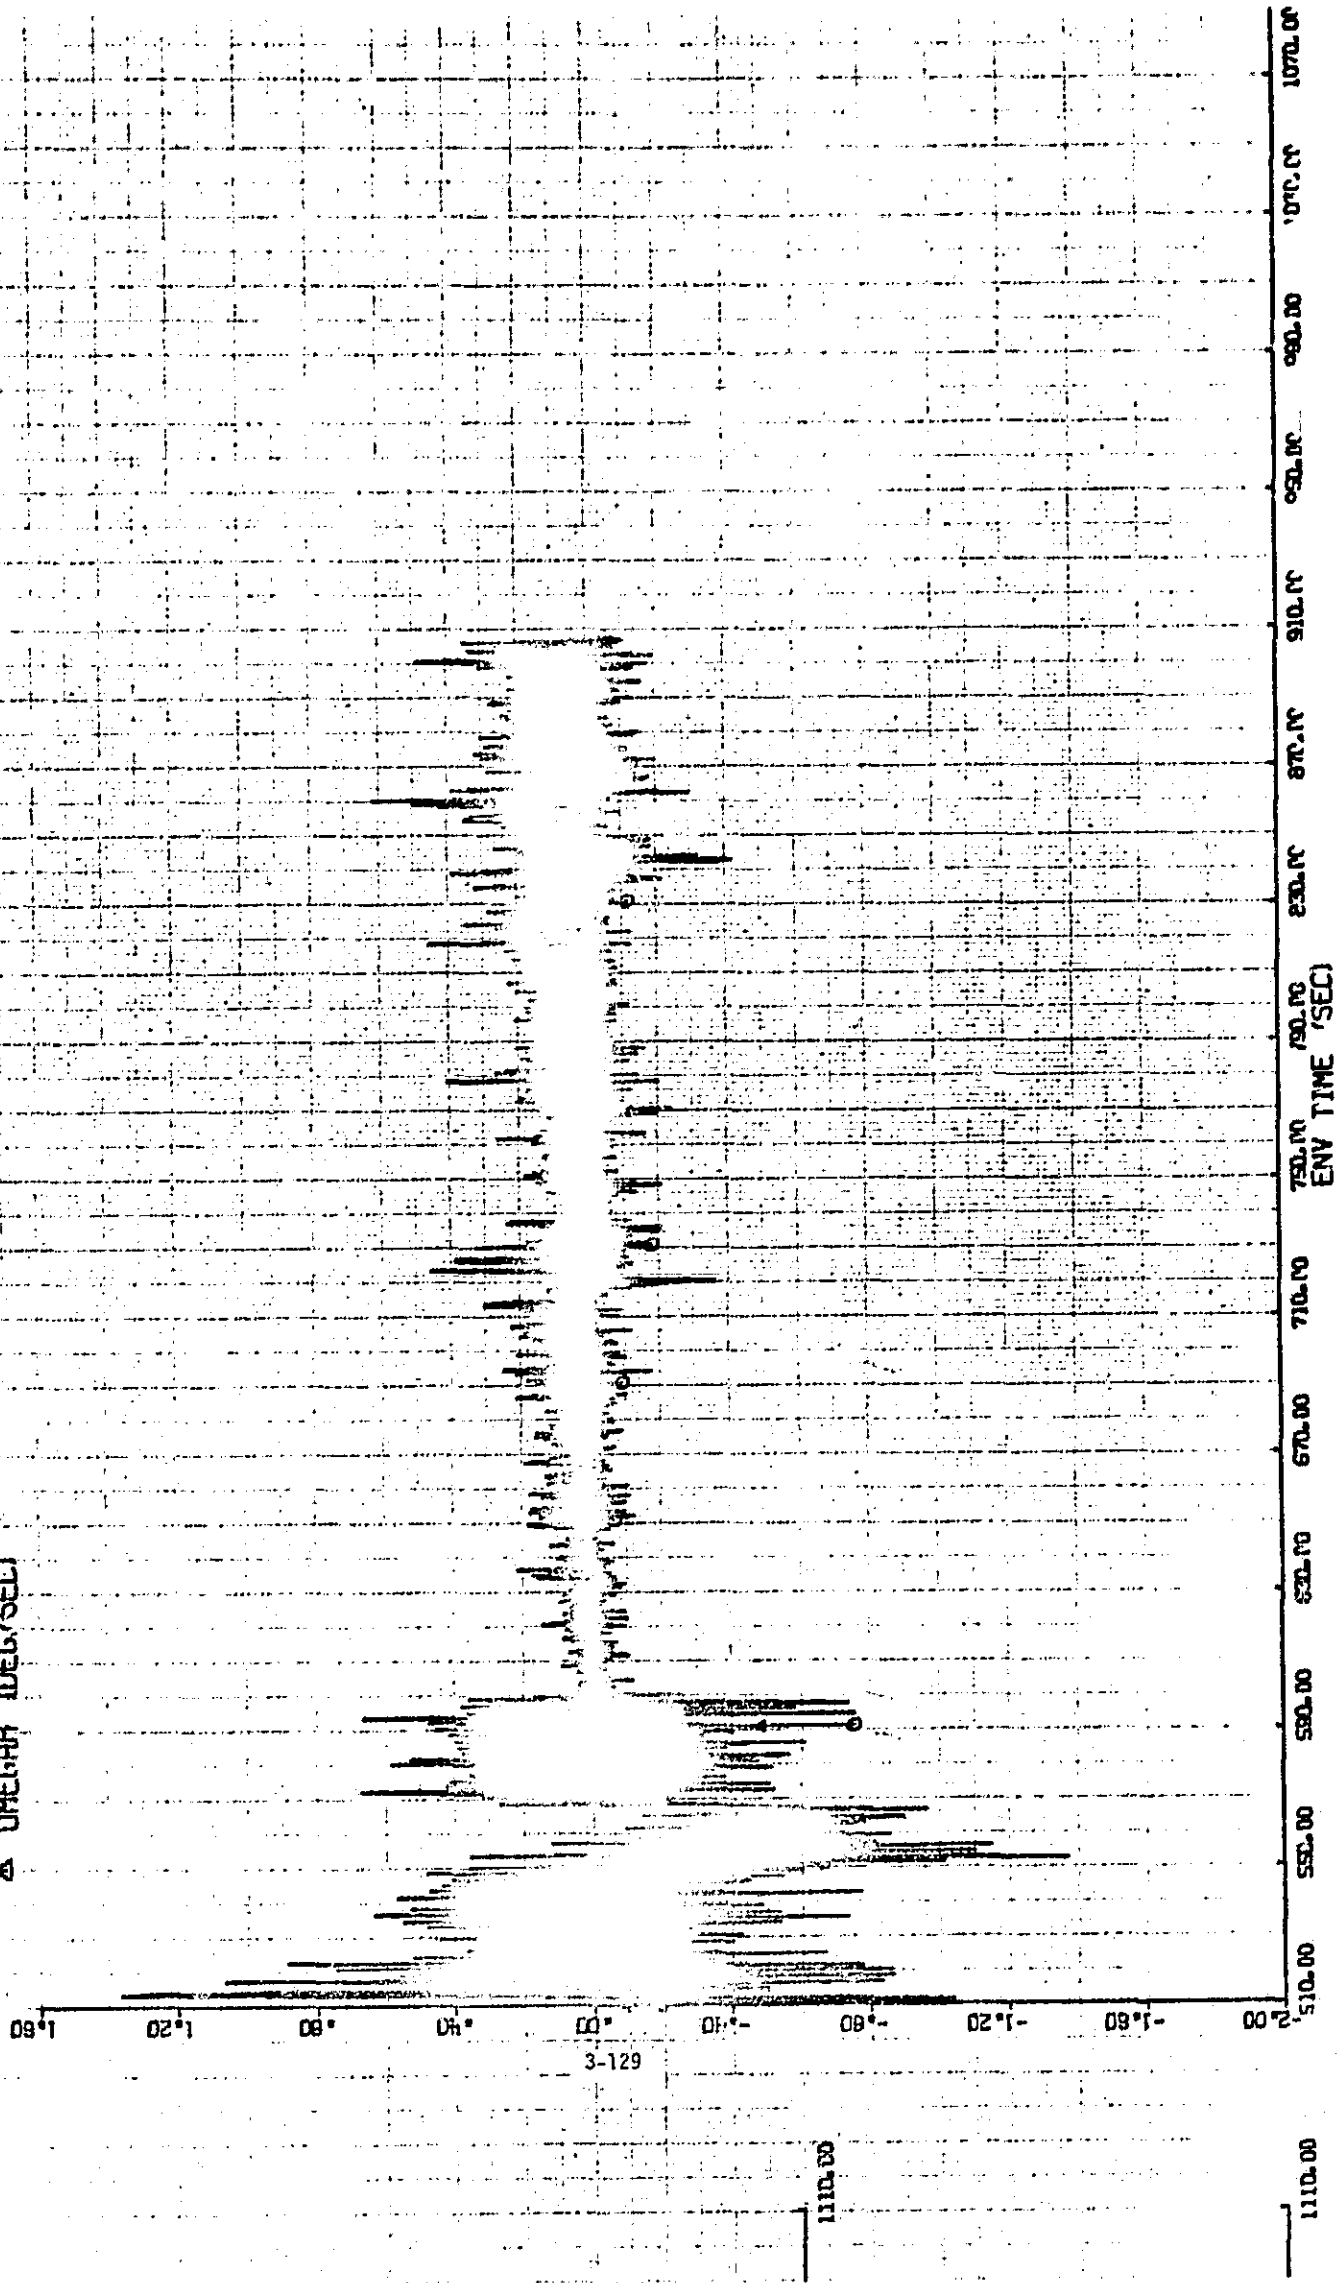
ROLL BODY RATES: ACTUAL AND ESTIMATED

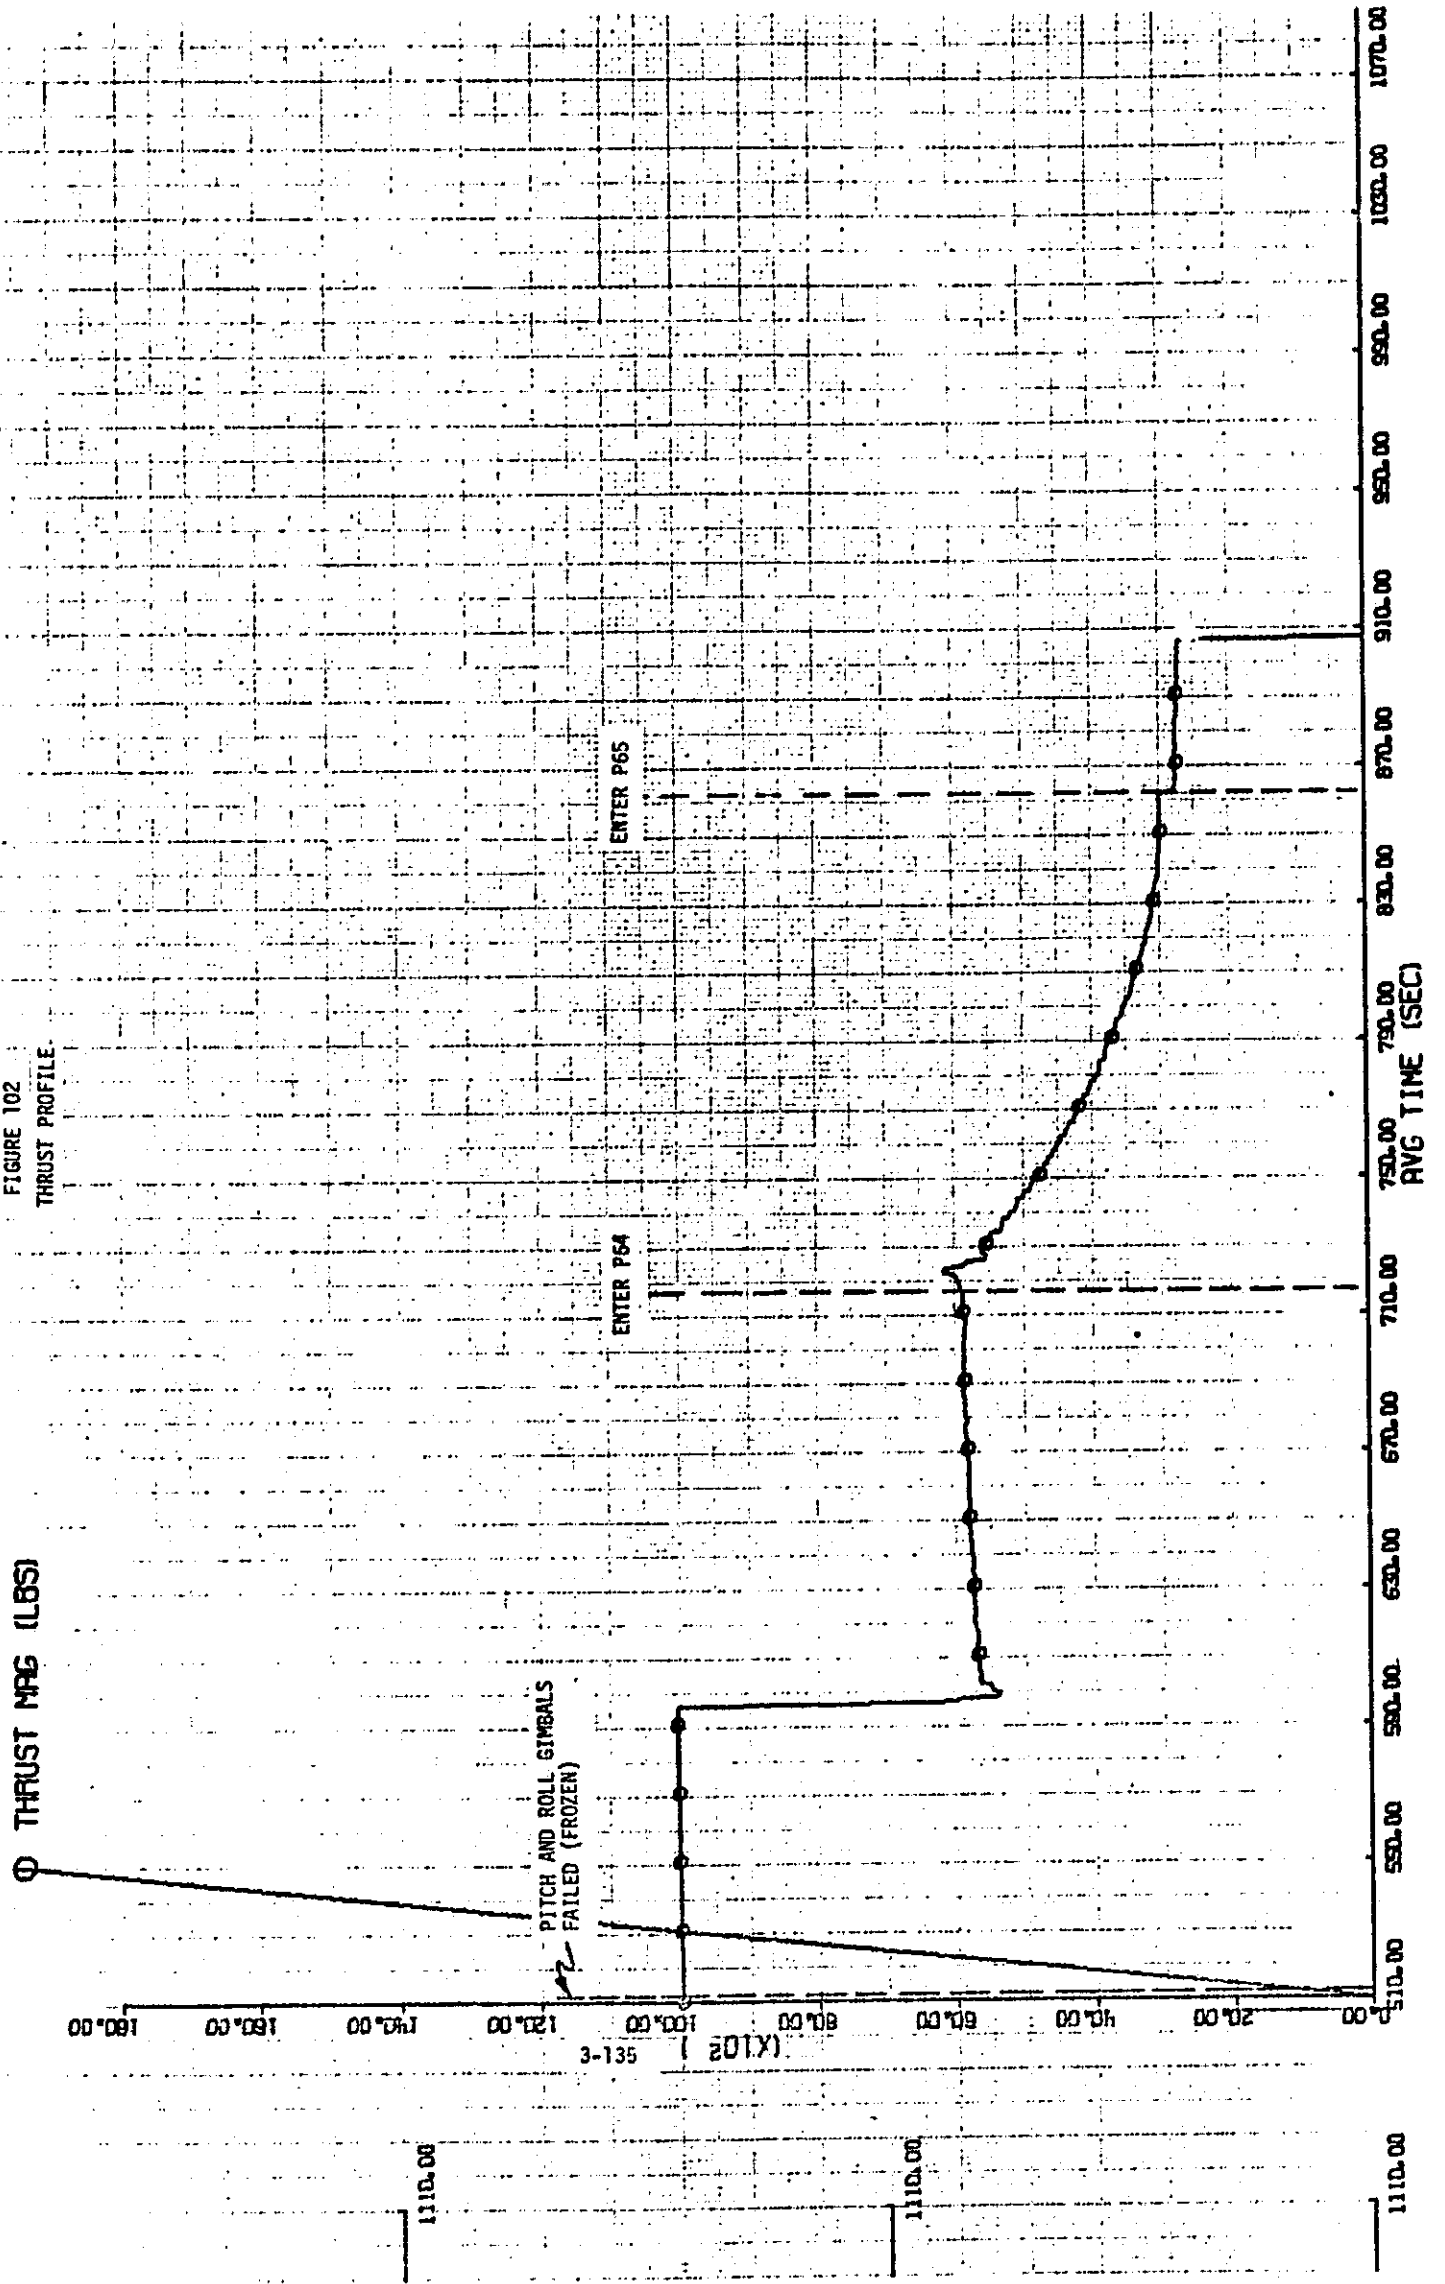
FIGURE 102
THRUST PROFILE

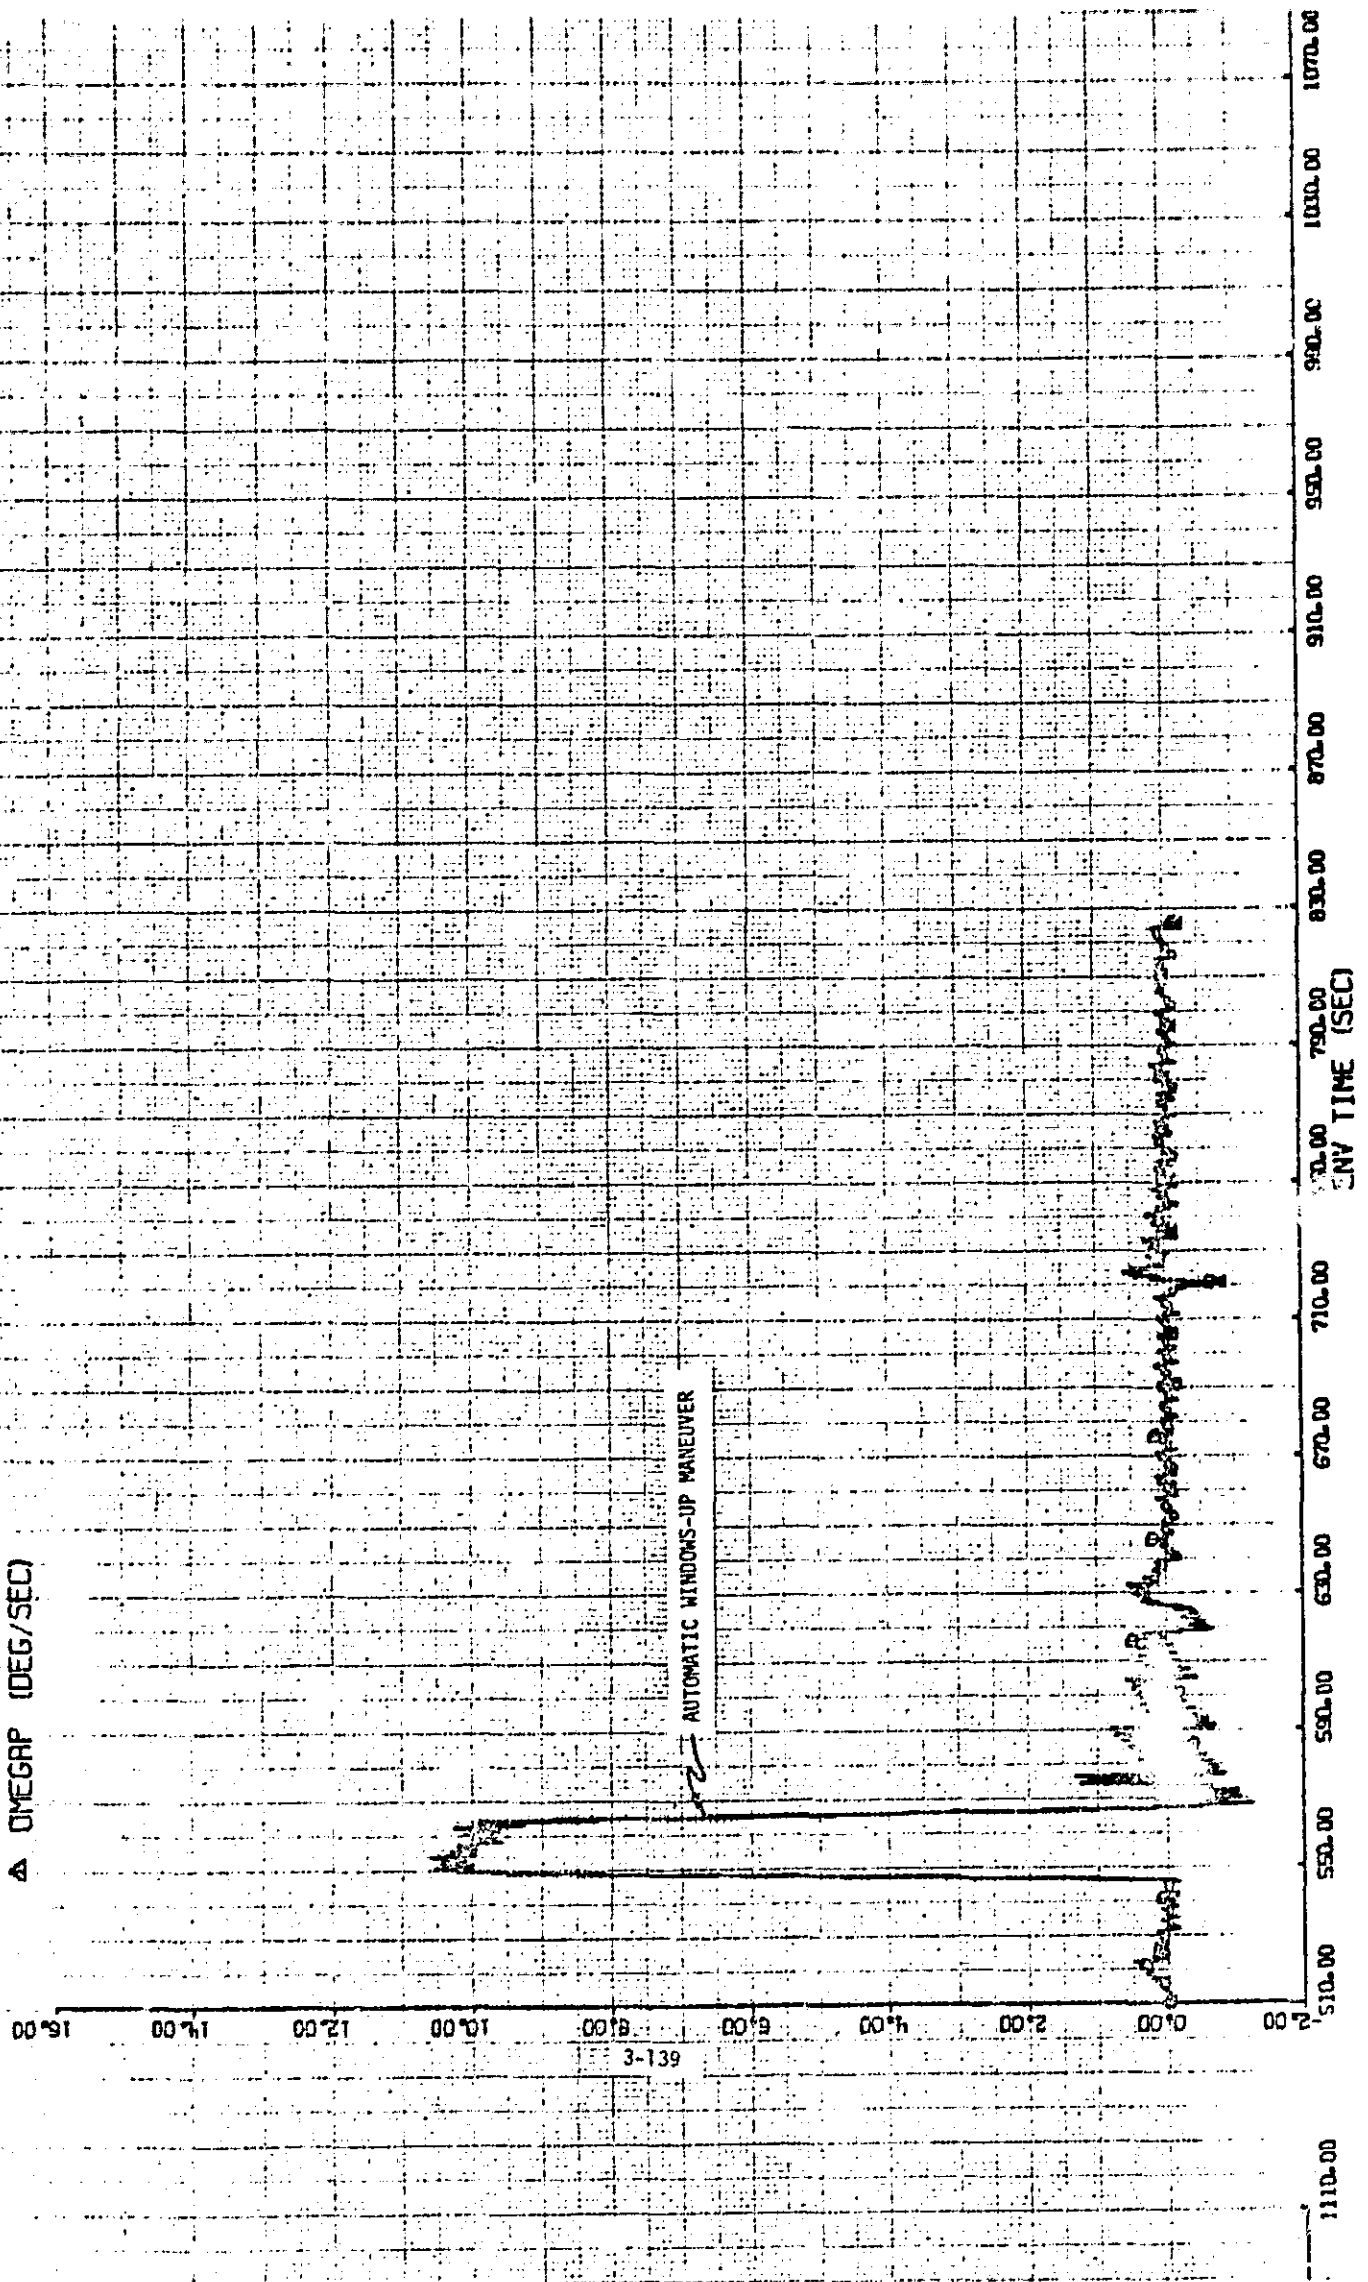
FIGURE 106
YAW BODY RATES: ACTUAL AND ESTIMATED

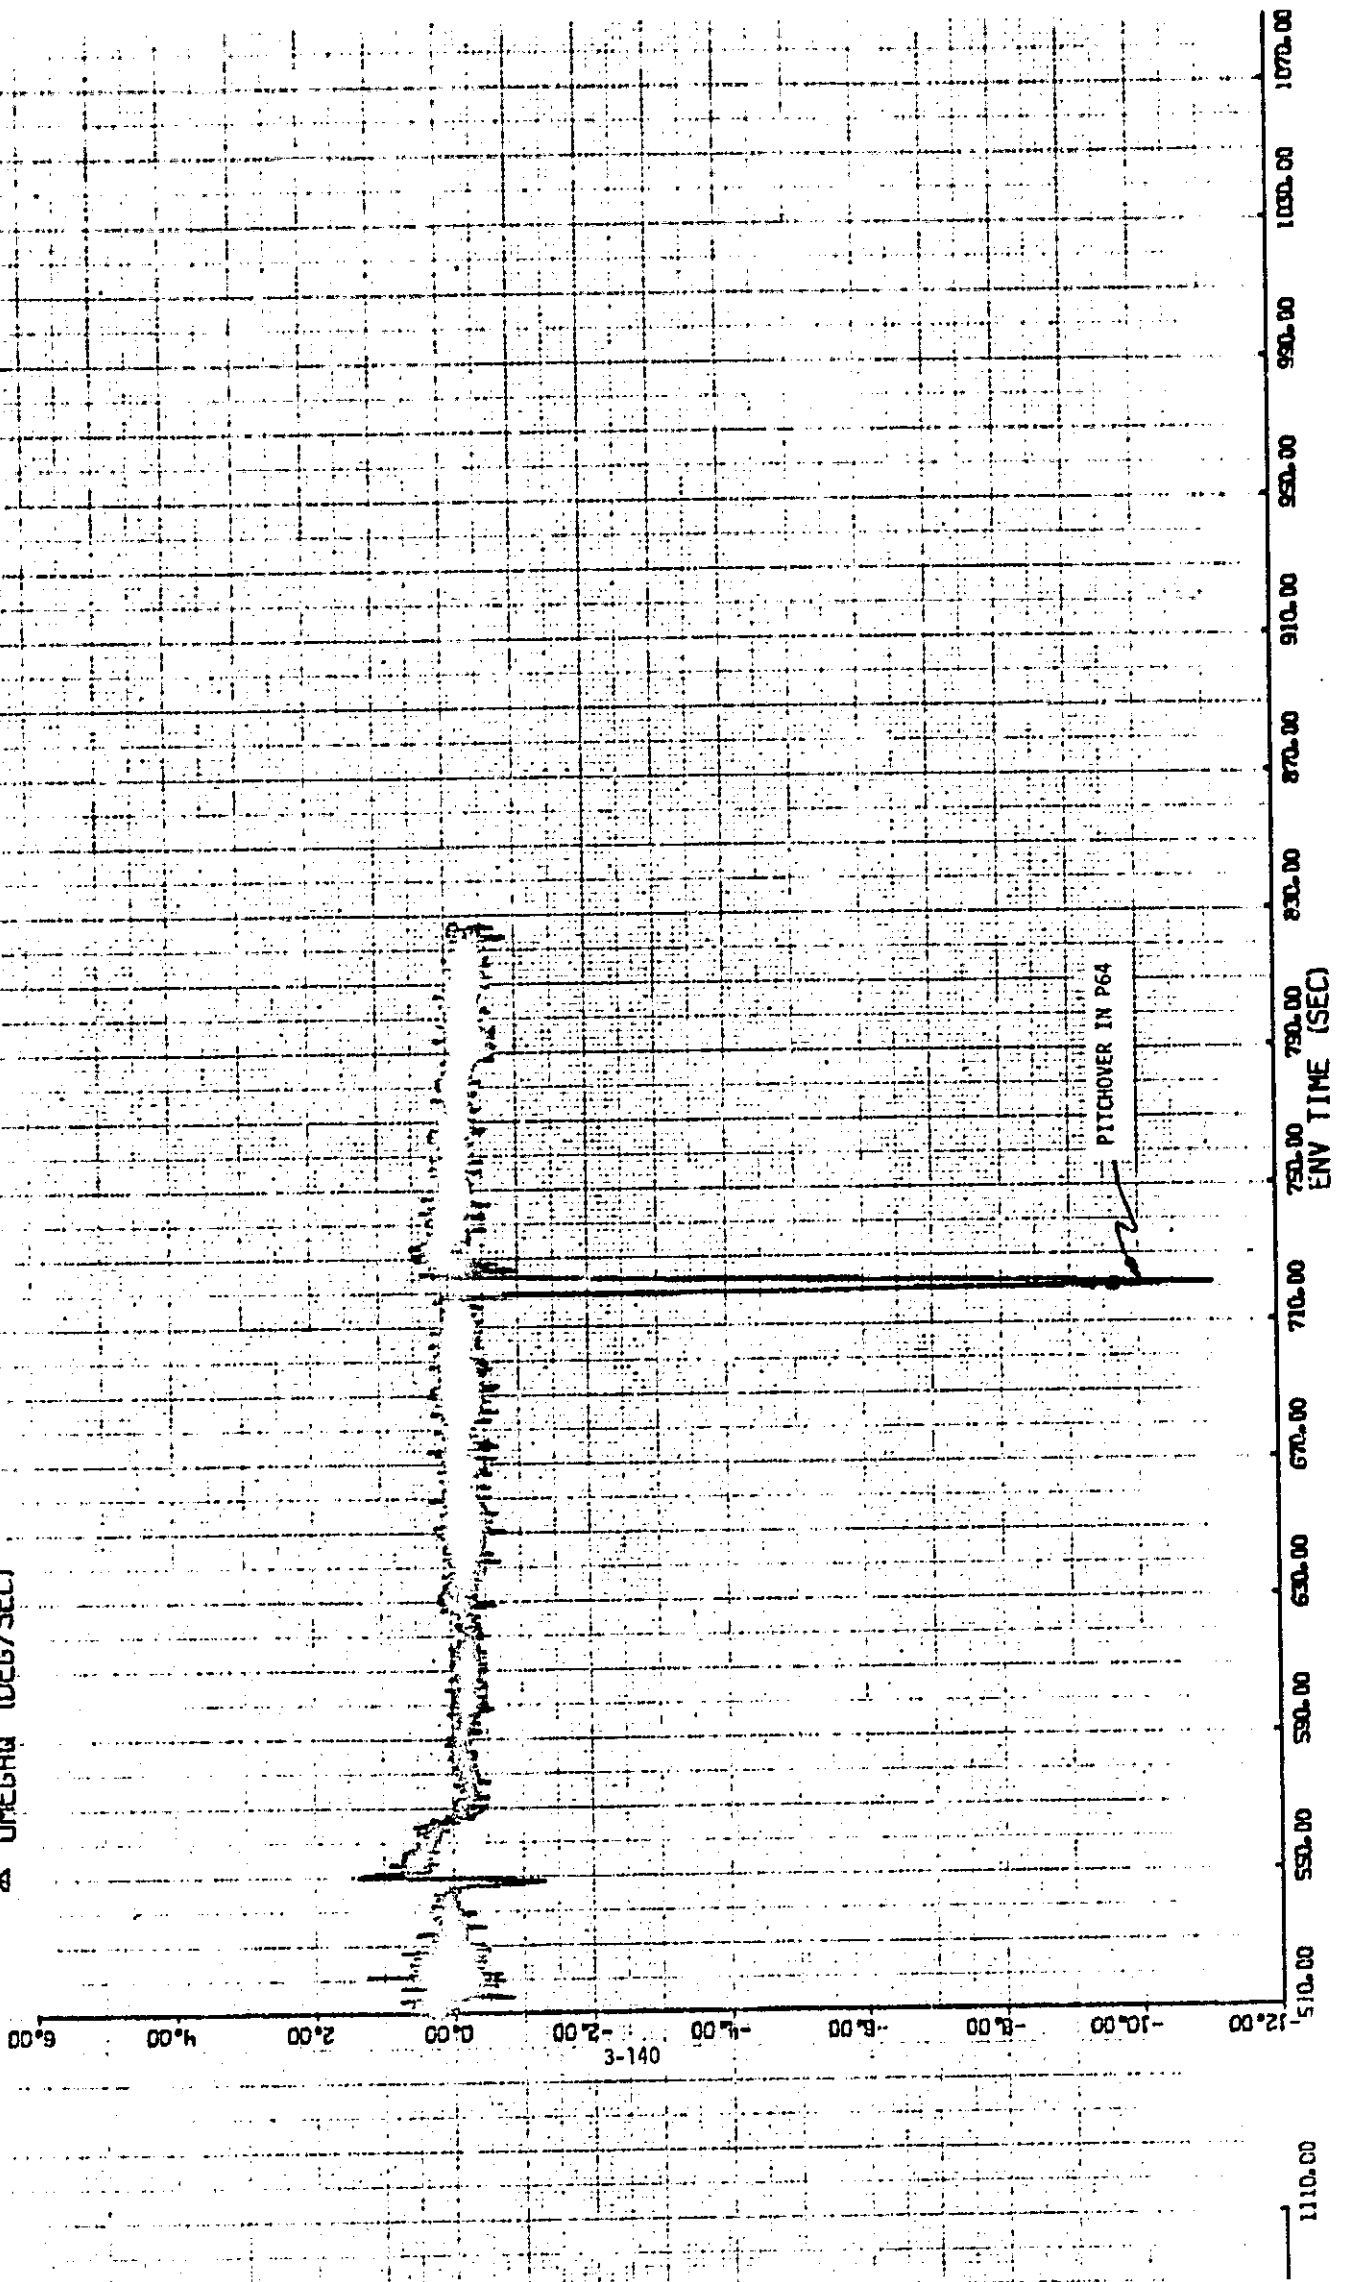
FIGURE 107
PITCH BODY RATES: ACTUAL AND ESTIMATED
