PROJECT TECHNICAL REPORT
TASK E-72B

LUMINARY 1B DAP PREFLIGHT PERFORMANCE
EVALUATION

NAS 9-8166

13 November 1969

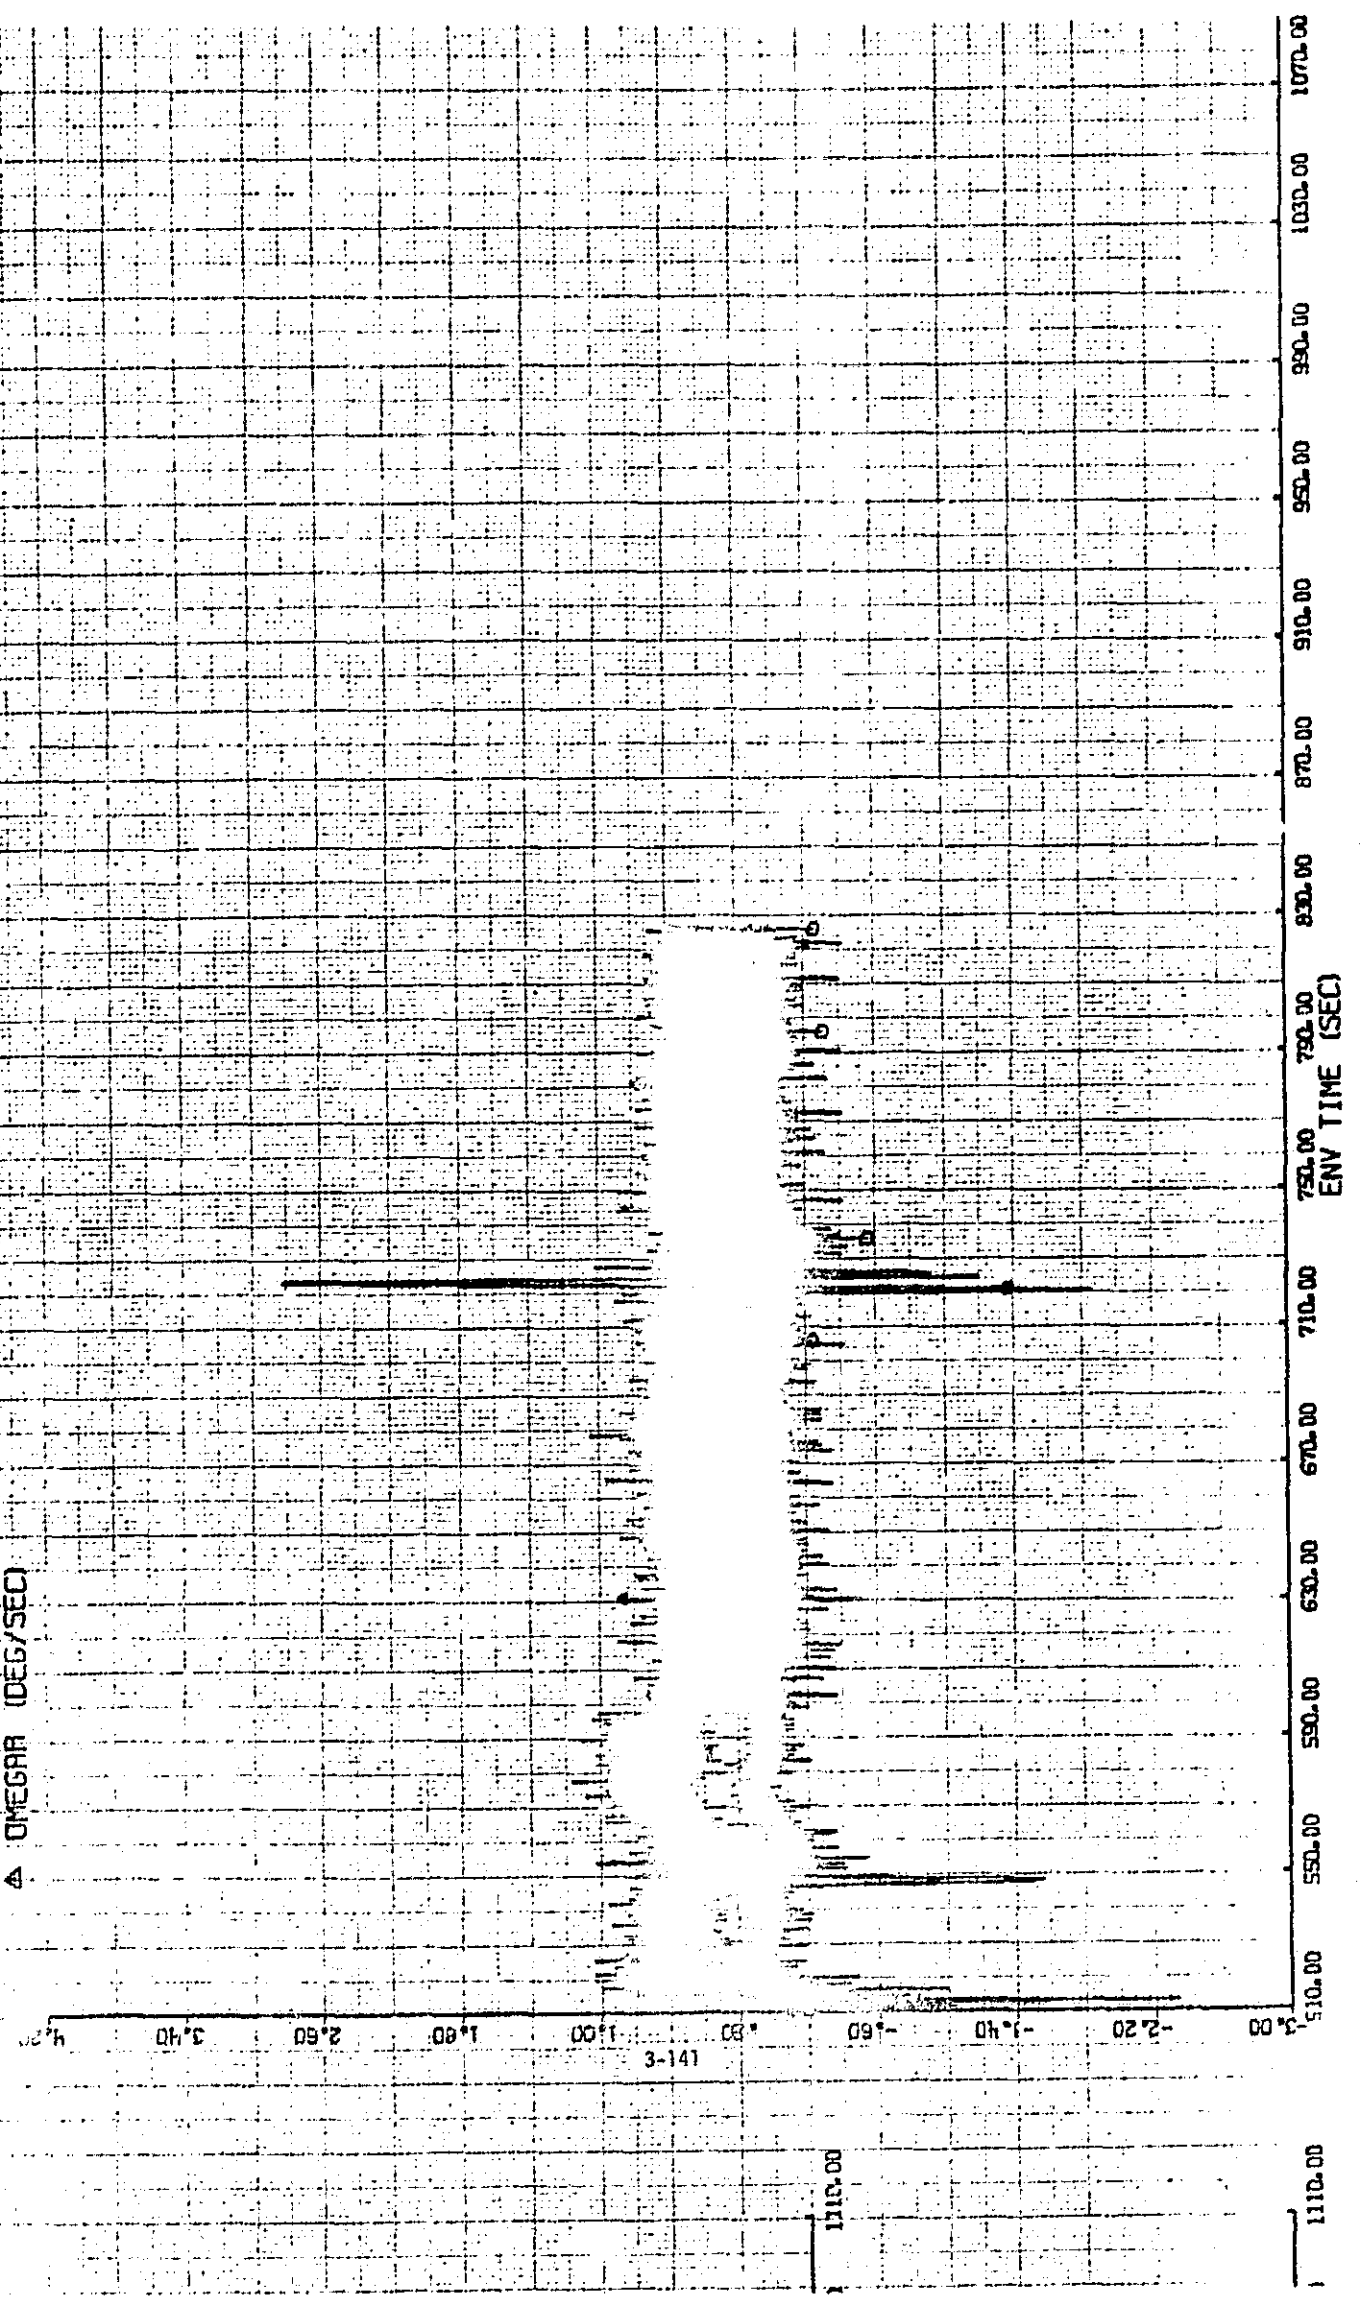
FIGURE 108
ROLL BODY RATES: ACTUAL AND ESTIMATED

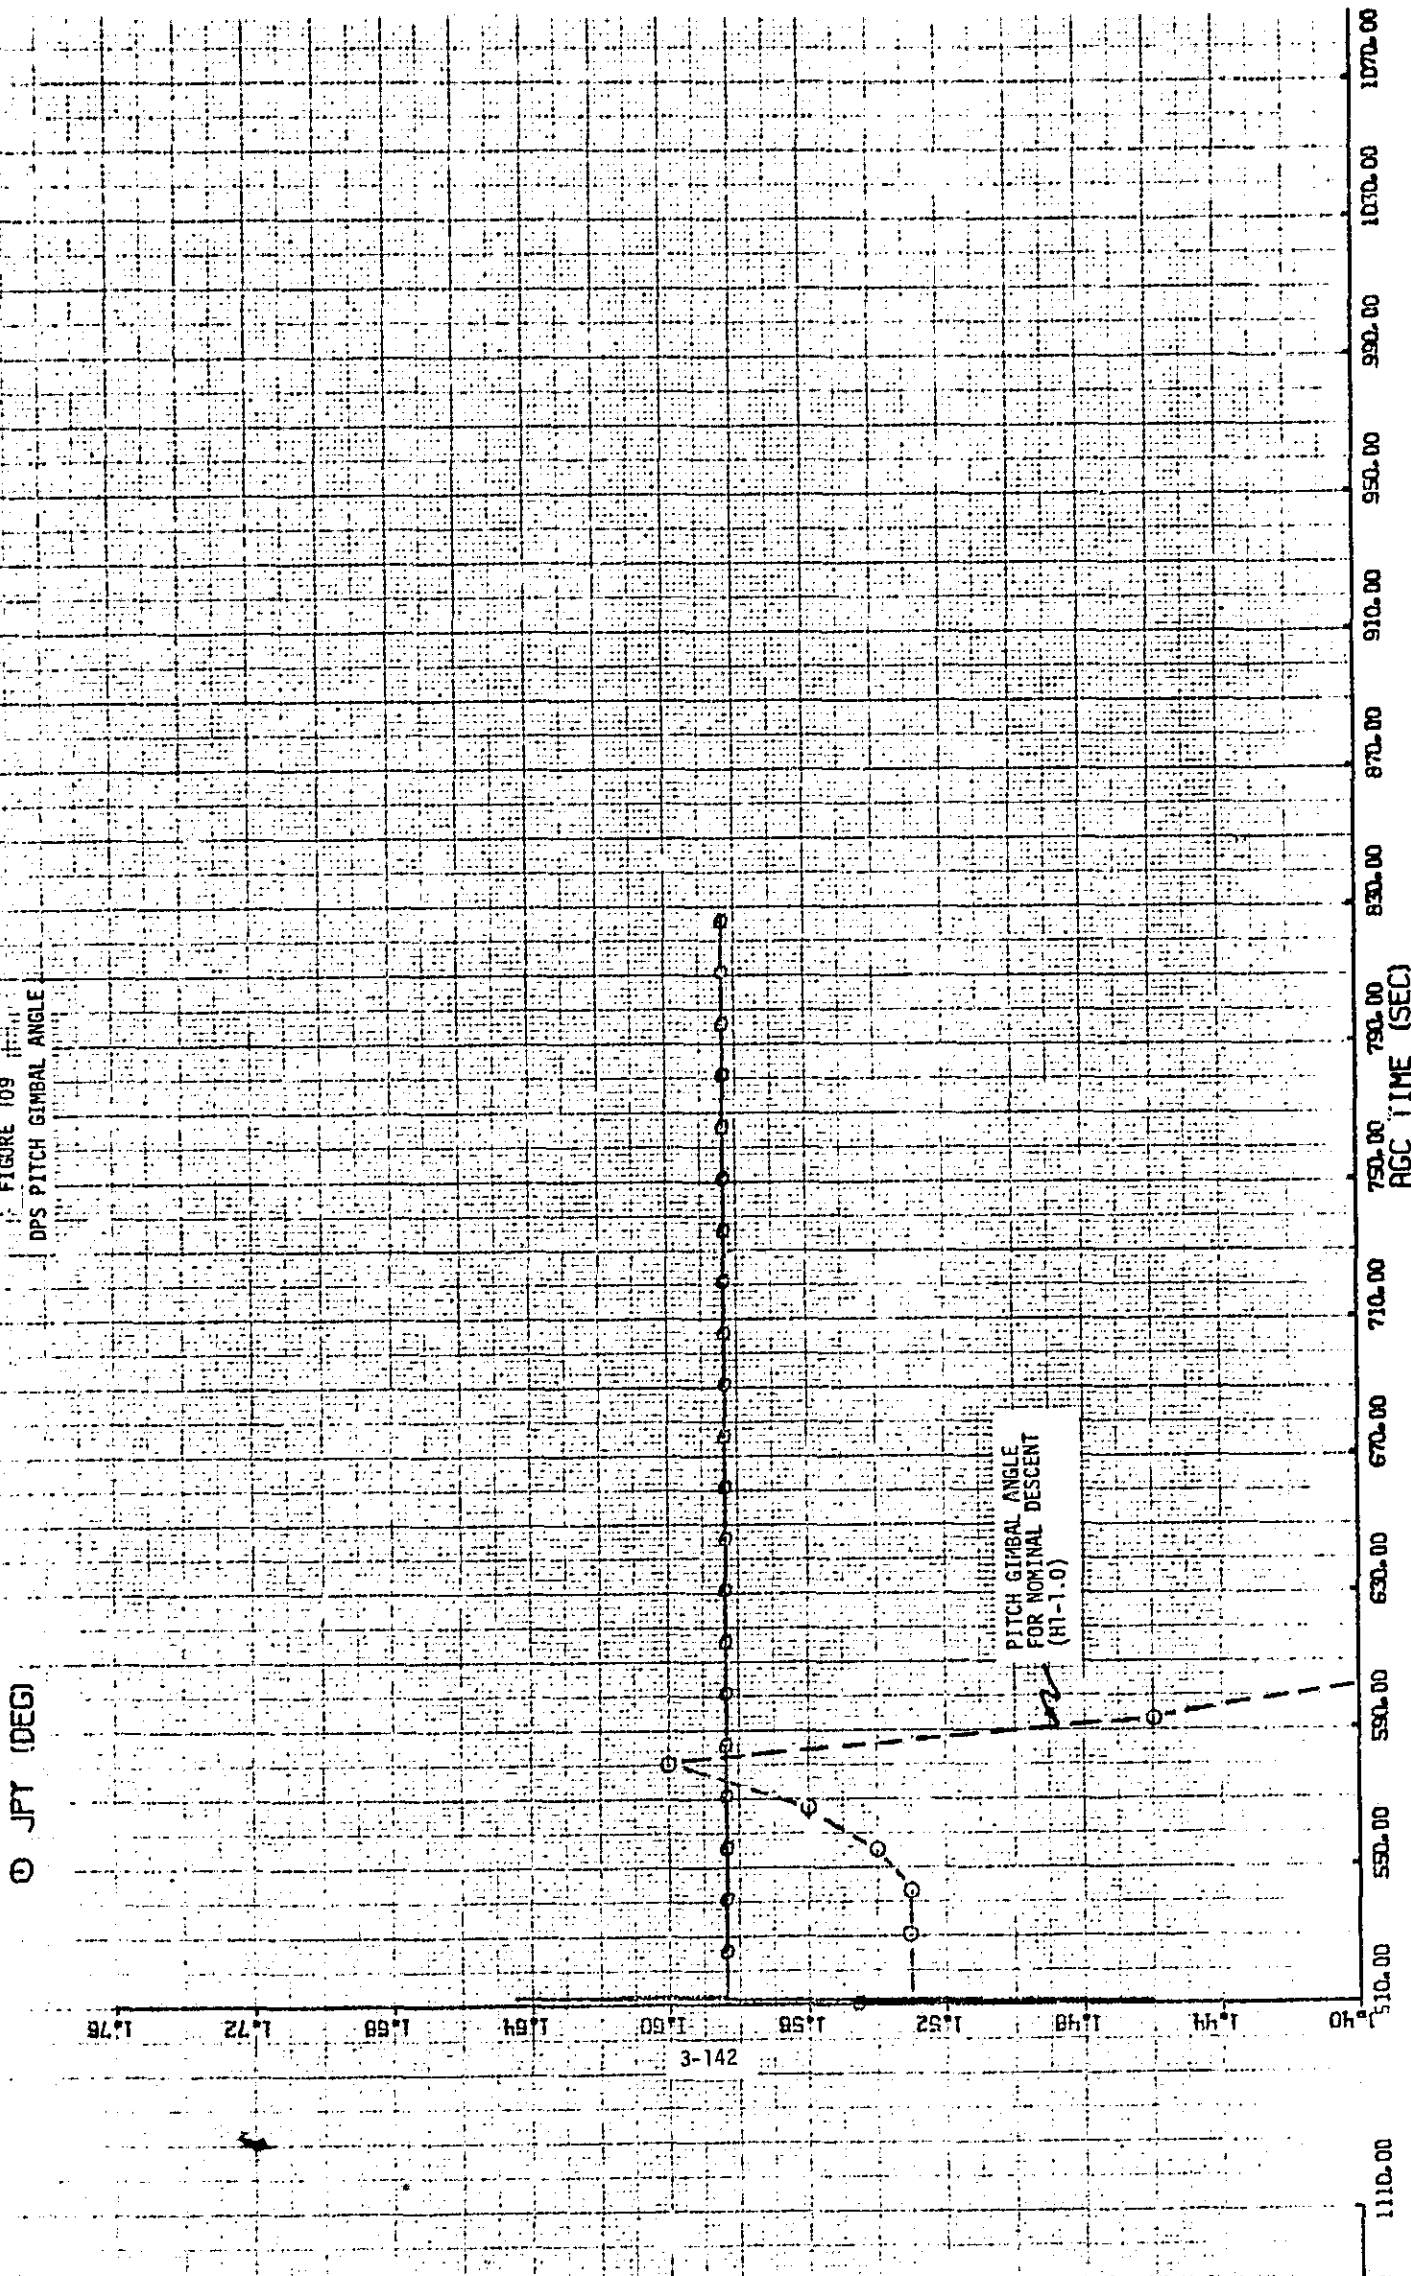
FIGURE 109
DPS PITCH GIMBAL ANGLE

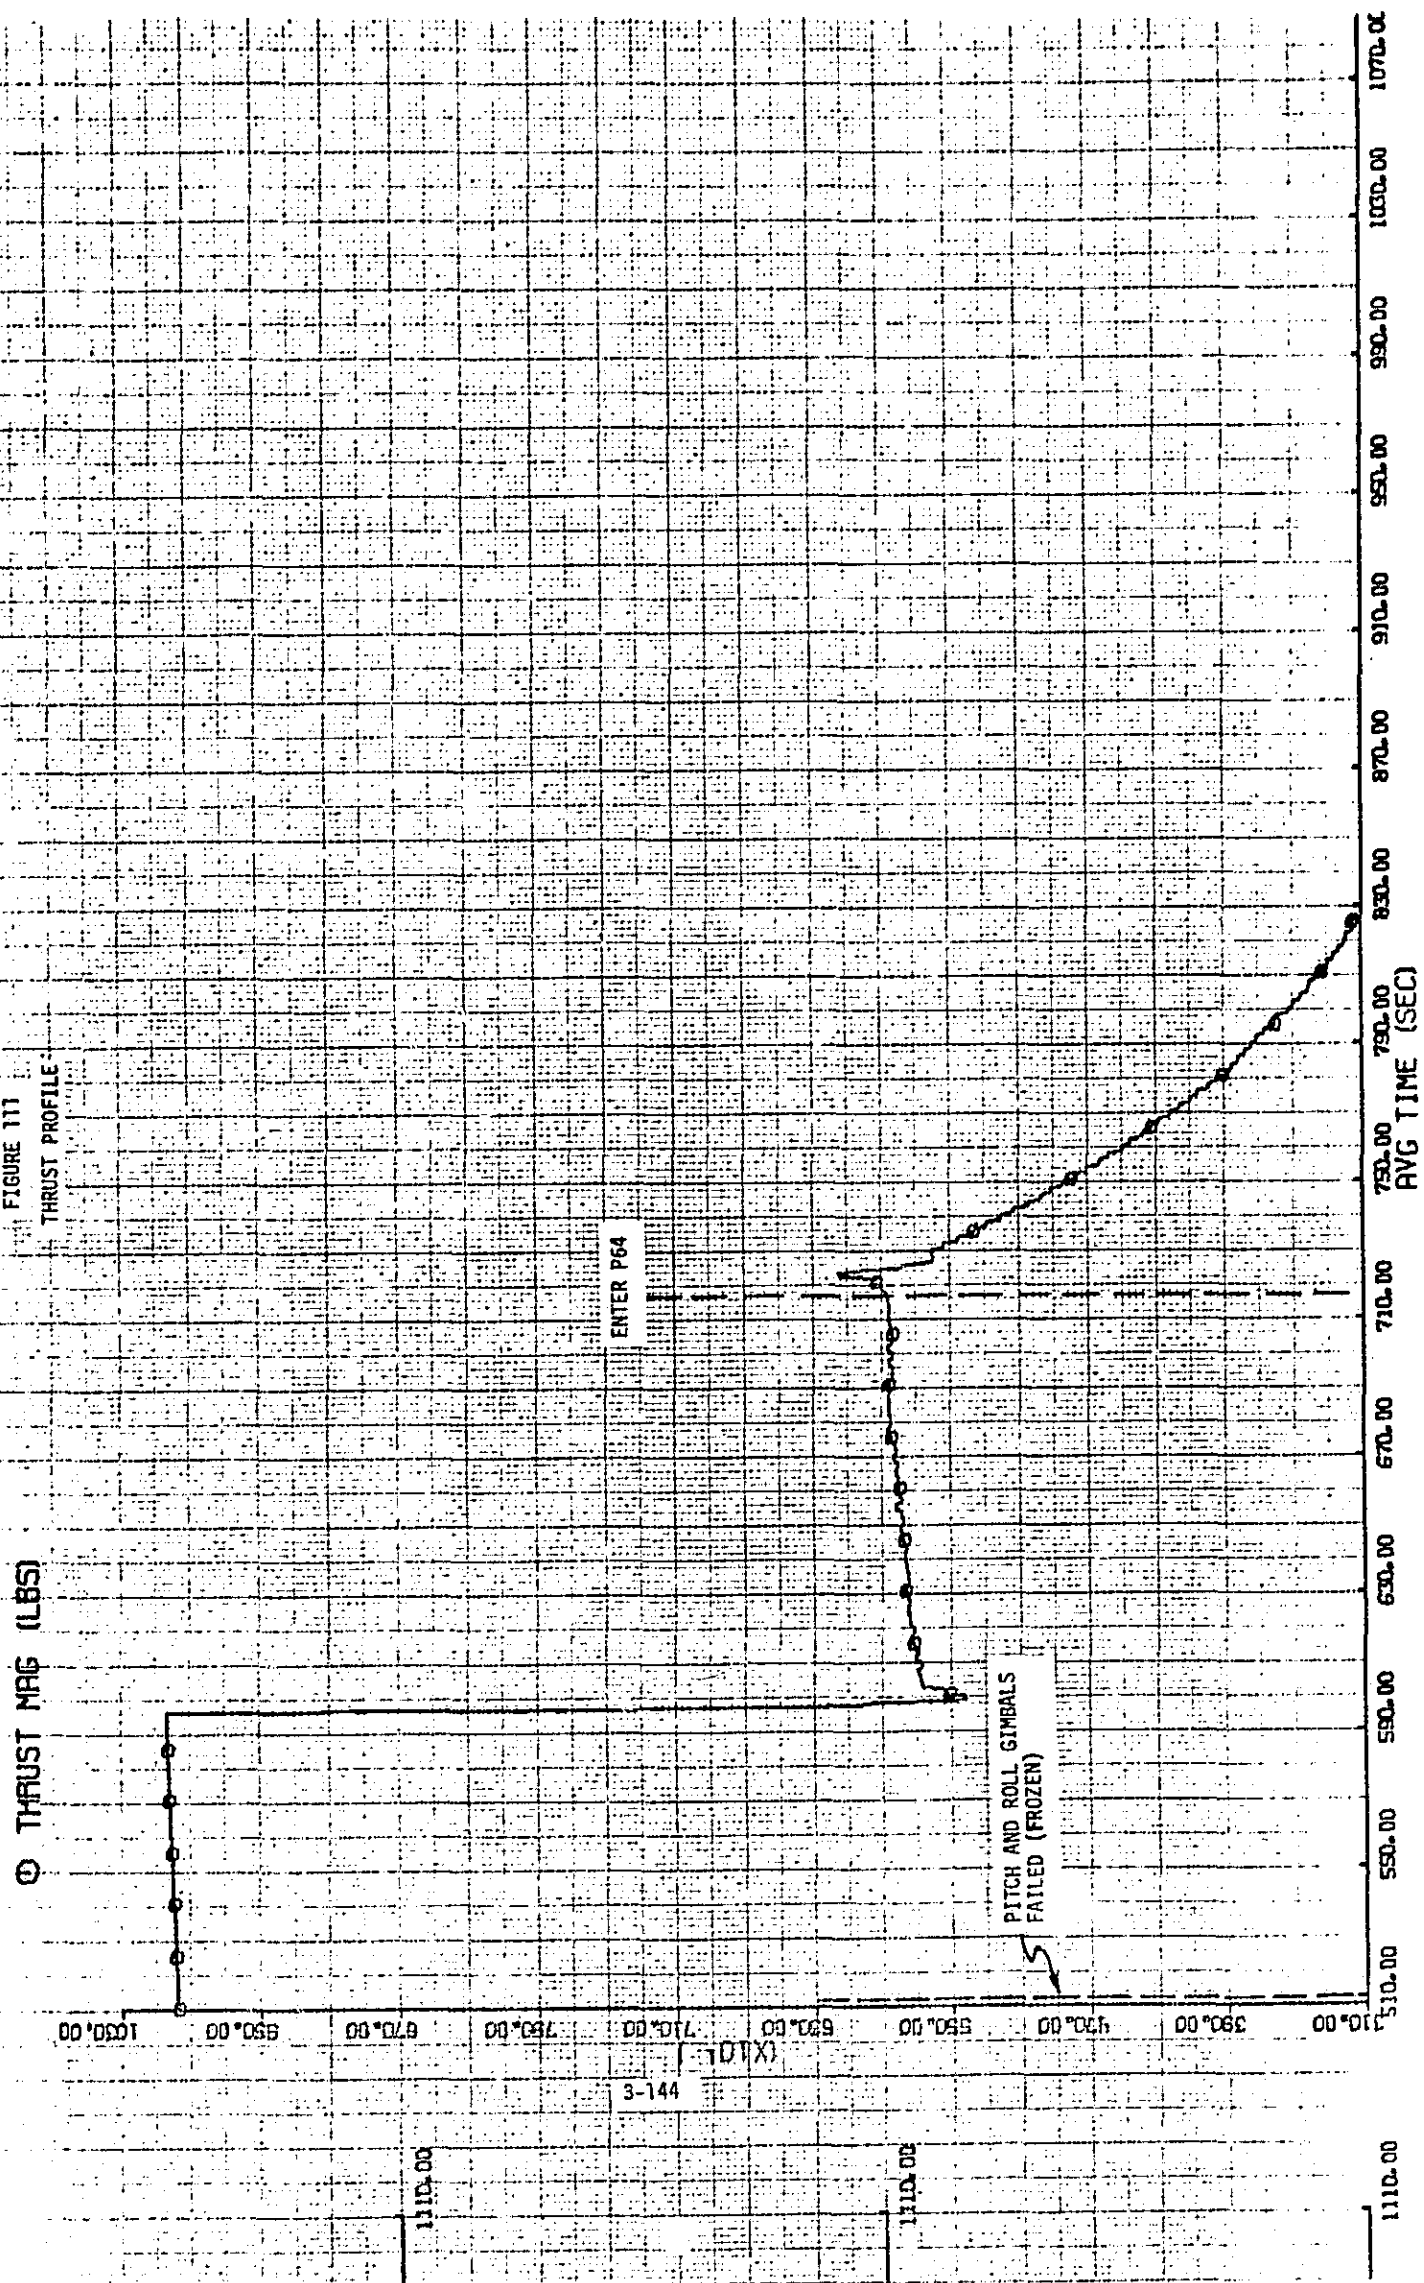
FIGURE 111
THRUST PROFILE

PITCH AND ROLL GIMBALS
FAILED (FROZEN)

The DPS gimbals were frozen at TIME = 512.0 seconds which is approximately 300 seconds after ignition. Disturbances due to thrust vector misalignments, at the time of gimbal failure, would hopefully be small enough to remain within the realm of RCS control effectiveness. Under these conditions the LM DAP would be expected to perform in a fashion similar to control during ascent burns. RCS limit cycling resulting from the constant body torques generated from thrust vector misalignments should be observed.
