IPL Source Switch IFM Bypass

OBJECTIVE: Regain failed MMU1 (2) IPL Source switch function on panel O6.

LOCATION: AV BAY 1 (2)

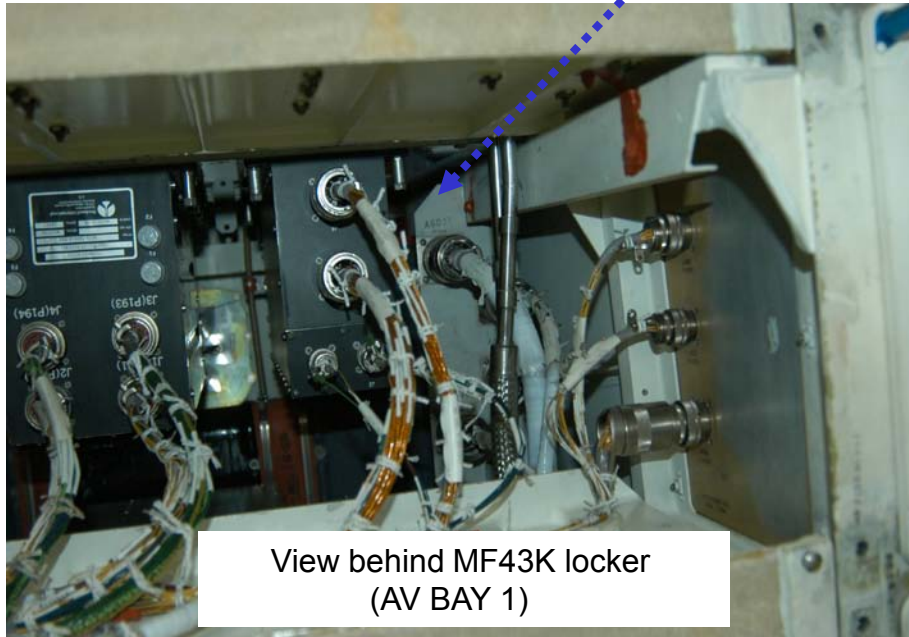
- Remove locker MF43K (MF57K)
- Locate appropriate bracket A60J1 (A61J1) and connector P104
- Locate appropriate wire

View behind MF43K locker
(AV BAY 1)

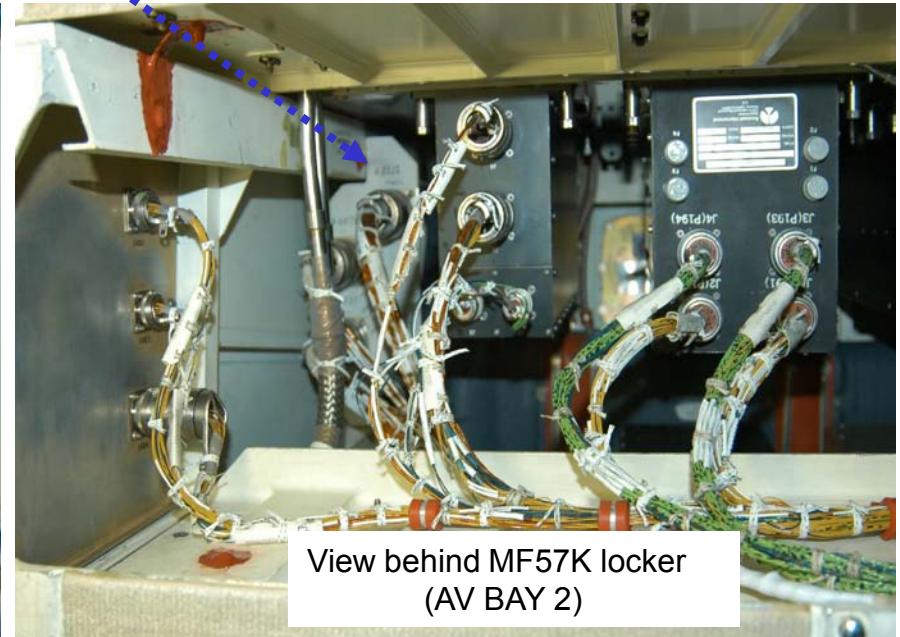
View behind MF57K locker
(AV BAY 2)

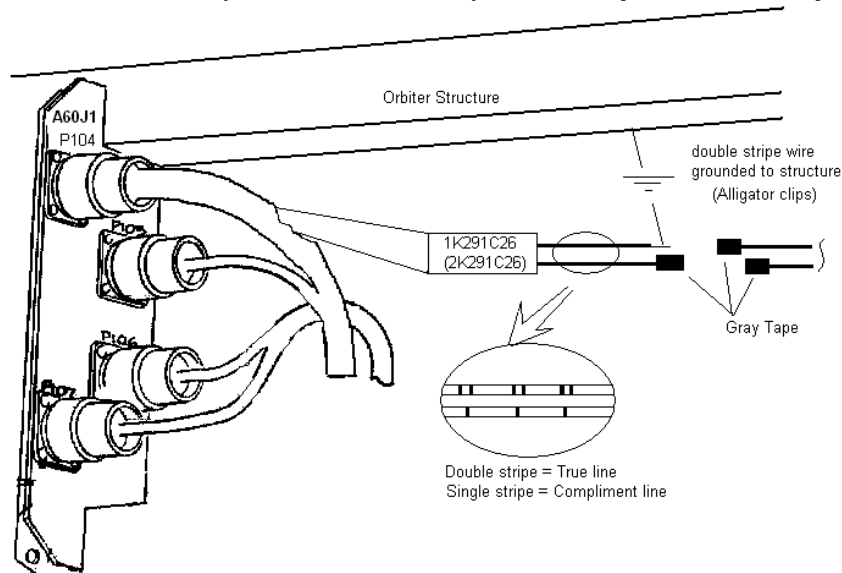
- Cut wire
- Ground True Line (to structure) and open Complement Line

After IPL is done

- Ground Compliment Line and open True Line
(this takes the switch to the OFF position)
